STAGE 2 REPORTS

RE: **Remediation Termination Request**
Rice Operating Company –EME SWD System
C-16(1) and C-16(2) Leaks – OCD Case No. 1R0476 and 1R0477
UL-C, Sec 16 T20S, R37E

Rice Operating Company (ROC) discovered an accidental discharge of an estimated 35 bbls of produced water at the EME C-16 (1) location on October 12th, 2005 and a discharge of an estimated 60 bbls of produced water at the EME C-16 (2) location on January 23rd, 2006 (Figure 1). Approximately 180 cubic yards of chloride impacted soils were subsequently removed from these locations and transported to the Sundance disposal facility in Eunice, New Mexico. During these remedial actions, the pipeline was then replaced with a new polypropylene line.

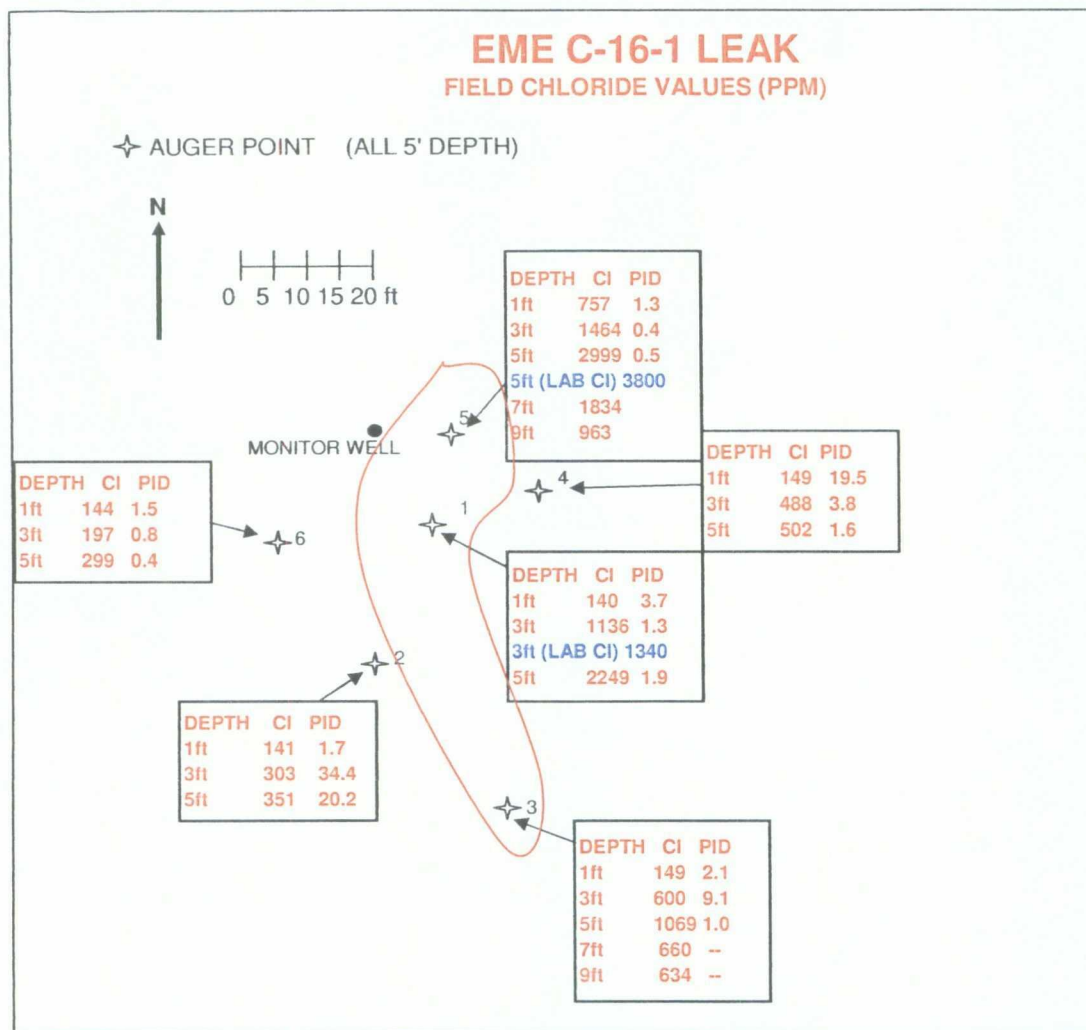
Figure 4 – EME C-16 (1). Soil chloride concentrations measured in June, 2008. Shaded area (covering approximately 1,150 sq ft) encompasses soils having a chloride concentration in excess of 1,000 ppm. The total area of affected soils is estimated to be approximately 2,000 sq ft and has an average estimated residual chloride concentration of 750 ppm over a thickness of 20 +/- ft. The depth to groundwater is approximately 18 ft.

These releases have occurred in an area with known regional impacts to groundwater quality, as evidenced by high relative upgradient groundwater chloride concentrations at each location. Nevertheless, in an effort to compensate for the potential leaching of residual soil chlorides from these two releases, ROC has been removing chloride-affected groundwater from these locations since July of last year. The goal of groundwater extraction was to remove 3,000 lbs of chloride mass from the C-16 (1) site and 633 lbs of chloride mass from the C-16 (2) site per NMOCD "e-mail" approval of July 2nd, 2008 and Texerra's subsequent Technical Summary of July 16th, 2008 (Figures 2&3 and 4&5).

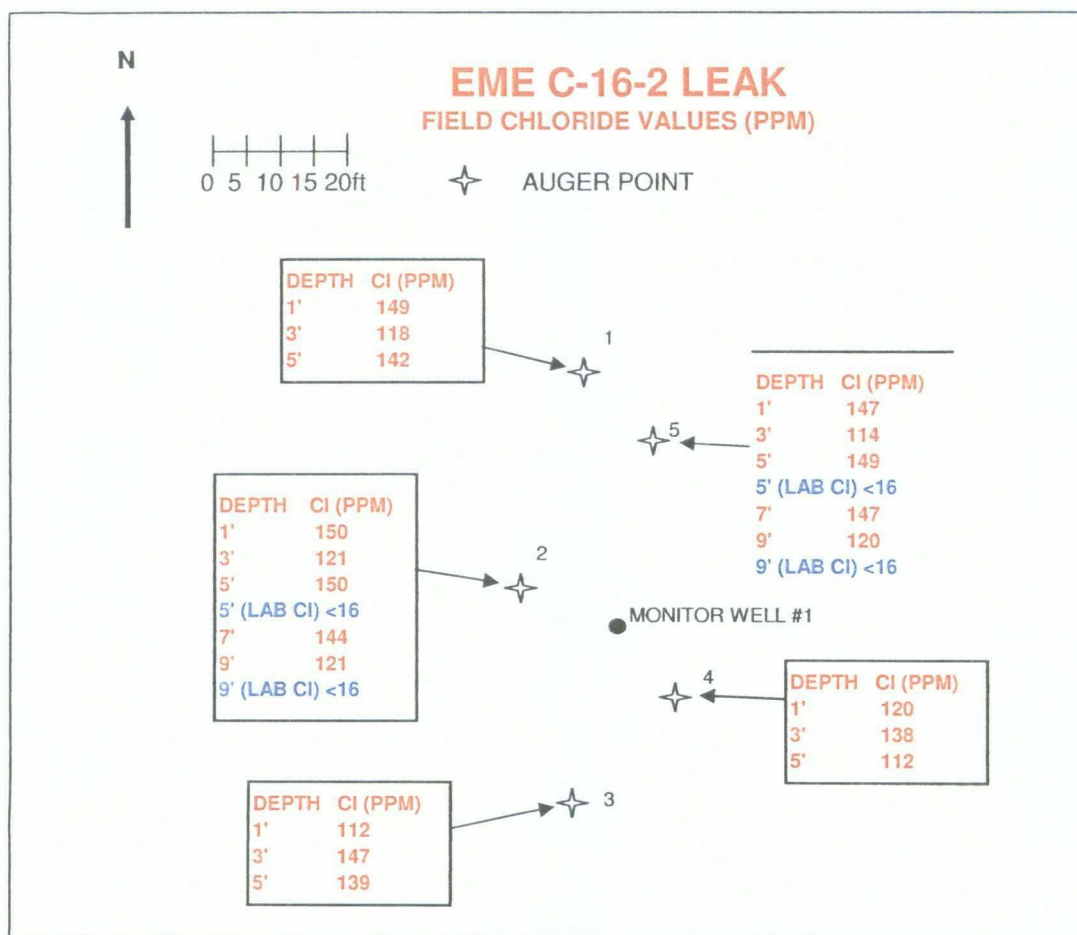
Figure 5 – EME C-16 (2). Soil chloride concentrations measured in June, 2008. Residual soil chloride impacts are negligible. The total area of affected soils is estimated to be approximately 2,000 sq ft and has an average estimated residual chloride concentration of 150 ppm (at most) over a thickness of 19 +/- ft, which is the depth to groundwater.

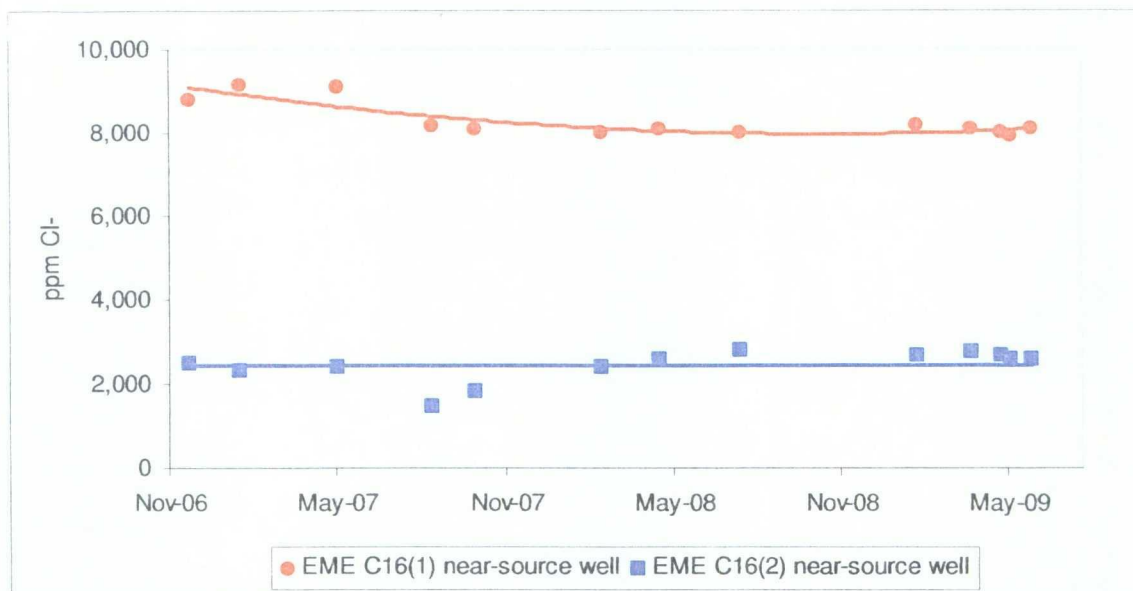
Figure 6 – Groundwater chloride concentrations at the at/near source monitor wells for EME C-16 (1&2).

ROC has removed nearly 3,221 bbls of groundwater from both locations since July of 2008, where it is estimated that each site contributed equally to this total. Based upon time averaged groundwater chloride concentrations of 8,315 and 2,403 ppm for the EME C-16 (1) and EME C-16 (2) sites, respectively, we have met our objectives for groundwater chloride mass reduction (Table 1). The at-source groundwater chloride concentrations have declined slightly but steadily at EME C-16 (1) and have held relatively steady at EME C-16 (2) (Figure 6). It should further be noted that natural vegetation is recovering well at both locations (Figures 7&8). We therefore respectfully request that NMOCD grant termination or similar closure status for these projects.

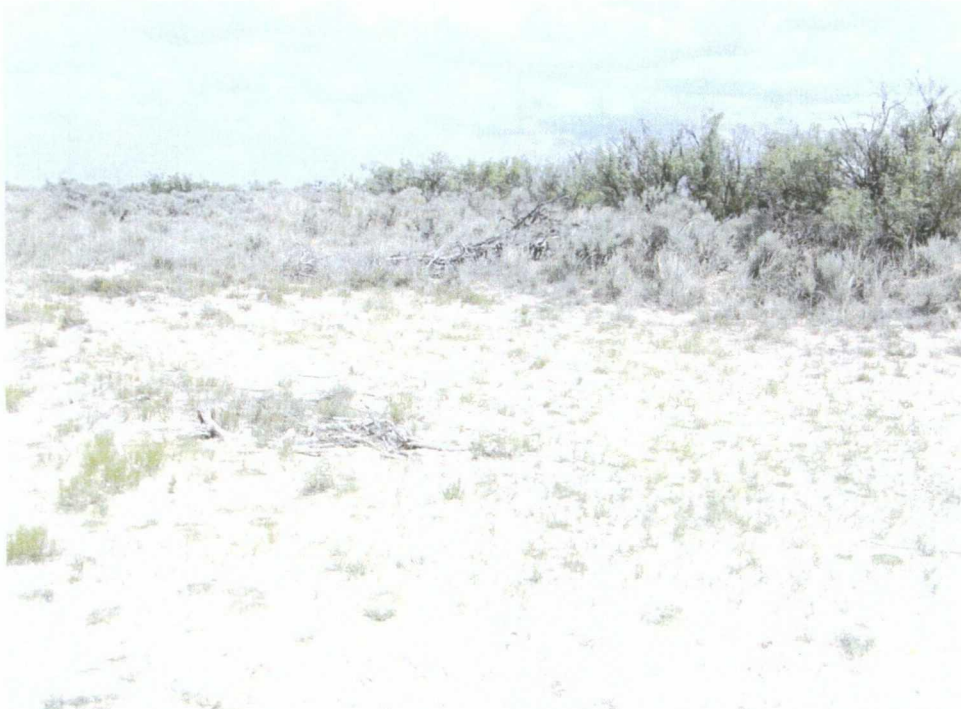
Figure 7 – EME C-16 (1) release location taken 06.30.09.

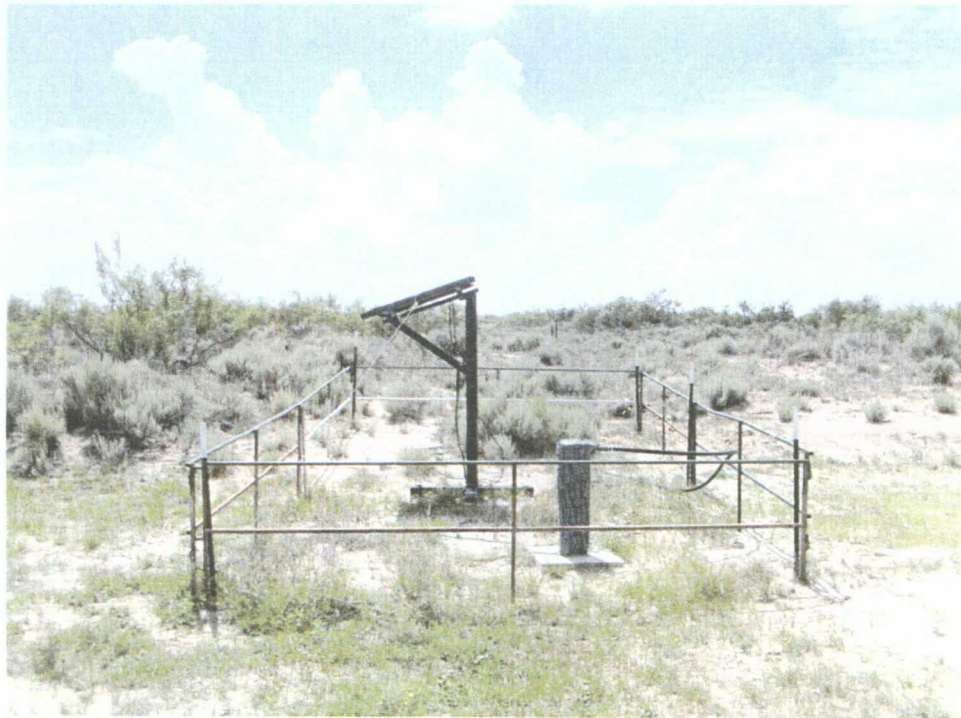
Figure 8 – EME C-16 (2) release location taken 06.30.09.
