# **HAWK B-1 #50 FLOW LINE C141 CLOSURE REPORT**

**API 30-025-38014**

**NMOCD 1RP #1923**

**July 31, 2009**

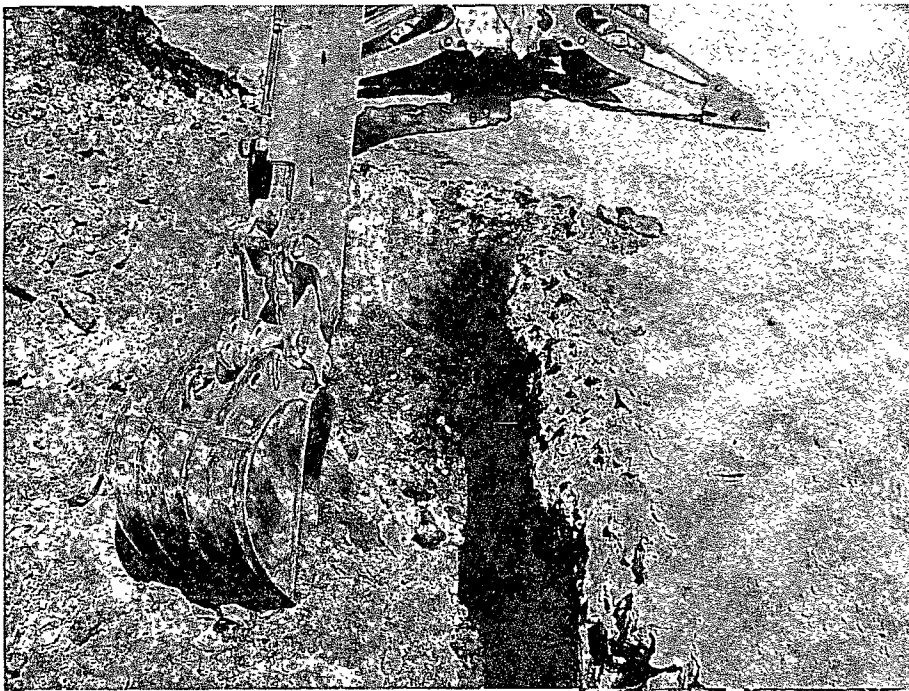
< 8/12/08 – Excavation of contaminated soil

The release area adjacent to Hill Rd. right-of-way was excavated to lateral extents limited by the road surface and numerous flow lines on the pasture side of the release. Bottom hole and sidewall chloride concentrations were below 500-ppm. The bottom of the excavation displayed the highest TPH concentration of 162-ppm and undetectable BTEX levels. The excavation was backfilled with native caliche purchased from the landowner. Lea County Road Dept requires cement reinforcement when the edge of a caliche road is excavated and backfilled. This was accomplished with a 41' X 4.5' X 2.5' deep pour of #2 FlowFill, and then covering with compacted caliche.

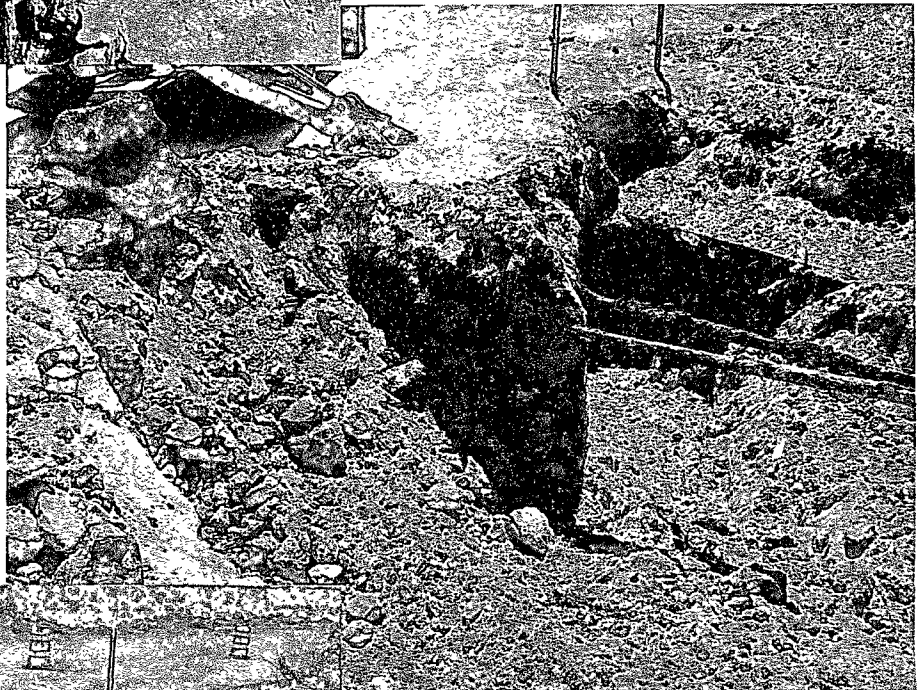
8/13/08 – Continuing excavation and field testing for chlorides >

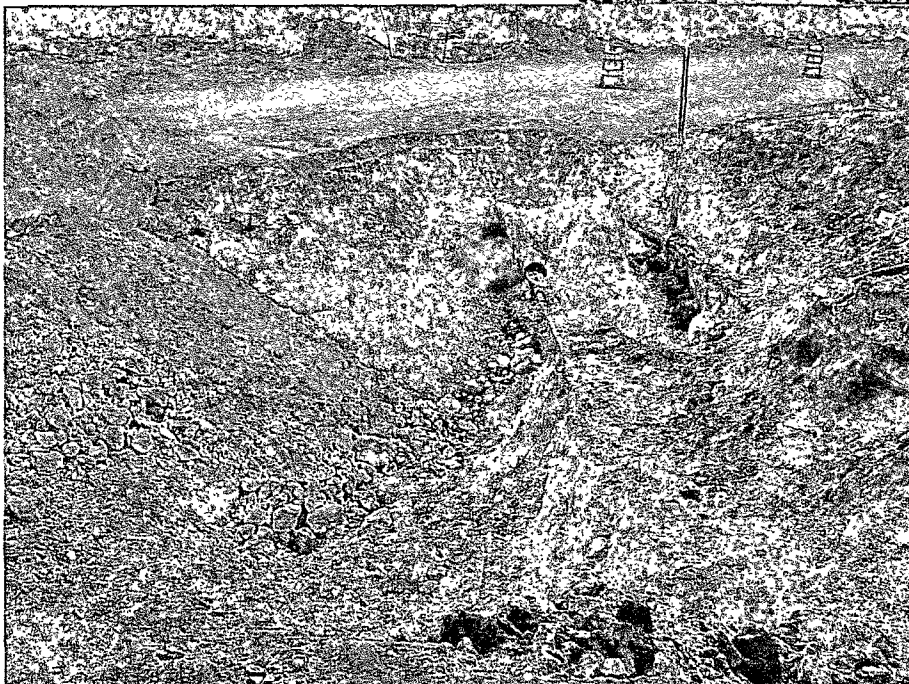
< 8/15/08 – Excavation complete, tested and ready for backfill.

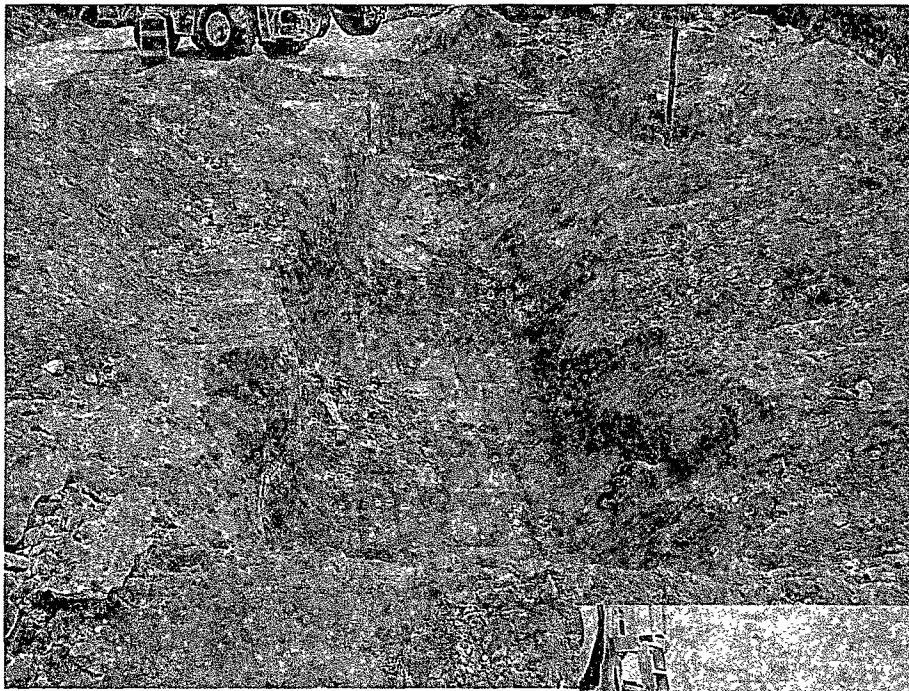
< 8/18/08 – #2 FlowFill  
trench complete, awaiting  
arrival of delivery trucks

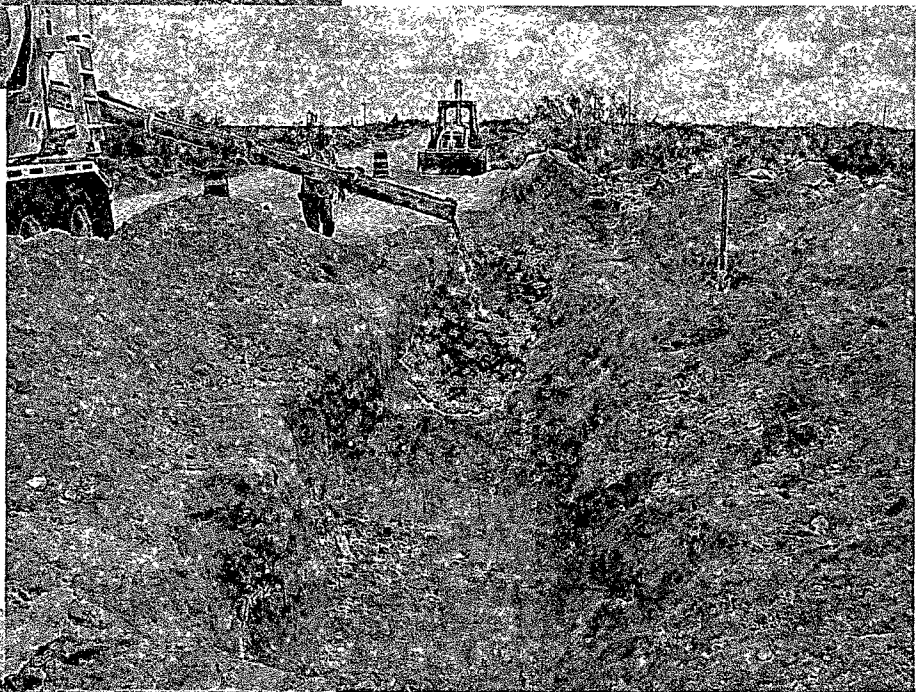
8/18/08 – Commencing  
FlowFill pour >

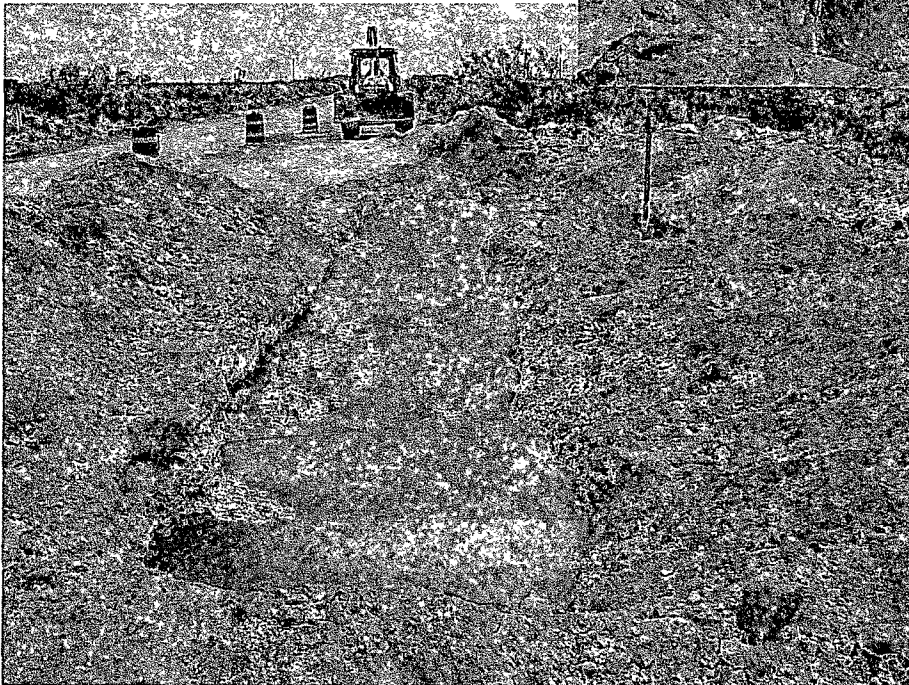
< 8/18/08 – FlowFill pour  
complete – allowed to set overnight,  
and covered the next day.
