Release Notification and Corrective Action

Name of Company: Sandlot Energy	Contact: Jackie Brewer
Address: PO Box 711; Lovington, NM 88260	Telephone No. 575-631-4592
Facility Name RESLER YATES #322	Facility Type Active Production Wellhead

**RE: Closure Report**

Operator: Sandlot Energy/Cantera  
Lease: Ressler Yates #322  
API: 30-015-10285  
Legal: UL-I (NE ¼ of the SE ¼) of Section 20, T18S, R28E  
Eddy County, New Mexico  
Coordinates Latitude: N32° 43' 52.40"; Longitude: W104° 11' 29.24"  
EPI Ref No.: 455004

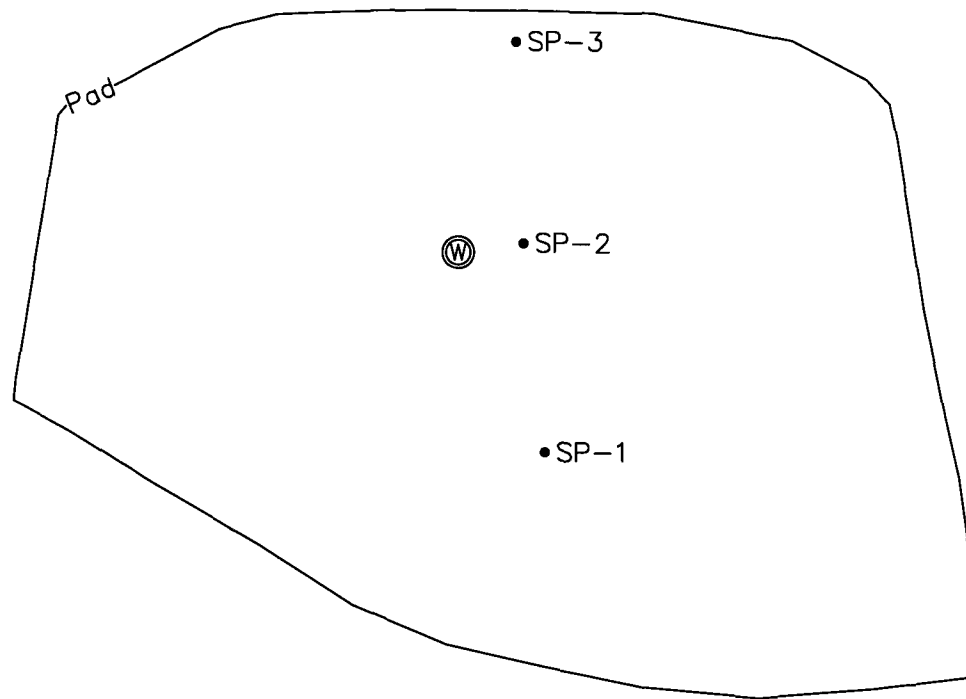
Figure 5  
Sample Location Map  
Sandlot Energy  
Resler Yates #322

On April 17, 2009 EPI mobilized at the well head to direct the location and depth of four (4) soil borings. The soil borings were advanced around the well head area. Due to rock encounter during the boring, soil samples were only collected at a depth of four (4) foot bgs, total depth (TD) of the soil boring (reference *Table 2 for Summary of Soil Boring Soil Sample Analytical Results*).

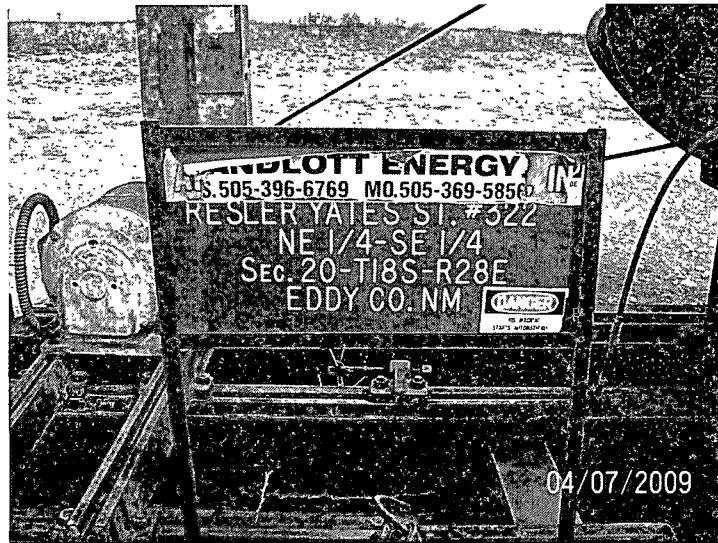
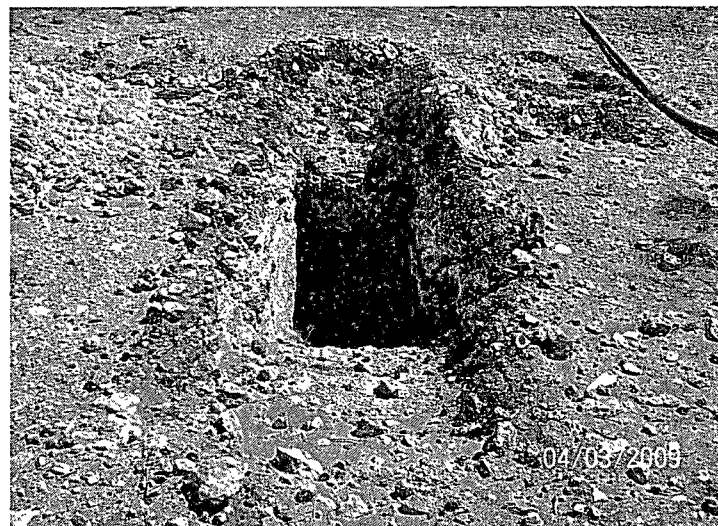
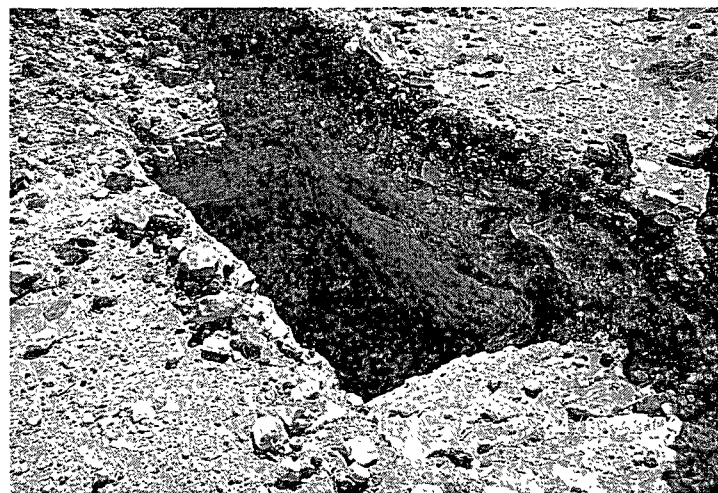
**ATTACHMENT I**  
**SITE PHOTOGRAPHS**

- C. **Remedial Activities** – In July 2008, Sandlot Energy/Cantera excavated the area around the well head, transported impacted material to Controlled Recovery Inc, and backfilled the hole with material from on site. No soil samples were prior to backfilling activities.

The entire area was contoured to allow natural drainage and vehicular traffic.
