Vacuum I-32 Vent Boot

**RICE OPERATING COMPANY
JUNCTION BOX FINAL REPORT**

SWD SYSTEM	JUNCTION	UNIT	SECTION	TOWNSHIP	RANGE	COUNTY	BOX DIMENSIONS - FEET		
							Length	Width	Depth
Vacuum	vent I-32 boot	I	32	17S	35E	Lea	no box; system abandonment

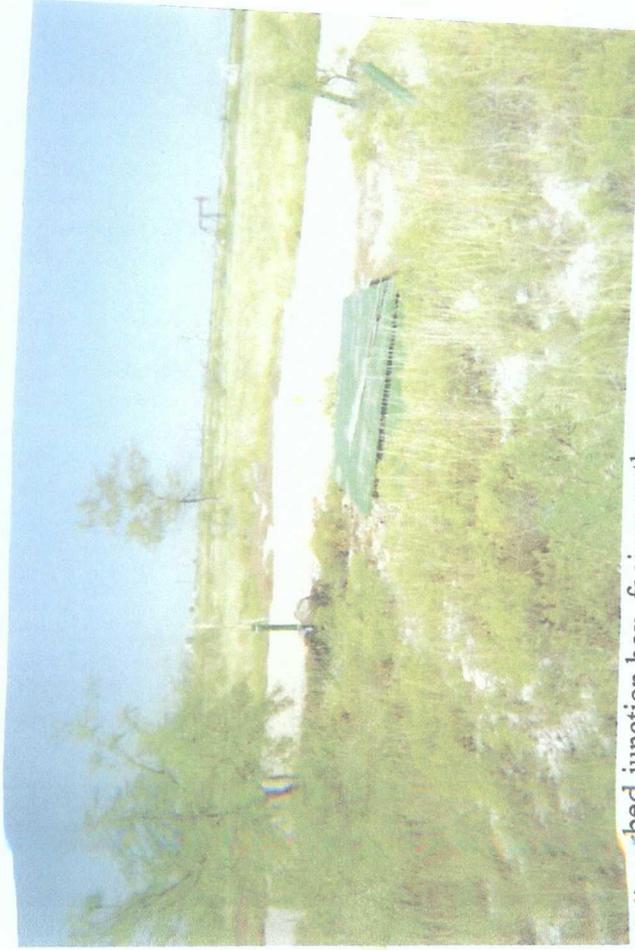
undisturbed junction box, facing north

10/25/2005

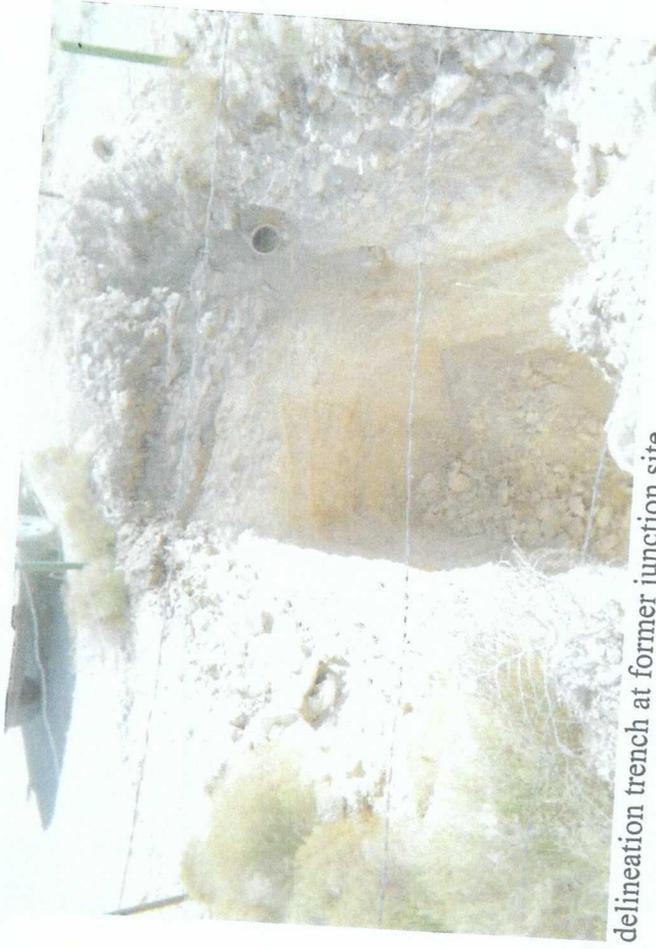
delineation trench at former junction site

3/04/2008

General Description of Remedial Action: This junction was addressed under the Vacuum SWD System abandonment. After this junction was removed, an investigation was conducted using a backhoe to collect soil samples at regular intervals producing a 5x3x12-ft-deep hole. Chloride field tests were performed on each sample, which yielded low concentrations. Organic vapors were measured using a PID, which also yielded low concentrations. The deepest sample, 12 ft BGS, was sent to a commercial laboratory for analysis of chloride and TPH, which confirmed low concentrations. The excavated soil was returned to the excavation and clean, imported soil was used as a top cap and to contour to the surrounding area. On 3/20/2008, the site was seeded with a blend of native vegetation and is expected to return to a productive capacity at a normal rate.

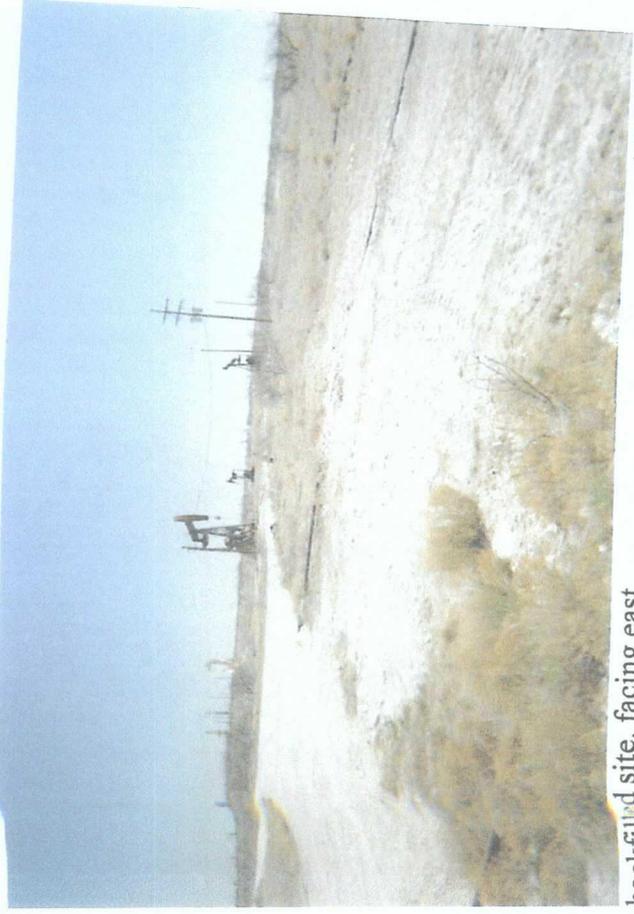
backfilled site, facing east

3/19/2008

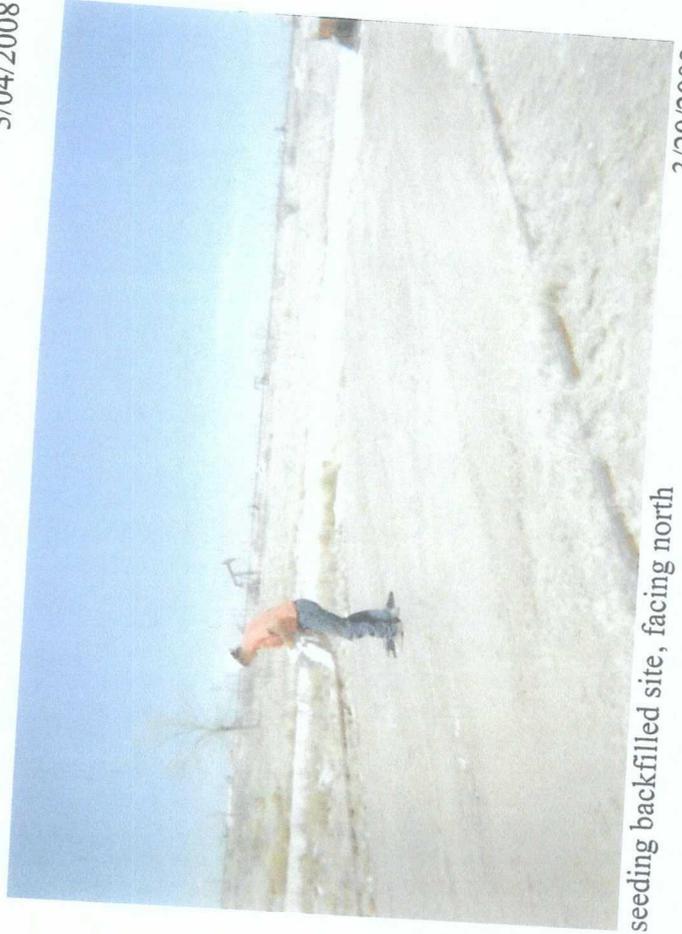
seeding backfilled site, facing north

3/20/2008

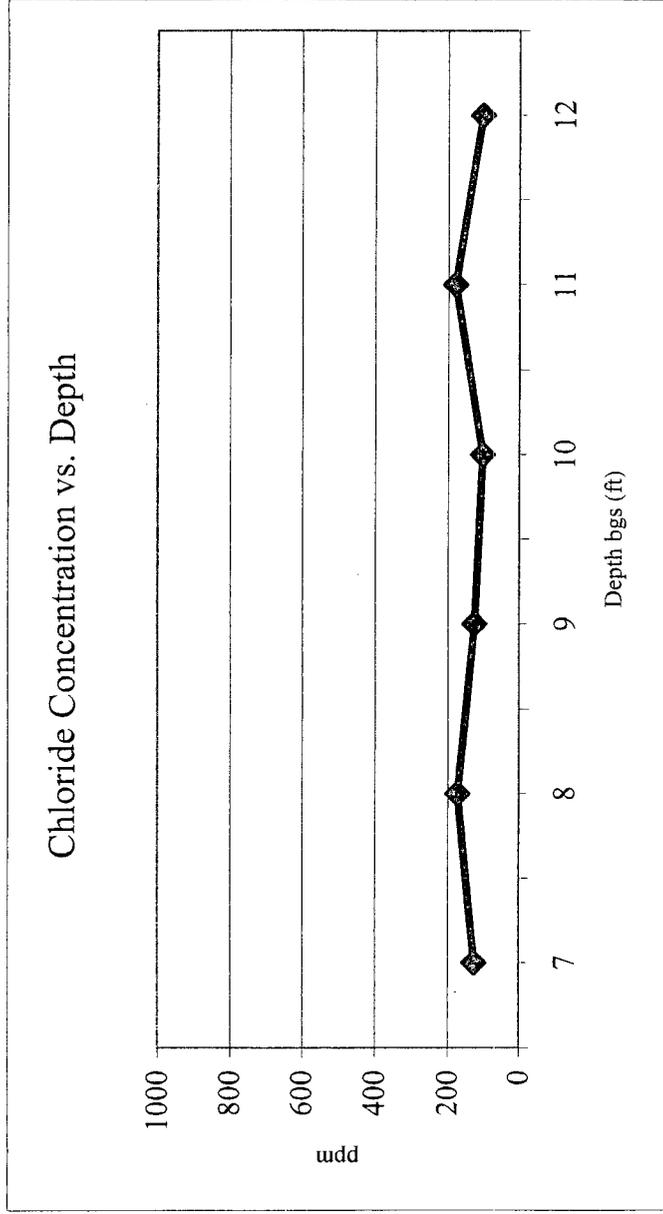
Backhoe samples at junction (source)

Depth bgs (ft)	[Cl] ppm
7	127
8	173
9	126
10	103
11	179
12	103

Groundwater = 80 ft
