Vacuum Exxon 'K' EOL

CLOSURE

**RICE OPERATING COMPANY
JUNCTION BOX FINAL REPORT**

Unit I, Section 32, T17S, R35E

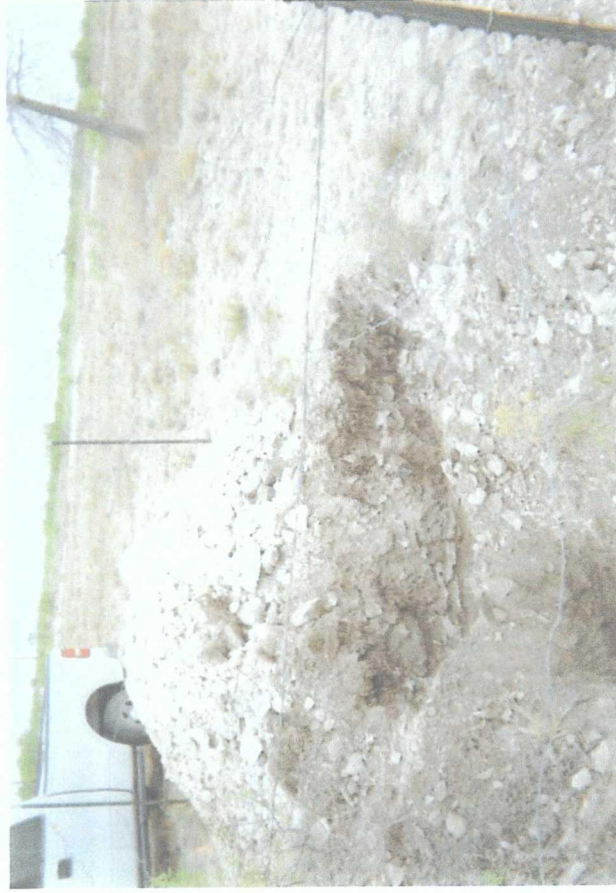
5/5/2008

delineation trench at former junction site, facing south

General Description of Remedial Action: This junction was addressed under the Vacuum SWD System abandonment. After the junction was removed, an investigation was conducted using a backhoe to collect soil samples at regular intervals producing a 5x3x6-ft-deep hole. Chloride field tests were performed on each sample, which yielded low concentrations. Organic vapors were measured using a PID, which also yielded low concentrations. The deepest sample, 6 ft BGS, was sent to a commercial laboratory for analysis of chloride and TPH, confirming low concentrations. The excavated soil was returned to the excavation and clean, imported soil was used as a top cap and to contour to the site to the surrounding area. On 5/22/2008, the site was seeded with a blend of native vegetation and is expected to return to a productive capacity at a normal rate.

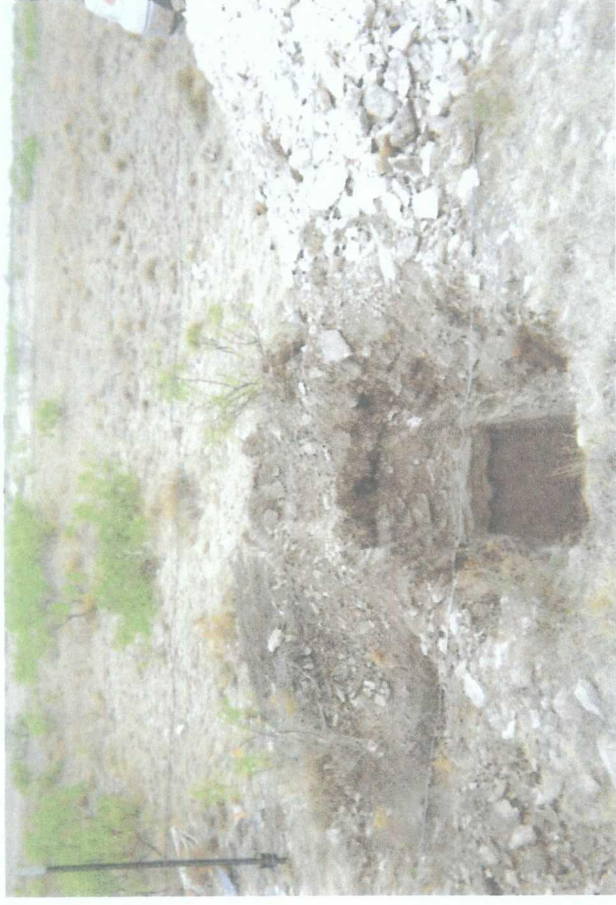
5/5/2008

delineation trench at former junction site, facing east

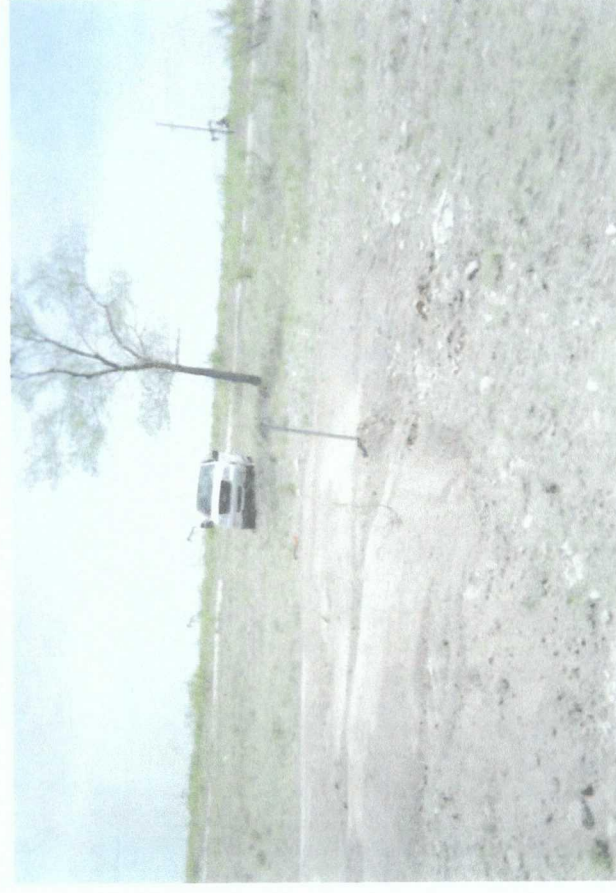
5/21/2008

backfilled excavation, facing south

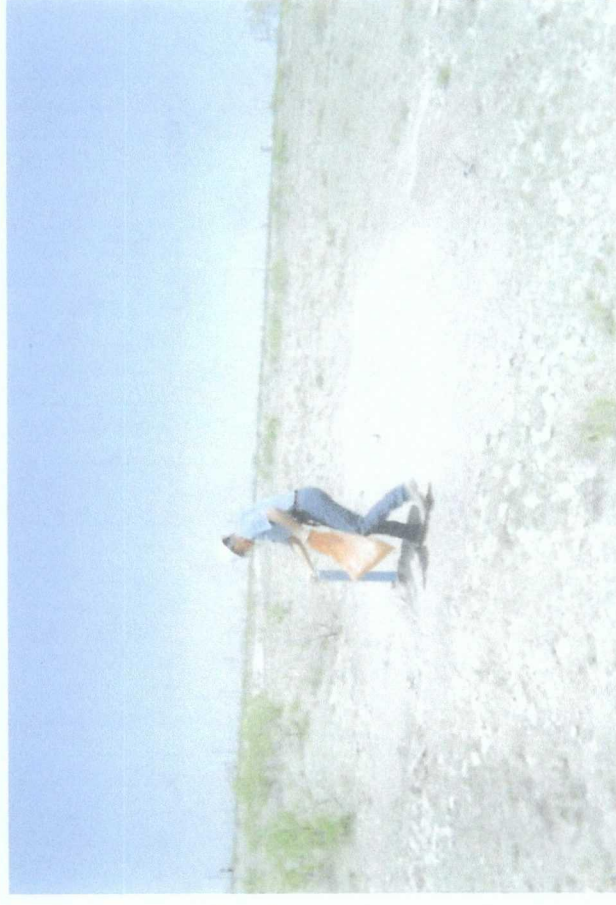
5/22/2008

seeding backfilled site, facing east
