Vacuum Jct J-34

**RICE OPERATING COMPANY
JUNCTION BOX FINAL REPORT**

Vacuum Jct. J-34

Unit J, Section 34, T17S, R35E

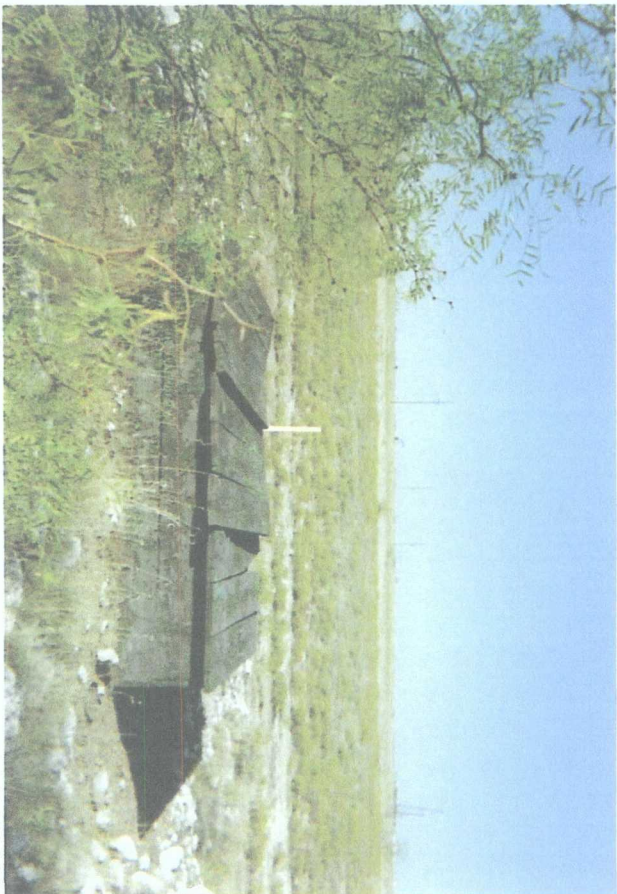
11/14/2005

undisturbed junction box, facing north

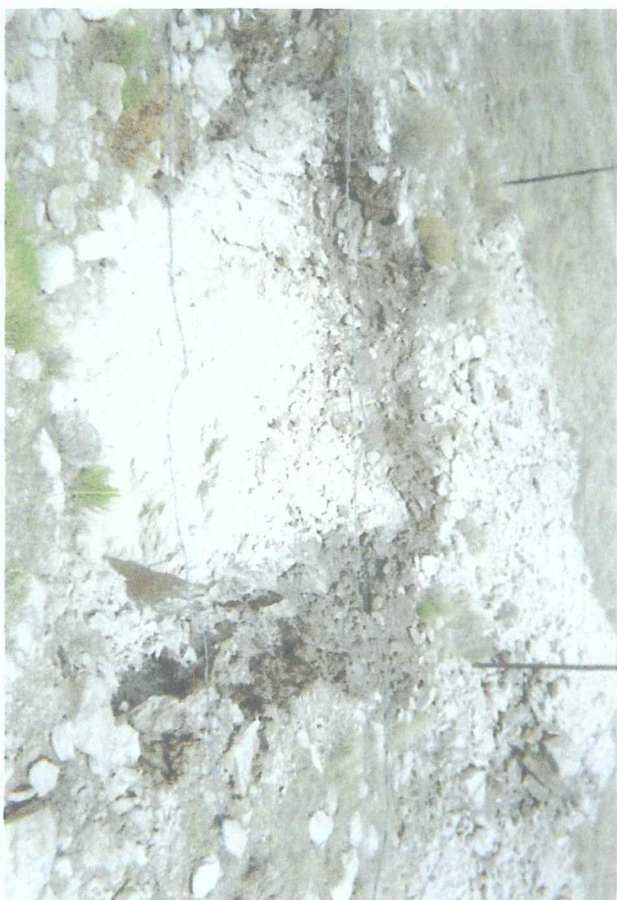
4/30/2008

delineation trench at former junction site

General Description of Remedial Action: This junction was addressed under the Vacuum SWD System abandonment. After this junction was removed, an investigation was conducted using a backhoe to collect soil samples at regular intervals producing a 5x3x8-ft-deep hole. Chloride field tests were performed on each sample, which yielded low concentrations similar to that of the background. Organic vapors were measured using a PID, which also yielded low concentrations. The deepest sample, 8 ft BGS, was sent to a commercial laboratory for analysis of chloride and TPH, which confirmed low concentrations. The excavated soil was returned to the excavation and clean soil was imported to top cap the site and to contour to the surrounding area. On 5/20/2008, the site was seeded with a blend of native vegetation and is expected to return to a productive capacity at a normal rate.

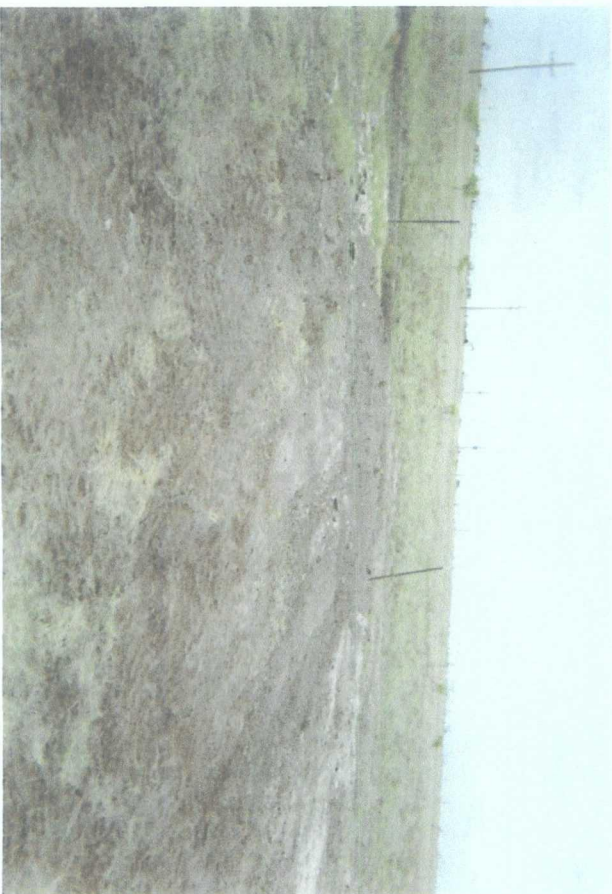
5/15/2008

backfilled excavation, facing north

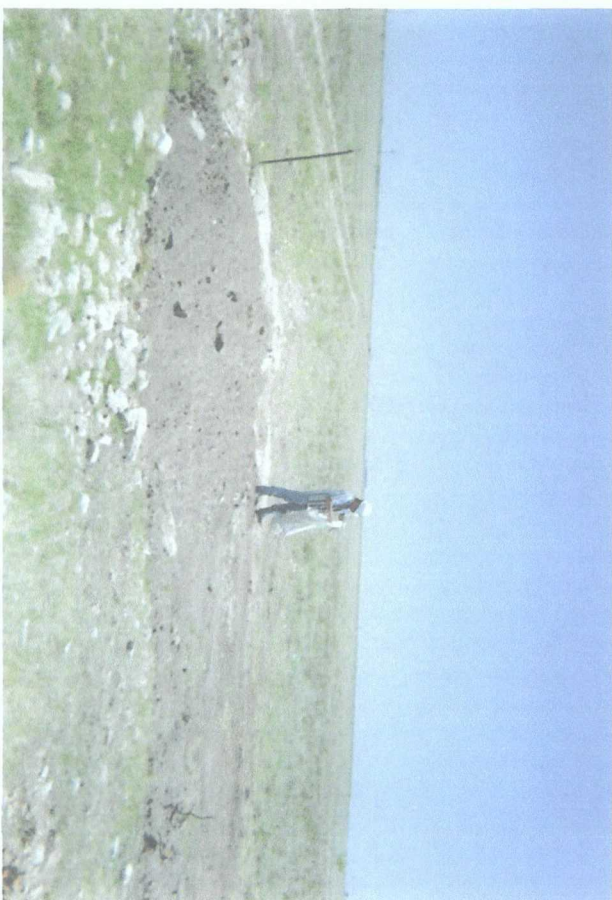
5/20/2008

seeding backfilled site, facing east

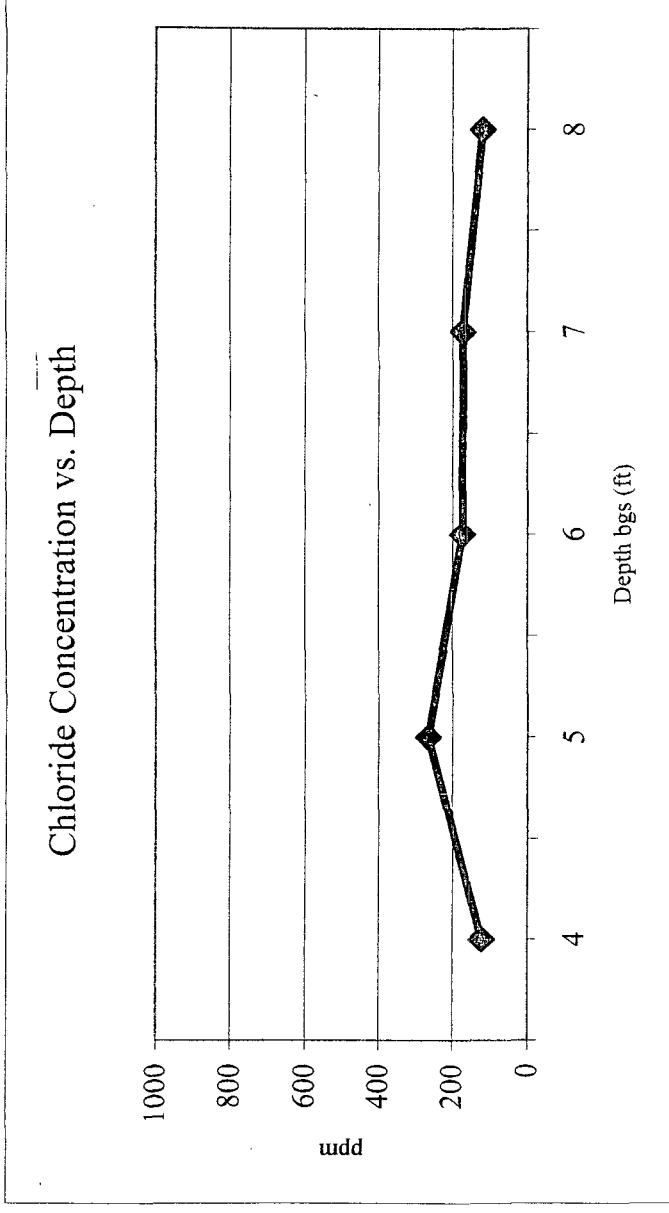
Vacuum Jct. J-34

Backhoe samples at junction (source)

Depth bgs (ft)	[Cl] ppm
4	122
5	266
6	174
7	172
8	119

Groundwater = 92 ft
