**RICE OPERATING COMPANY
JUNCTION BOX FINAL REPORT**

SWD SYSTEM	JUNCTION	UNIT	SECTION	TOWNSHIP	RANGE	COUNTY	BOX DIMENSIONS - FEET		
Blinebry-Drinkard (BD)	M-33 vent	M	33	21S	37E	Lea	Length 16'	Width 10'	Depth 4'
							moved 40 ft east

BD M-33 vent

Unit M, Section 33, T21S, R37E

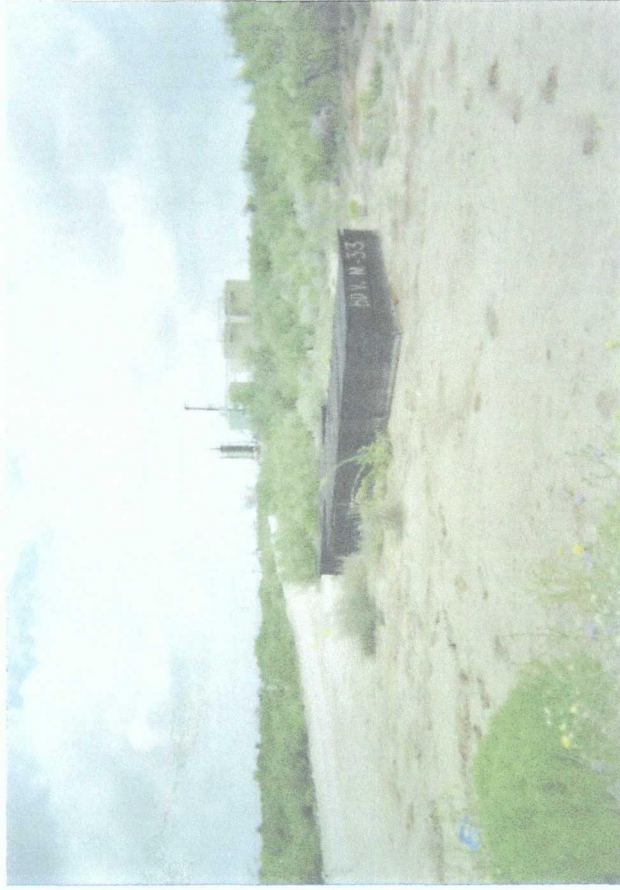
undisturbed junction box, facing north

8/5/2005

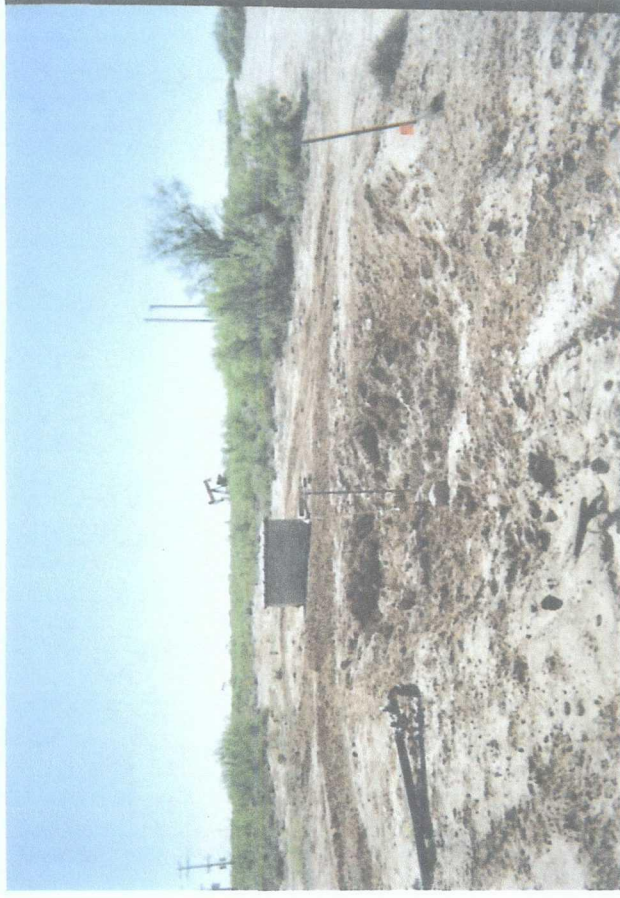
hand auger at former junction site

10/19/2007

General Description of Remedial Action: This junction was addressed under the pipeline replacement/upgrade program. A new, watertight junction box was built 40 ft east of the former. After the former box was removed, an investigation was conducted using hand auger to collect soil samples at regular intervals. Chloride field tests were performed on each sample, which yielded low concentrations similar to that of the background. Organic vapors were measured using a PID, which also yielded low concentrations. The deepest sample was sent to a commercial laboratory for analysis of chloride and TPH, which confirmed low concentrations. Clean soil was imported to backfill the site and to contour to the surrounding area. On 11/30/2007, the site was seeded with a blend of native vegetation and is expected to return to a productive capacity at a normal rate.

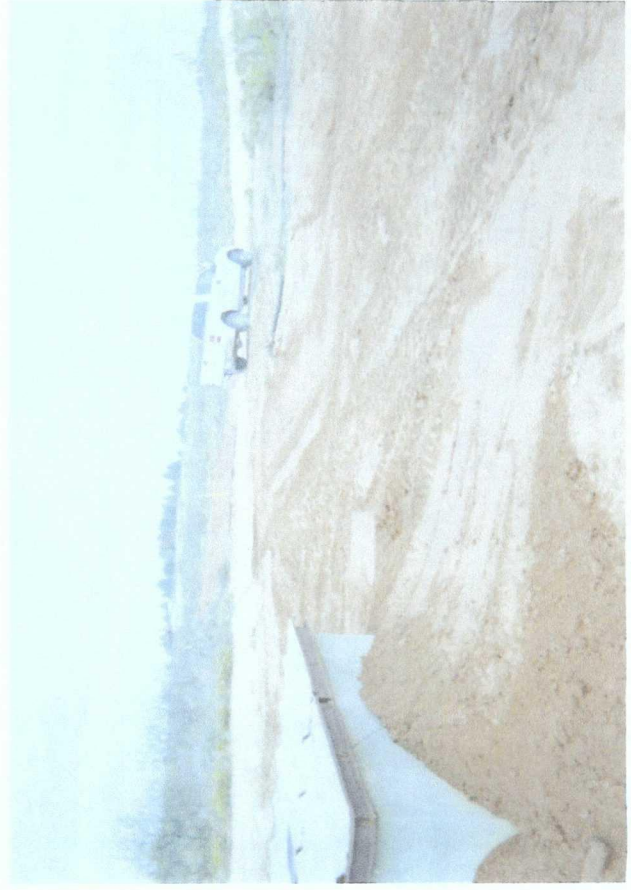
spreading clean, imported soil on site

11/30/2007

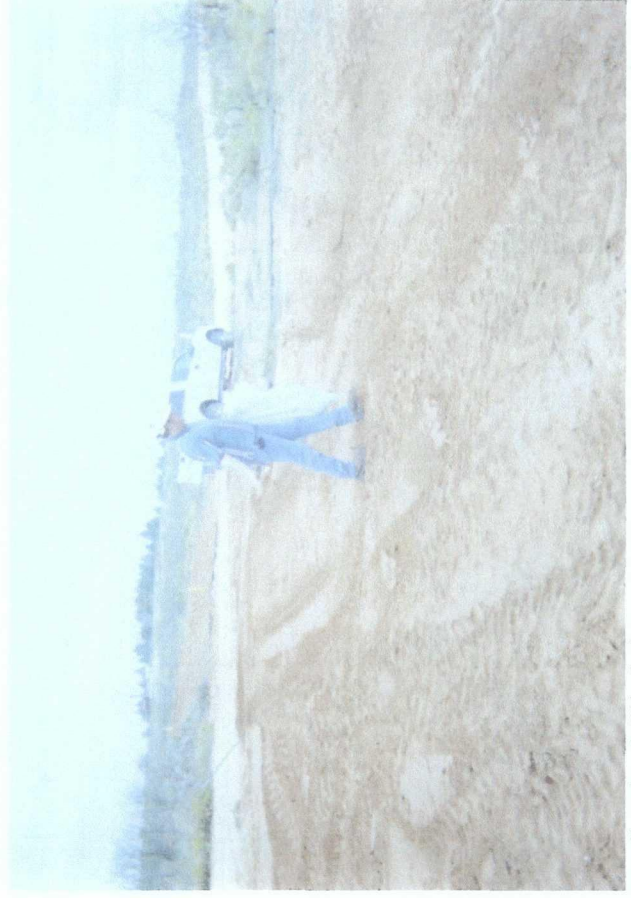
seeding backfilled site

11/30/2007
