**RICE OPERATING COMPANY
JUNCTION BOX FINAL REPORT**

SWD SYSTEM	JUNCTION	UNIT	SECTION	TOWNSHIP	RANGE	COUNTY	BOX DIMENSIONS - FEET		
Blinebry-Drinkard (BD)	Jct. P-15 (2 boxes)	P	15	22S	37E	Lea	Length	Width	Depth
							same location

BD Jct. P-15

Unit P, Section 15, T22S, R37E

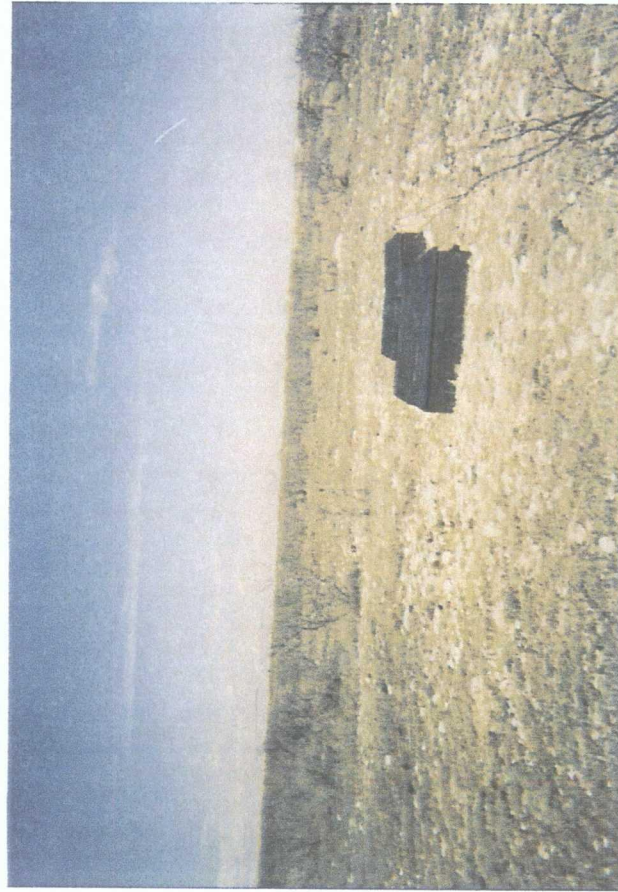
2/7/2005

undisturbed junction boxes, facing north

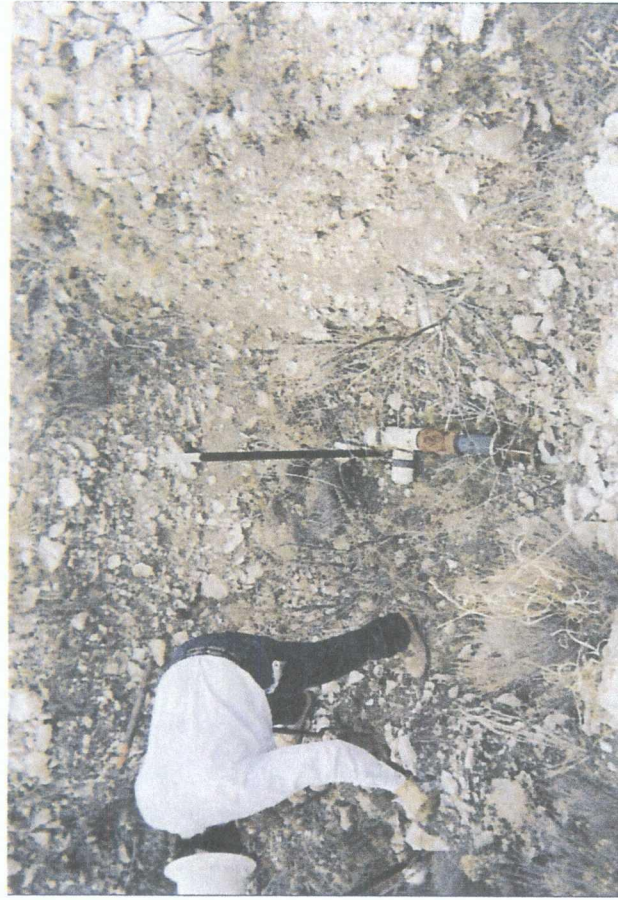
3/8/2007

taking a 4-wall composite sample

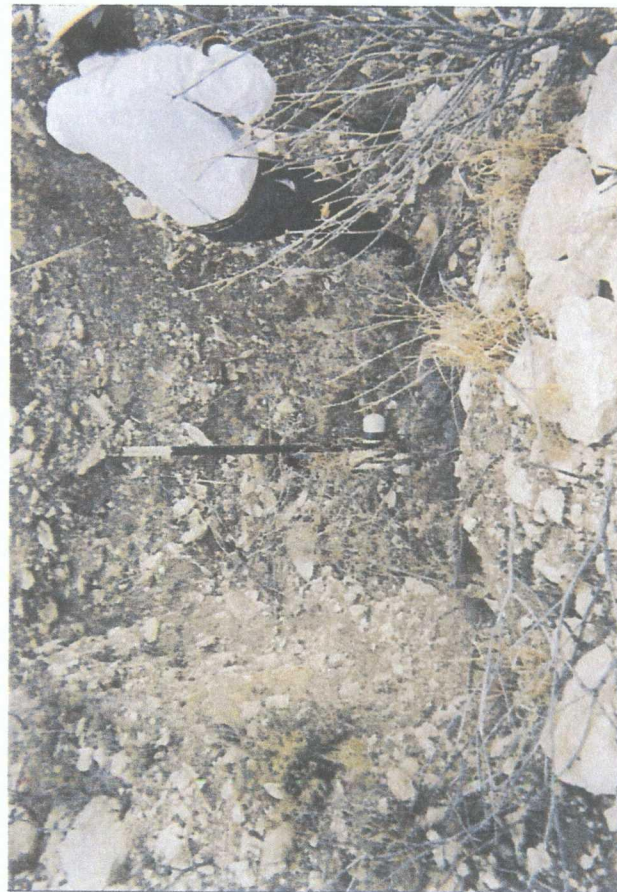
3/8/2007

taking a bottom grab sample at the source

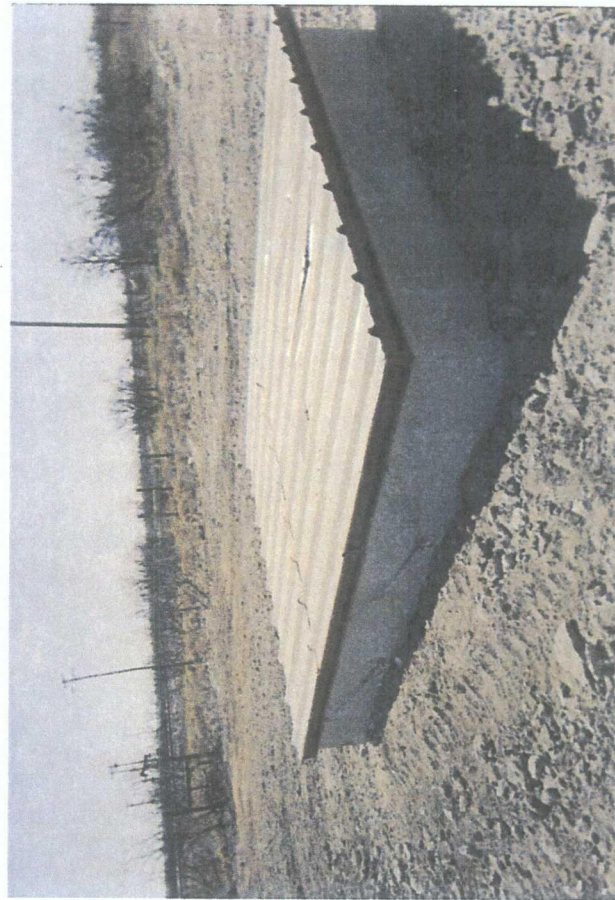
3/20/2008

new, watertight junction box

After the former junction boxes were removed, an investigation was conducted using hand auger at the source to collect soil samples. Field tests were performed on each sample to determine chloride and organic vapor concentrations. Chloride field tests yielded low concentrations. Organic vapors were measured using a PID, which also yielded low concentrations. A 4-wall composite sample and a 5 ft bottom grab sample from the source was sent to a commercial laboratory for analysis of chloride and TPH, confirming low concentrations. The excavated soil was returned to the excavation after new plumbing and new pipeline was installed. A new, watertight junction box was built in place of the former junction boxes.
