BD Markham State 36 EOL

1R426-196

**RICE OPERATING COMPANY
JUNCTION BOX FINAL REPORT**

Unit I, Section 36, T21S, R36E

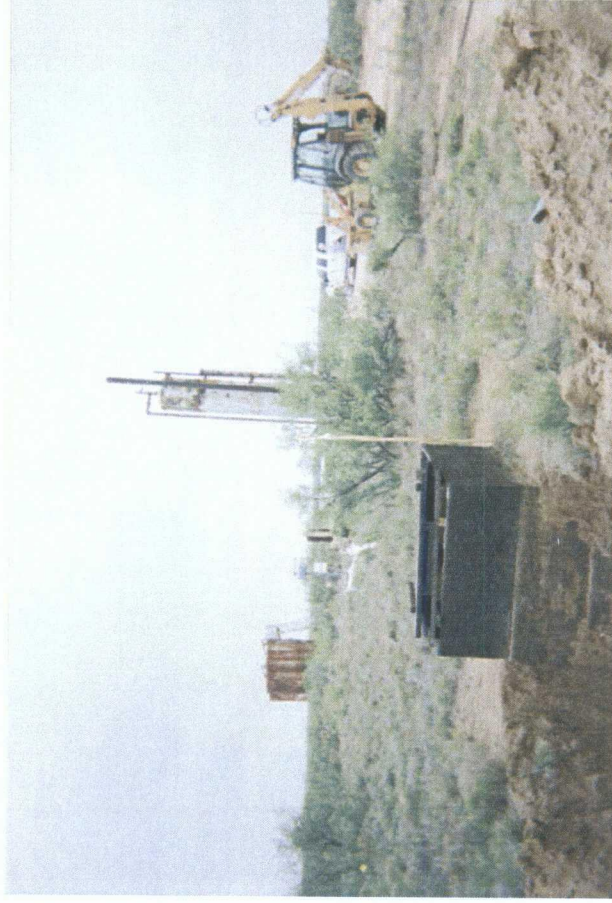
9/3/2008

former junction box

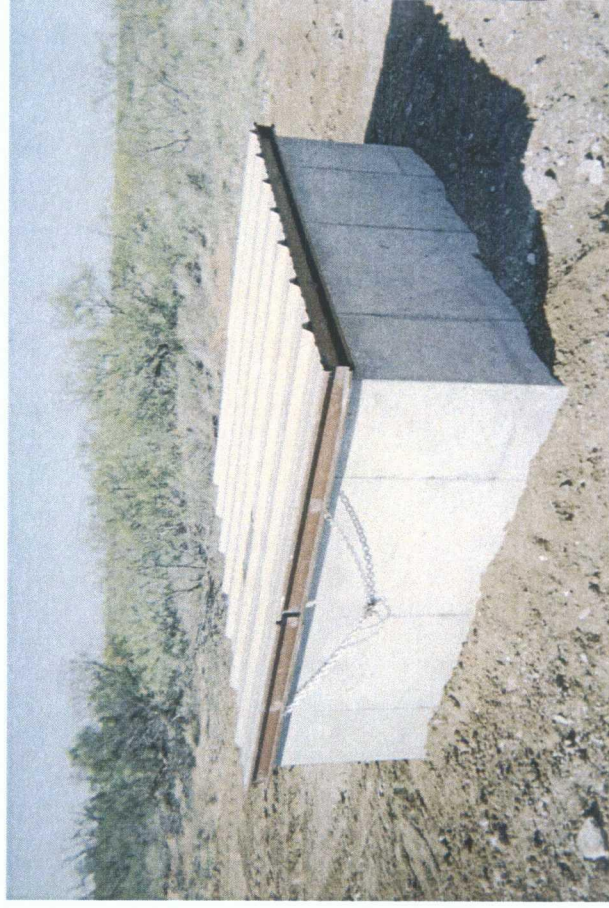
11/4/2008

new, watertight junction box

General Description of Remedial Action: This junction was addressed during the pipeline replacement/upgrade program. After the former junction box was removed, an investigation was conducted using a backhoe to collect soil samples at regular intervals producing a 3x5x12-ft-deep excavation. Chloride field tests were performed on each sample which yielded low concentrations similar to that of the background. Organic vapors were measured using a PID, which also yielded low concentrations. The deepest sample, 12 ft BGS, was sent to a commercial laboratory for analysis of chloride and TPH, confirming low concentrations. The excavated soil was returned to the excavation and a new, watertight junction box was built in place of the former.
