BD Jct C-4-2

/R426-202

**RICE OPERATING COMPANY  
JUNCTION BOX DISCLOSURE\* REPORT**

# BD Jct. C-4-2

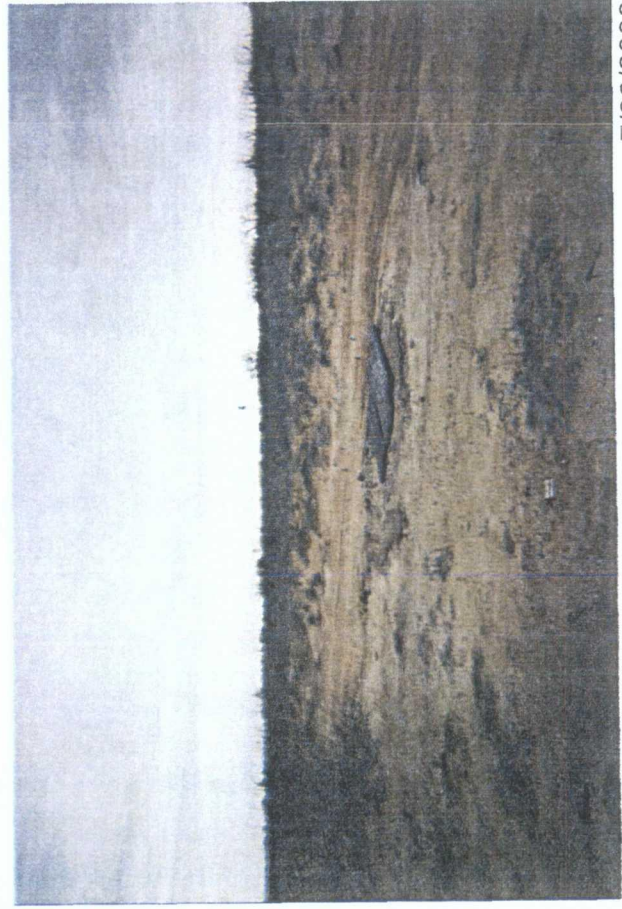
undisturbed junction box

7/28/2003

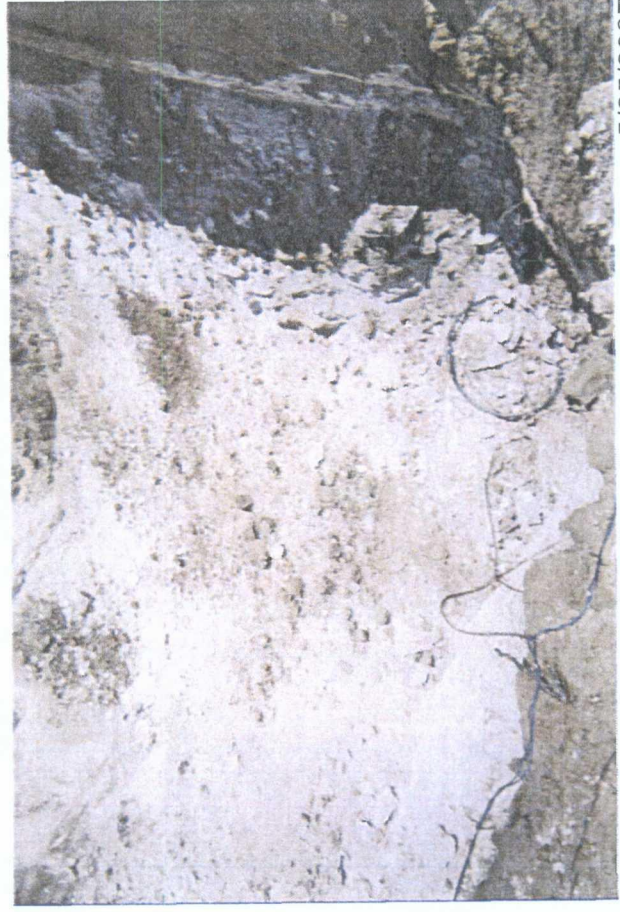
excavation at former junction site

5/25/2007

**General Description of Remedial Action:** This junction box was eliminated during the pipeline replacement/upgrade program. After the former junction box was removed, an investigation was conducted using a backhoe to collect soil samples at regular intervals producing a 30x30x12-ft-deep excavation. Chloride field tests performed on each sample yielded elevated concentrations that did not relent with depth. Organic vapors were measured using a PID, which yielded low concentrations. Representative composite samples were sent to a commercial laboratory for analysis of chloride and TPH, which confirmed elevated chloride concentrations. The excavated soil was blended on site with clean imported soil and returned to the excavation up to 6 ft below ground surface (BGS). At 6-5 ft BGS, a 1-ft-thick clay barrier was installed. The remaining fill was used to backfill the excavation and clean, imported soil was used as a top cap and to contour to the surrounding area. On 6/18/2007, the site was seeded with a blend of native vegetation and is expected to return to a productive capacity at a normal rate. An identification plate was placed on the surface above the former junction to mark the presence of the clay below.

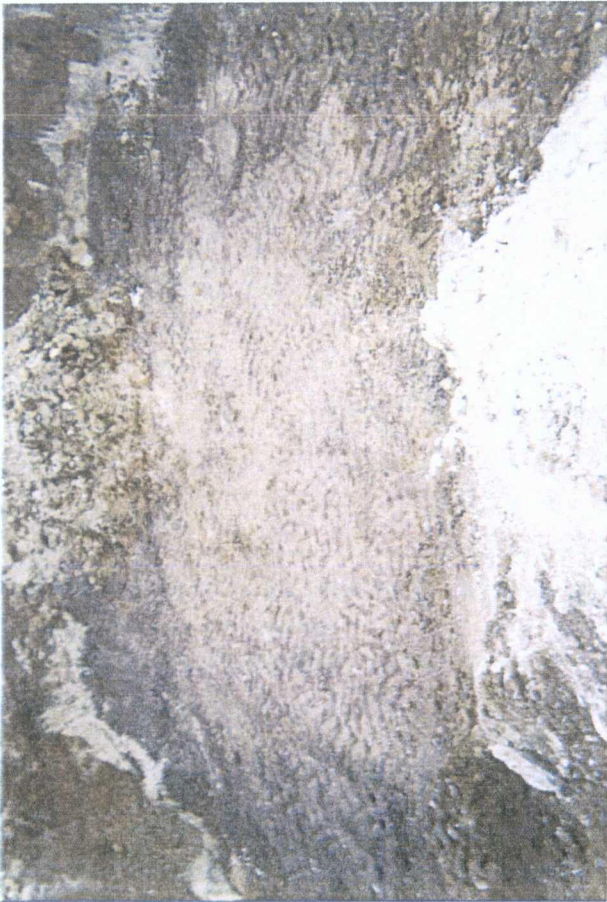
excavation with clay barrier installed

6/11/2007

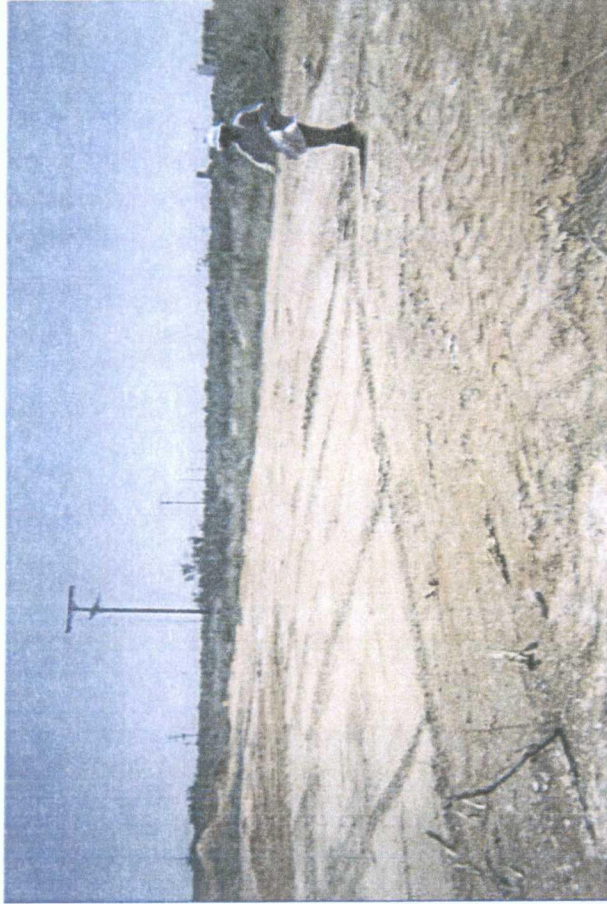
seeding backfilled site

6/18/2007

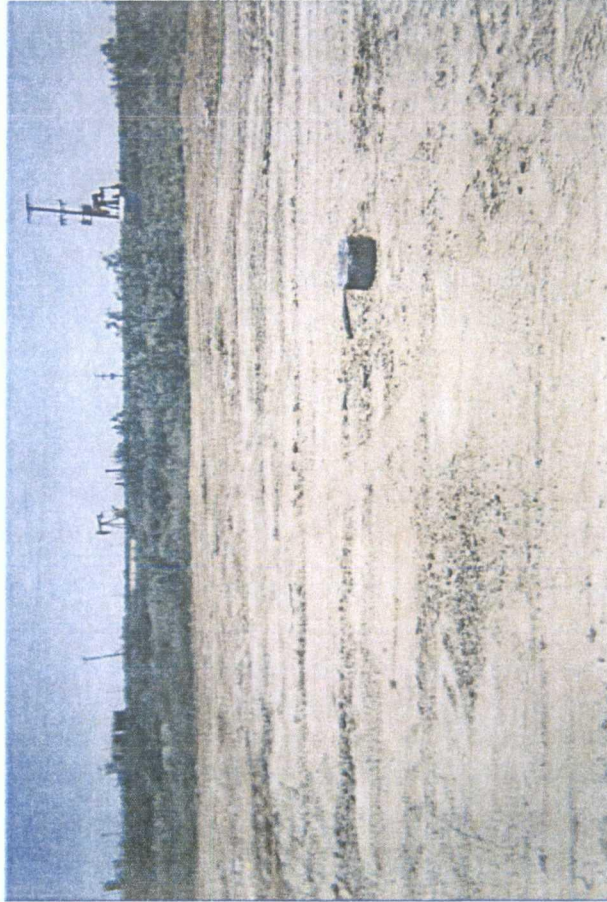
site complete with clay marker

6/18/2007

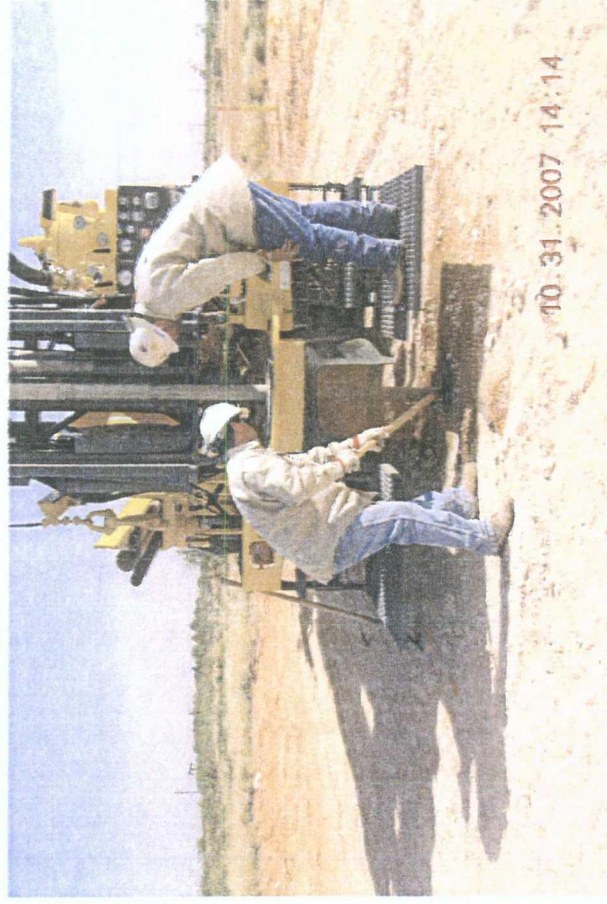
soil boring #1 at the source

10/31/2007

To further investigate depth of chloride presence, four soil borings were initiated on 10/31/2007 and 11/1/2007. Soil borings #1 and #2 were advanced to a depth of 85 ft BGS, soil boring #3 was advanced to a depth of 60 ft BGS, and soil boring #4 was advanced to a depth of 50 ft BGS. Soil samples were collected every 5 ft and field tested for chlorides. The deepest sample from each soil boring was sent to a commercial laboratory for analysis of chloride, which confirmed elevated concentrations. Each borehole was plugged with bentonite to the ground surface. NMOCD was notified of potential groundwater impact on 1/9/2009.
