RICE OPERATING COMPANY JUNCTION BOX DISCLOSURE* REPORT

BD vent A-1

SYSTEM	JUNCTION	UNIT	SECTION	TOWN SHIP	RANGE
BD	VENT A-1	A	1	22S	36 E 488

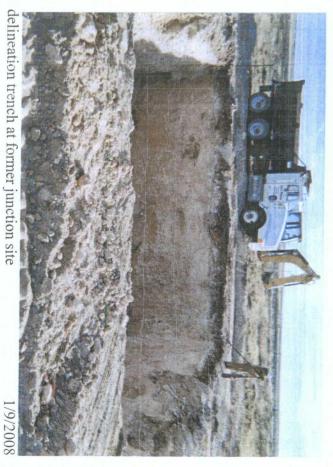
delineation trench at former junction site

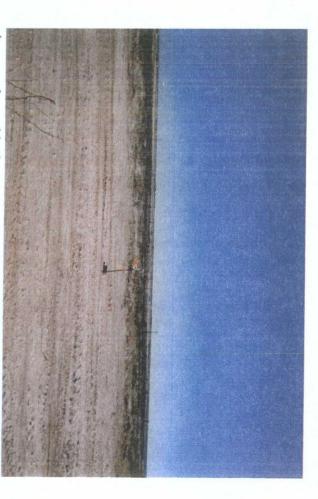
1/29/2008

site complete with clay marker

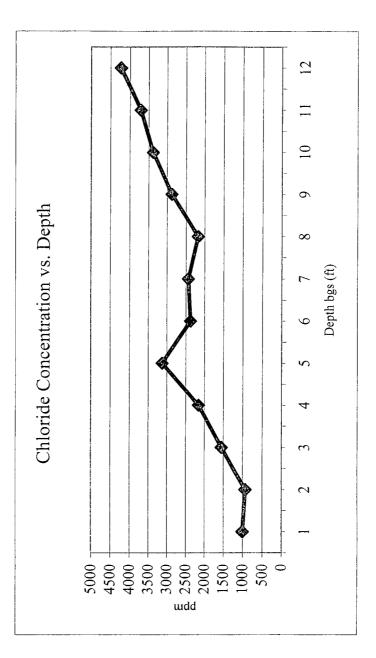
BD vent A-1 Unit'A', Sec. 1, T22S, R36E

Backhoe samples at 5 ft north of the junction (source)

1008	986	1556	2159	3128	2377	2436	2176	2881	3384	3713	4233
Depth bgs (ft)	_	2	3	4	5	9	<i>L</i>	8	6	10	11	12
