**RICE OPERATING COMPANY  
JUNCTION BOX DISCLOSURE\* REPORT**

SWD SYSTEM	JUNCTION	UNIT	SECTION	TOWNSHIP	RANGE	COUNTY	BOX DIMENSIONS - FEET		
Blinebry-Drinkard. (BD)	B-4-2	B	4	22S	37E	Lea	Length	Width	Depth
							Eliminated

# BD Junction B-4-2

Unit B, Section 4, T22S, R37S

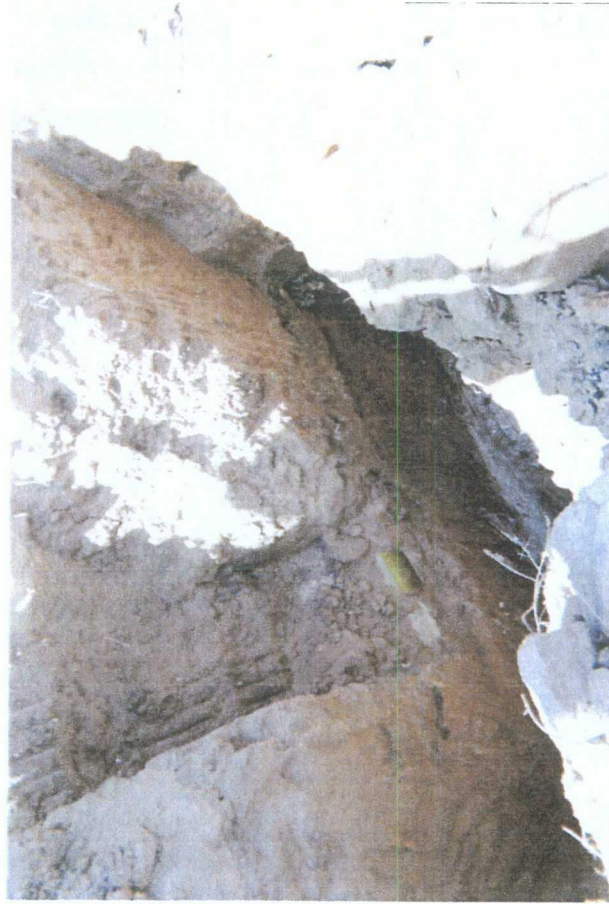
3/25/08

Source vertical

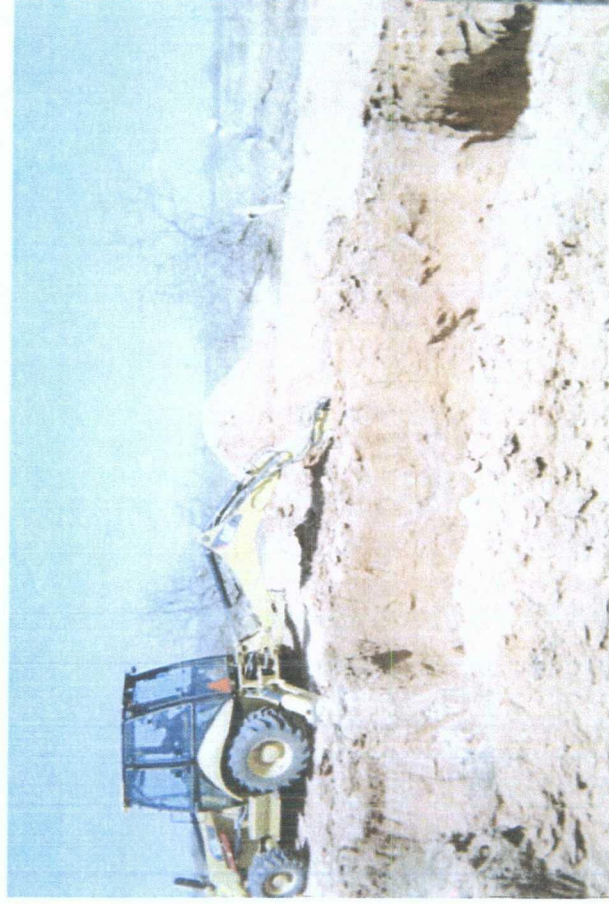
3/31/08

Delineation vertical being dug

LOCATION	DEPTH	mg/kg
4-Wall COMP.	n/a	983
Bottom Comp.	12'	1201
Blended Backfill	n/a	543
vertical delineation trench at the junction (10' east of source)	2'	638
	4'	415
	6'	420
	8'	941
	10'	755
	12'	1778

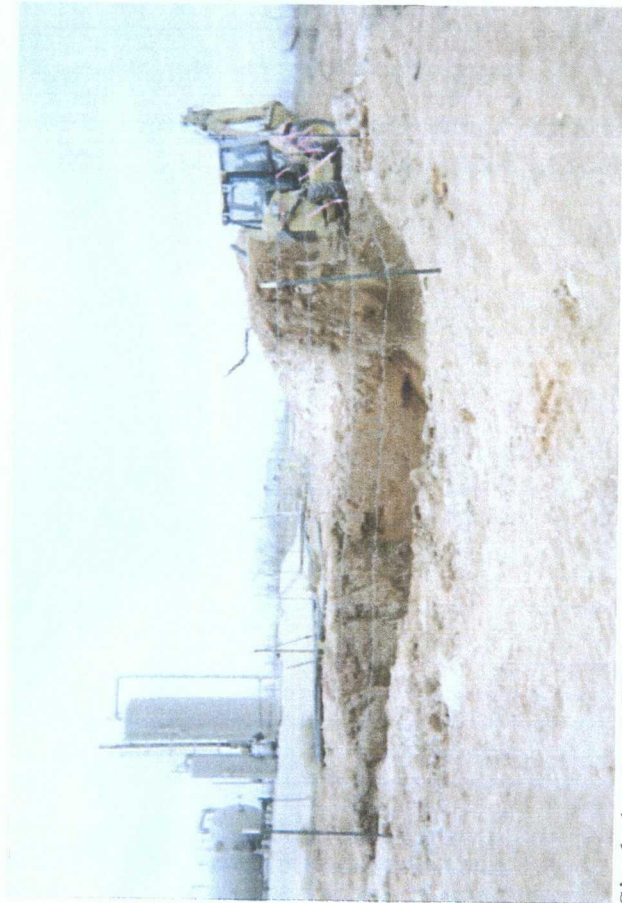
4/09/08

Site being backfilled

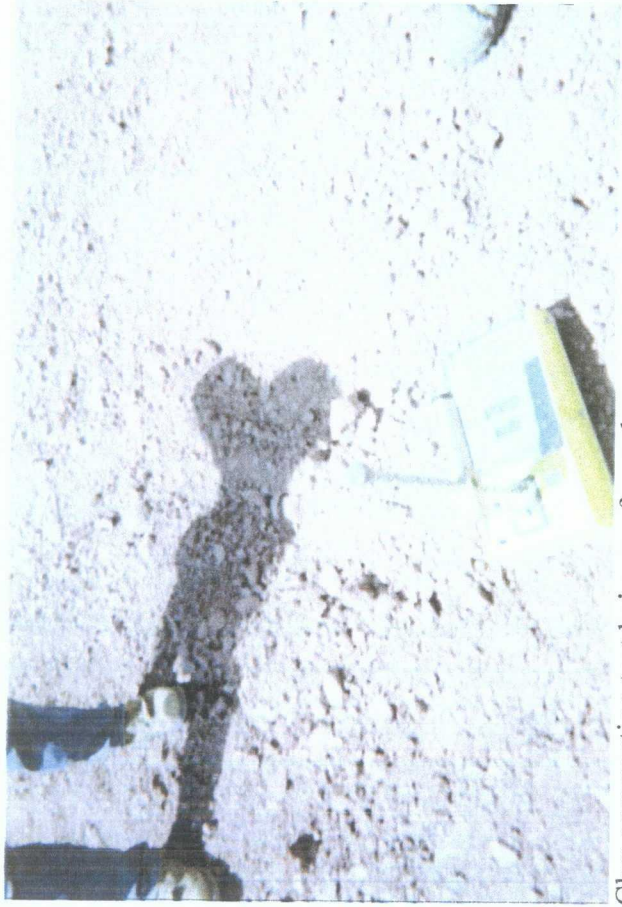
4/10/08

Clay compaction test being performed

Test No.	Location	Dry Density		Depth
		% Max	% Moisture	
SG 1	15' N. & 15' W. of SE Corner of Pad	94.4	10.7	FSG

Required Compaction: 90% - 95%

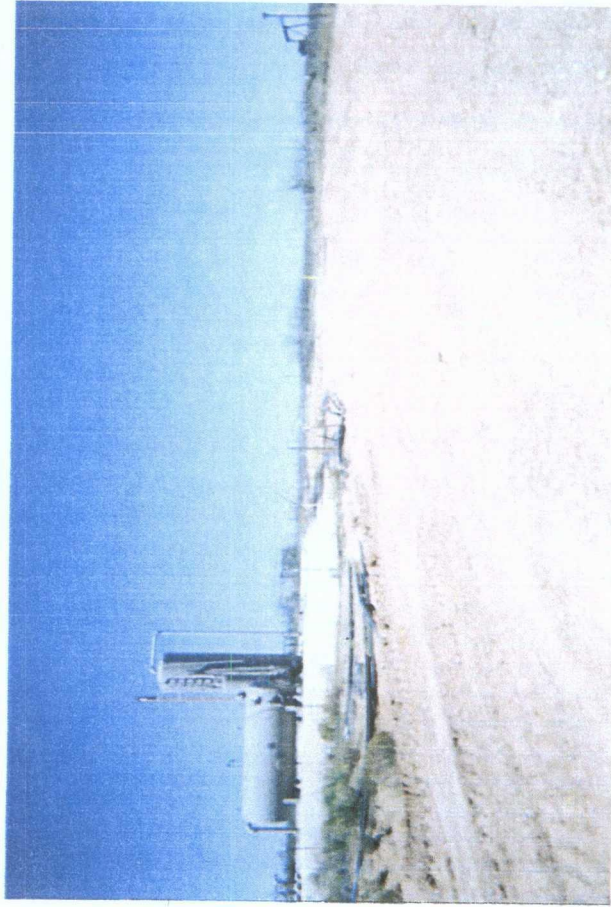
4/11/08

Site complete

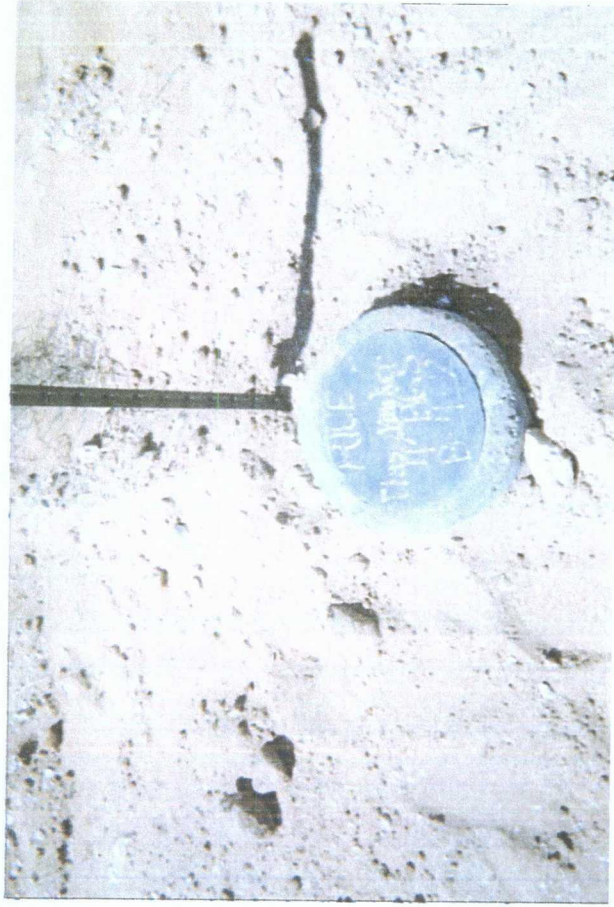
4/14/08

Clay marker

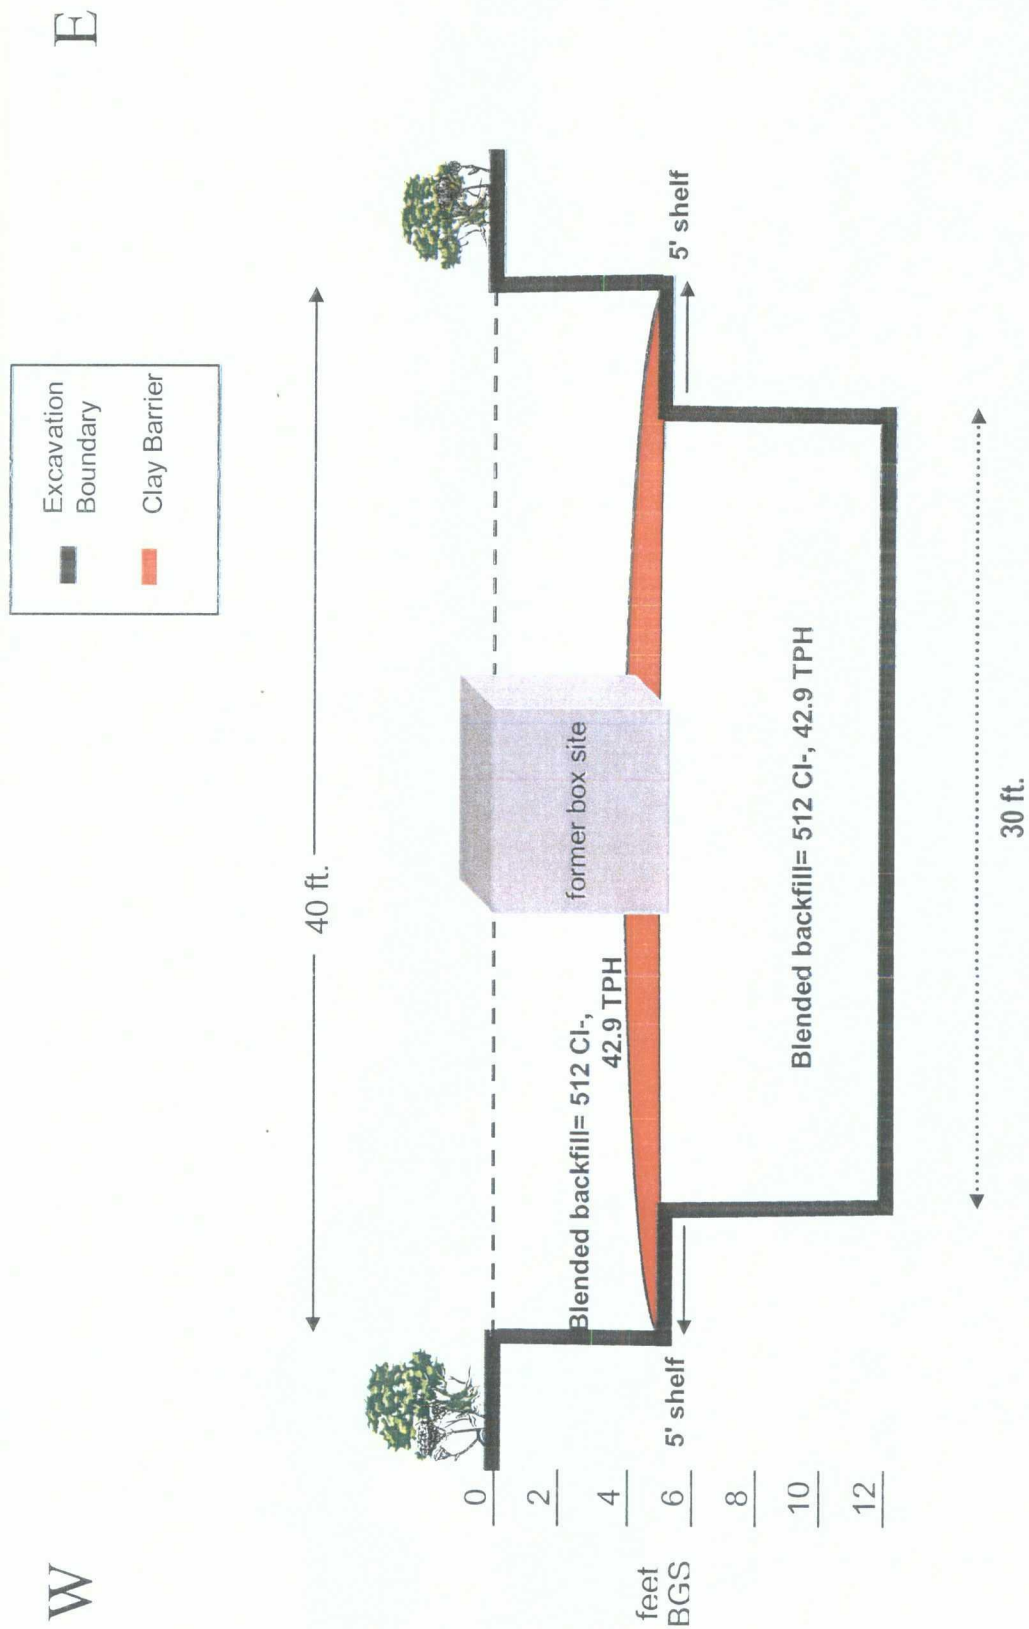
# Excavation Cross-Section

Soil Excavated 333 cubic yards Excavation Length 30 Width 25 Depth 12 feet

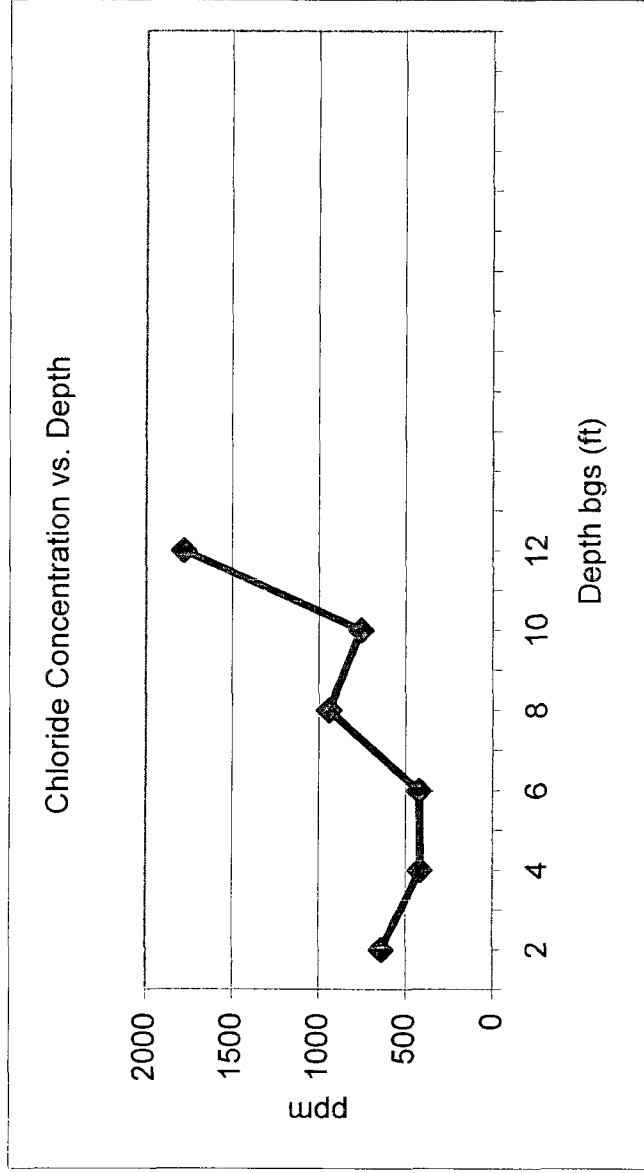
# BD JCT. B-4-2

Backhoe samples at junction (10' east of source)

Depth bgs (ft)	Cl ppm
2	638
4	415
6	420
8	941
10	755
12	1778

Groundwater = 97 (ft.)
