RICE OPERATING COMPANY
JUNCTION BOX DISCLOSURE* REPORT

BD vent M-31-1

Unit M, Section 31, T21S, R37E

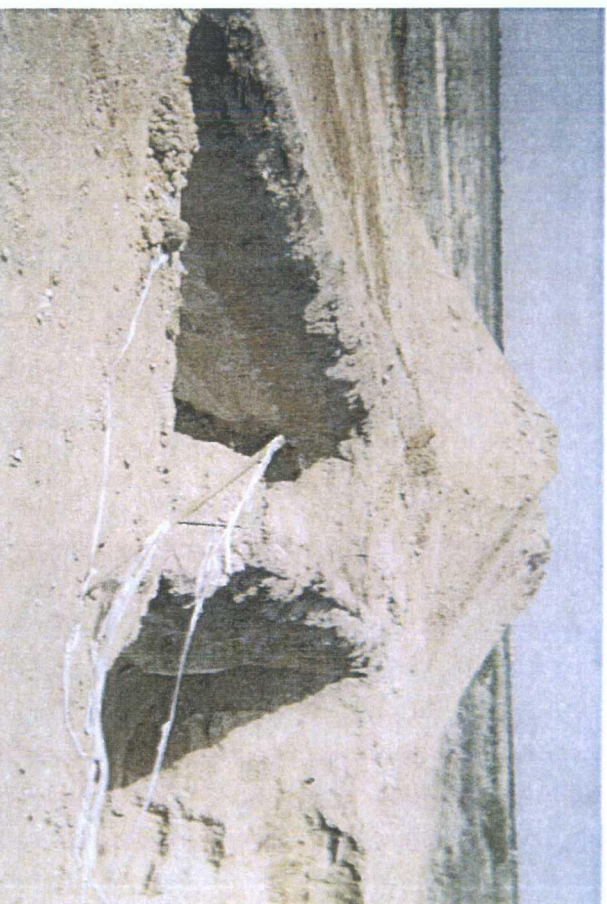
7/17/2008

excavation at former junction site

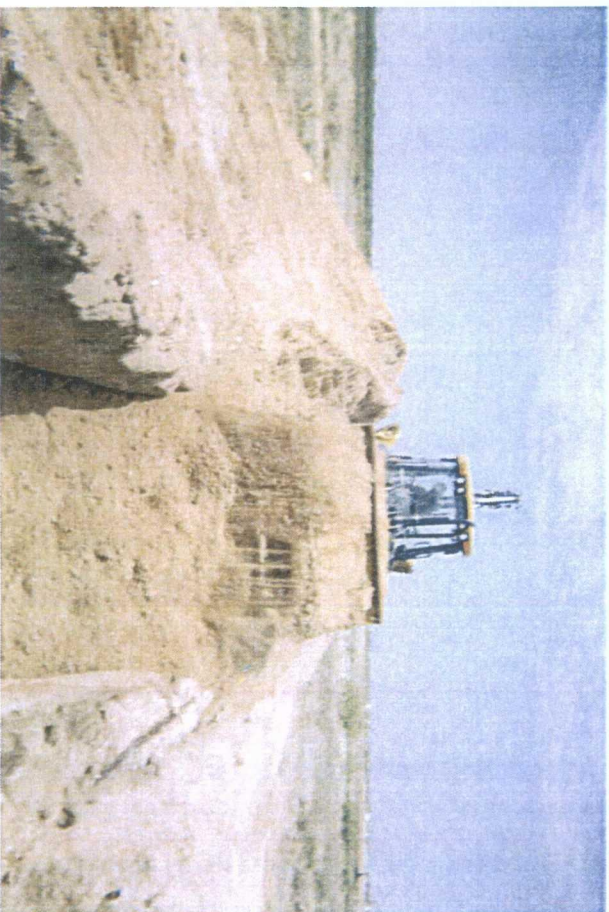
7/18/2008

backfilling excavation
