EME Jct K-32-1

**RICE OPERATING COMPANY
JUNCTION BOX FINAL REPORT**

SWD SYSTEM	JUNCTION	UNIT	SECTION	TOWNSHIP	RANGE	COUNTY	BOX DIMENSIONS - FEET		
Eunice Monument Eumont (EME)	Jct. K-32-1	K	32	20S	37E	Lea	Length	Width	Depth
							eliminated

Unit K, Section 32, T20S, R37E

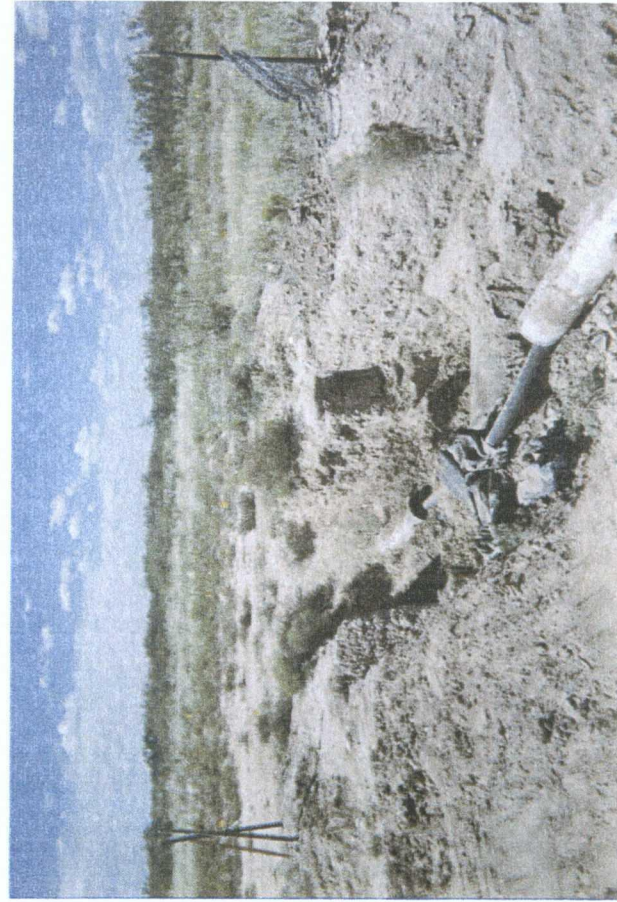
31 inch gas, steel pipeline

General Description of Remedial Action: This junction box was eliminated during the pipeline replacement/upgrade program. After the box was removed, the site was investigated using a backhoe to collect soil samples at regular intervals producing a 5x2x15-ft-deep hole. Due to concerns of a 31" gas, steel pipeline running through the site, excavation could not be extended laterally; therefore, the source was excavated to 15' bgs. A chloride field test performed on each sample yielded chloride levels decreasing with depth. Organic vapors were measured using a PID, which yielded low concentrations. A commercial laboratory analysis was performed on the backfill composite as well as the deepest sample at the source (15' bgs). The site was then backfilled and contoured to the surrounding area. On 8/31/2007, the site was seeded with a blend of native vegetation and is expected to return to a productive capacity at a normal rate.

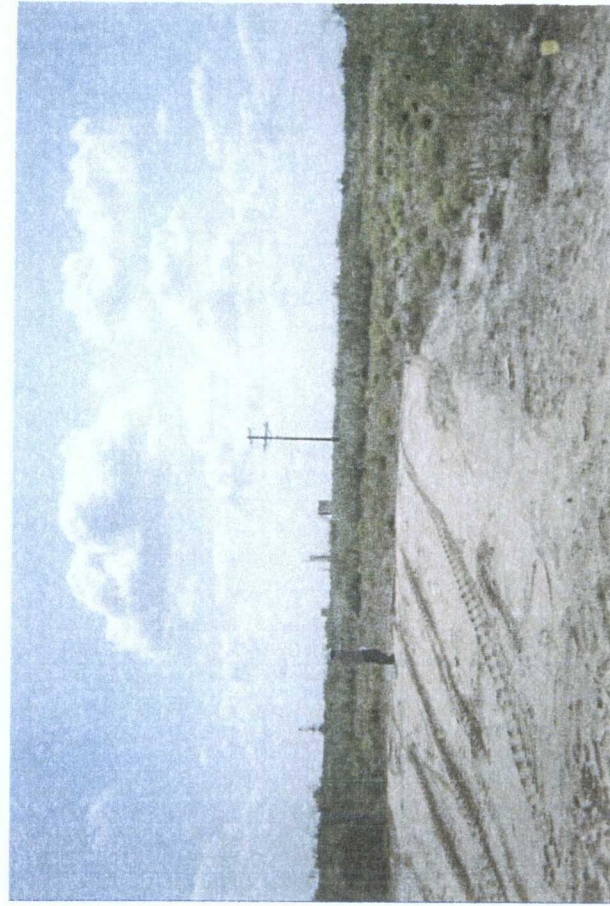
seeding backfilled site

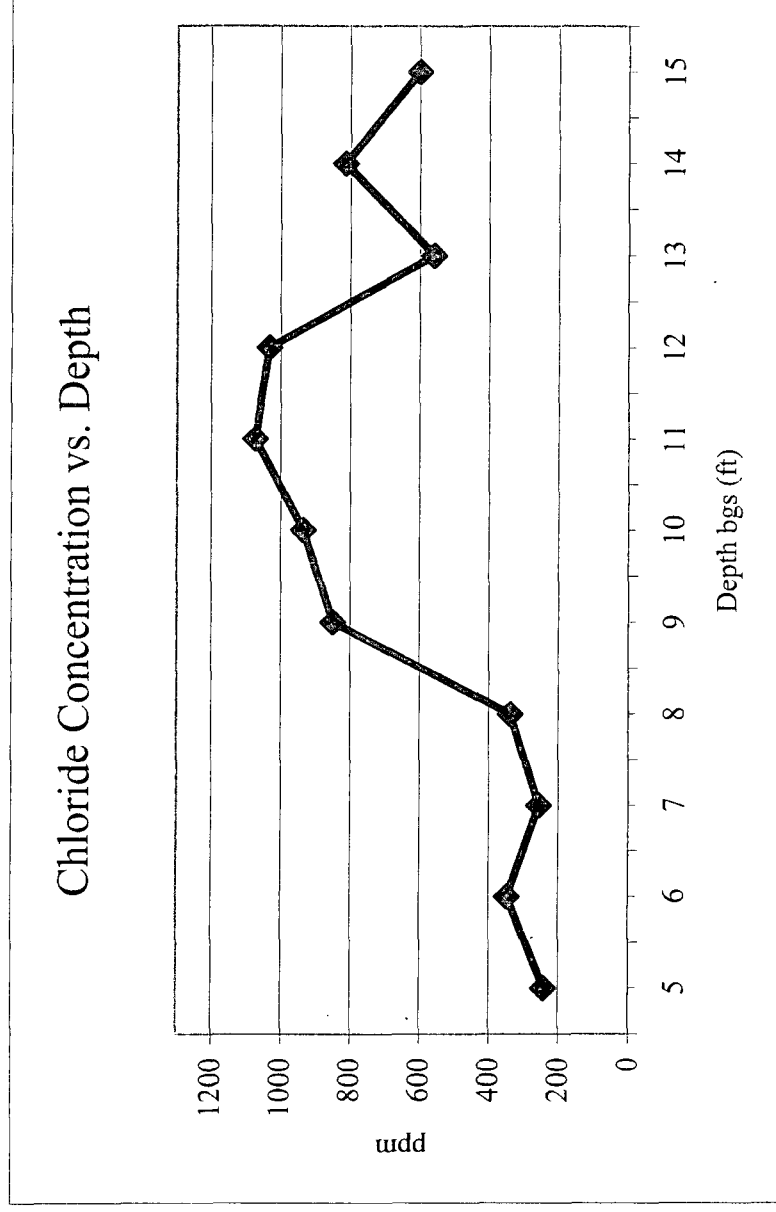
CHLORIDE CONCENTRATION CURVE

Backhoe samples at junction (source)

Depth bgs (ft)	[Cl ⁻] ppm
5	242
6	347
7	256
8	338
9	849
10	935
11	1073
12	1033
13	559
14	814
15	600

Groundwater = 200 ft
