EME Jct C-29

RICE OPERATING COMPANY JUNCTION BOX FINAL REPORT

Unit C, Section 29, T19S, R37E

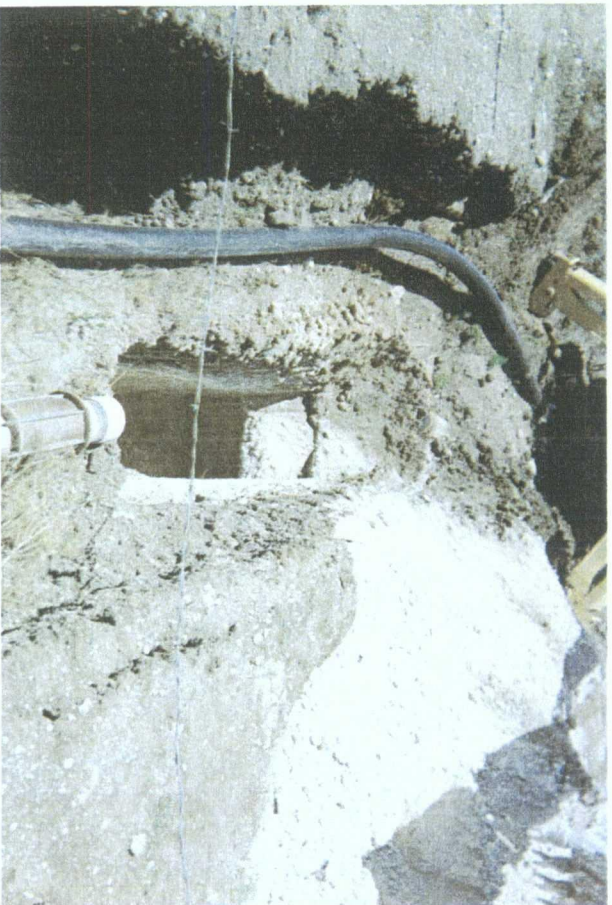
source vertical

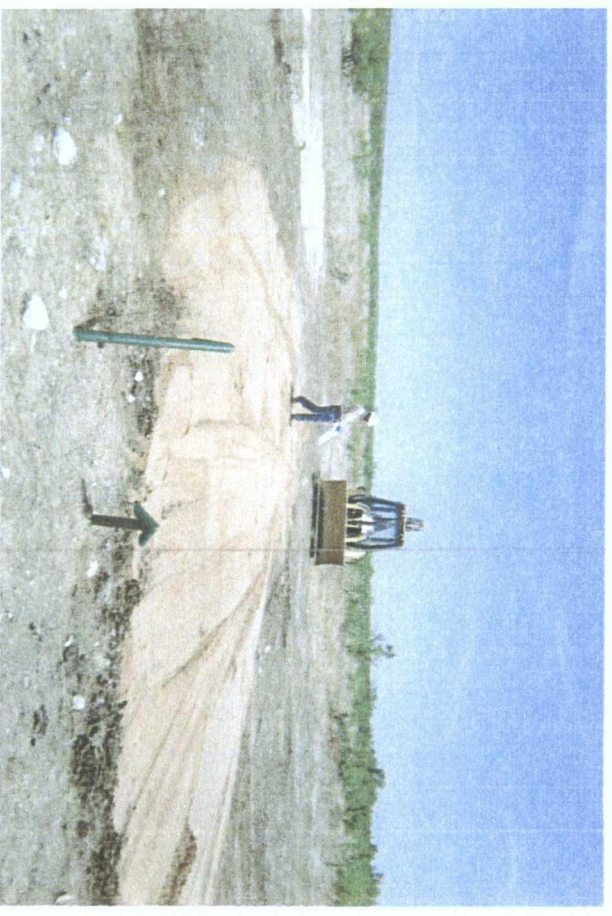
seeding backfilled site, facing north

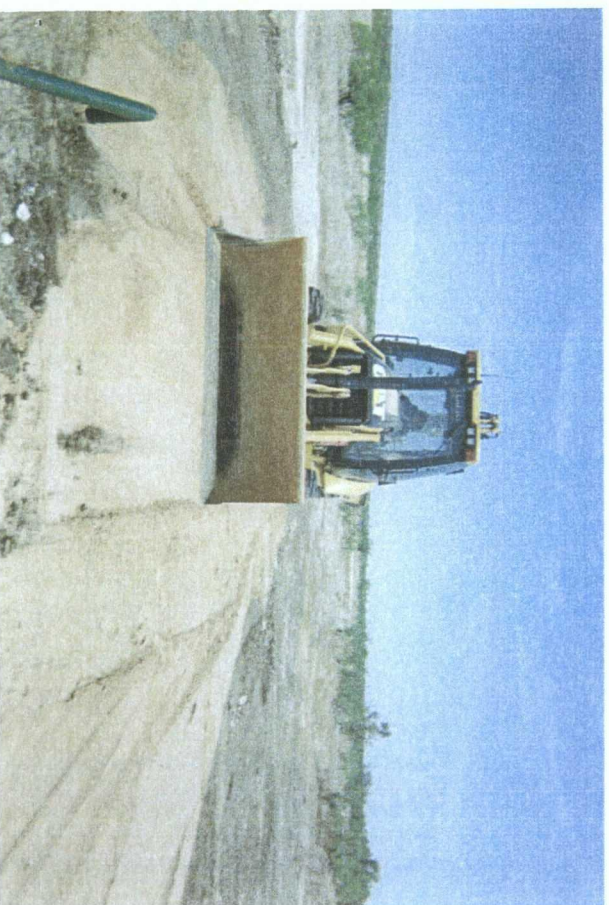
back dragging site facing north

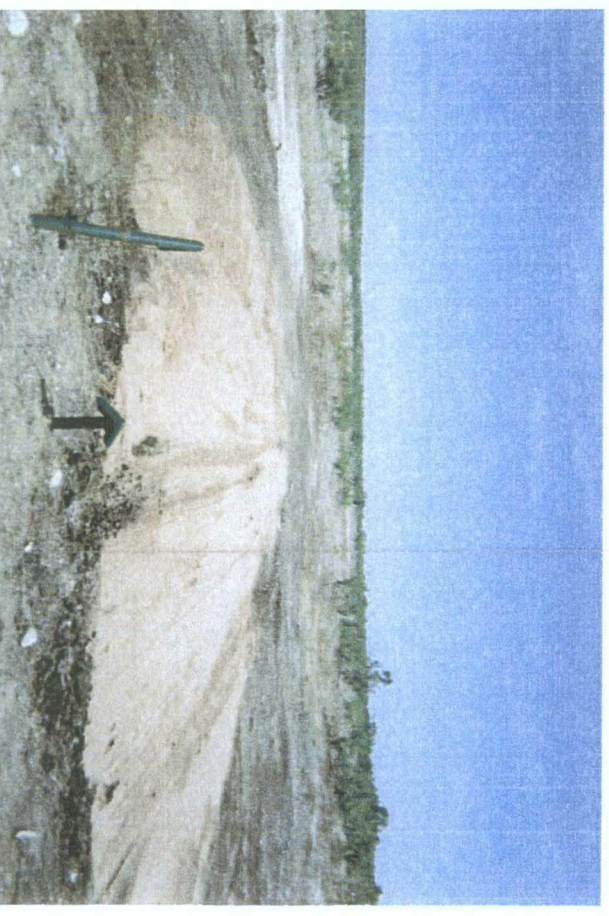
site complete, facing north

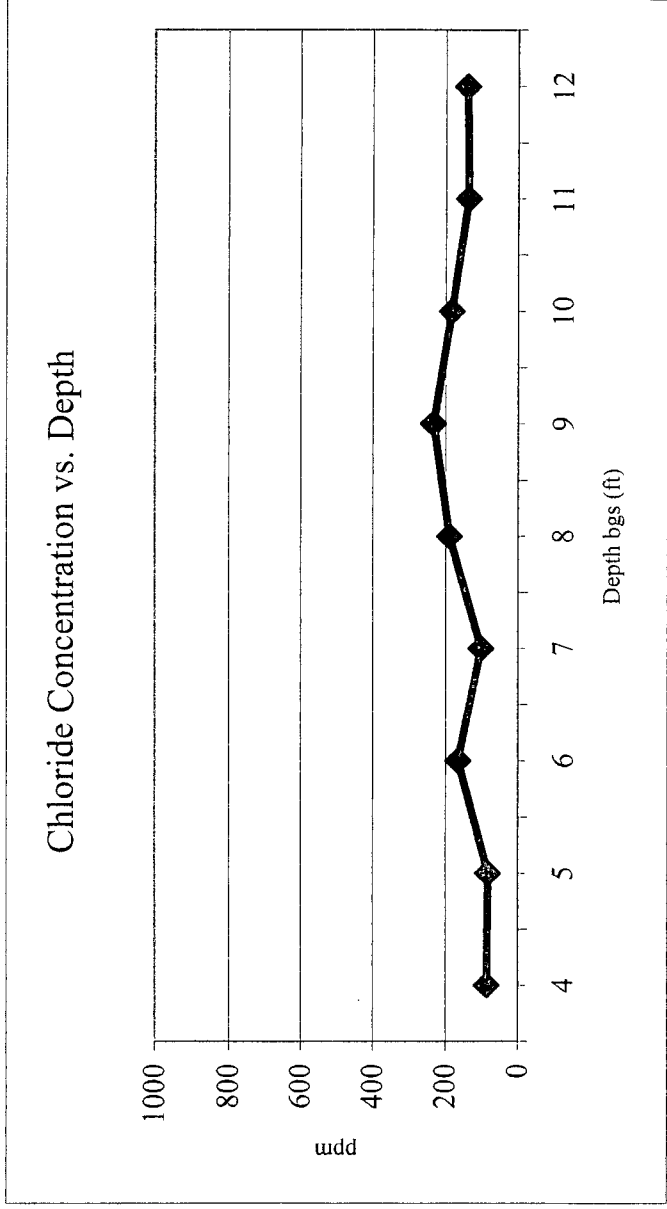
Backhoe samples at junction (source)

Depth bgs (ft)	[Cl ⁻] ppm
4	87
5	83
6	165
7	103
8	189
9	233
10	183
11	137
12	141

Groundwater = 30 ft
