9  
**EME Apache Laughlin EOL**

**RICE OPERATING COMPANY  
JUNCTION BOX FINAL REPORT**

## EME Jct. D-9 boot

Unit D, Section 9, T20S, R37E

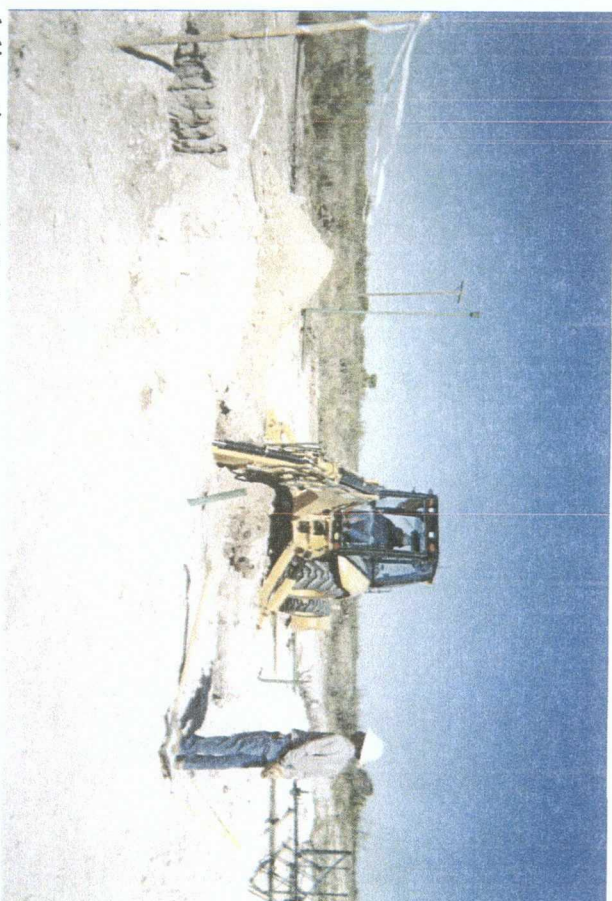
10/30/2007

delineation trench, facing north

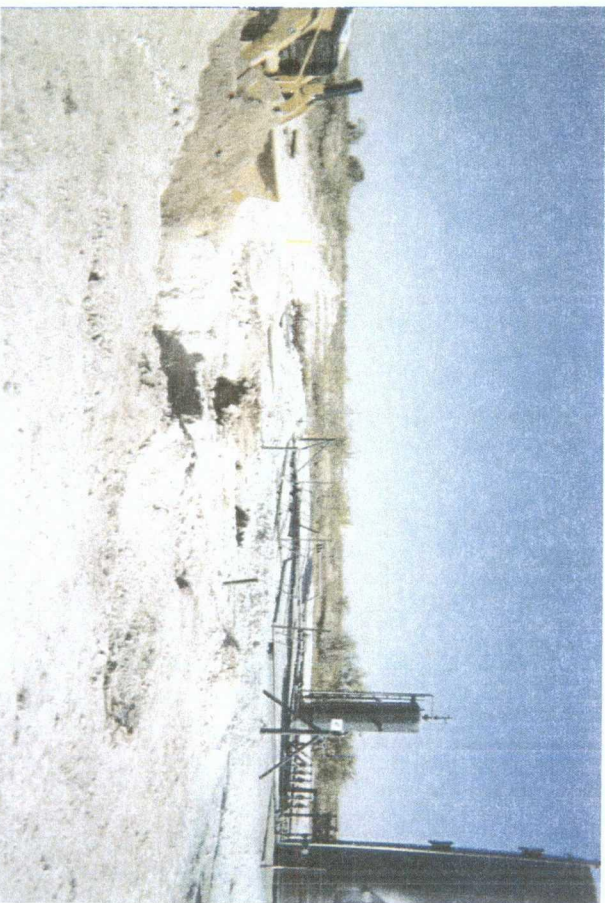
11/09/2007

backfilling excavation site

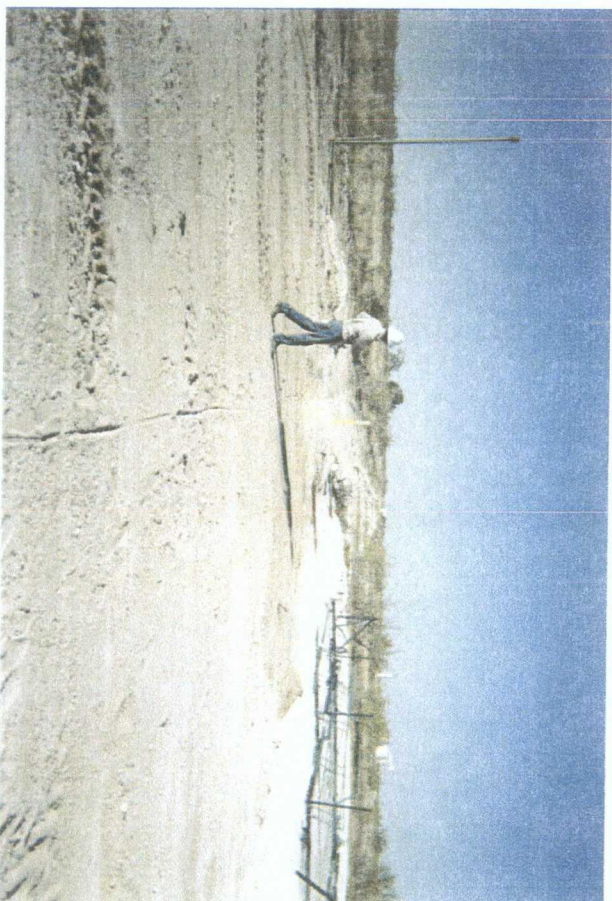
11/09/2007

seeding backfilled site, facing north

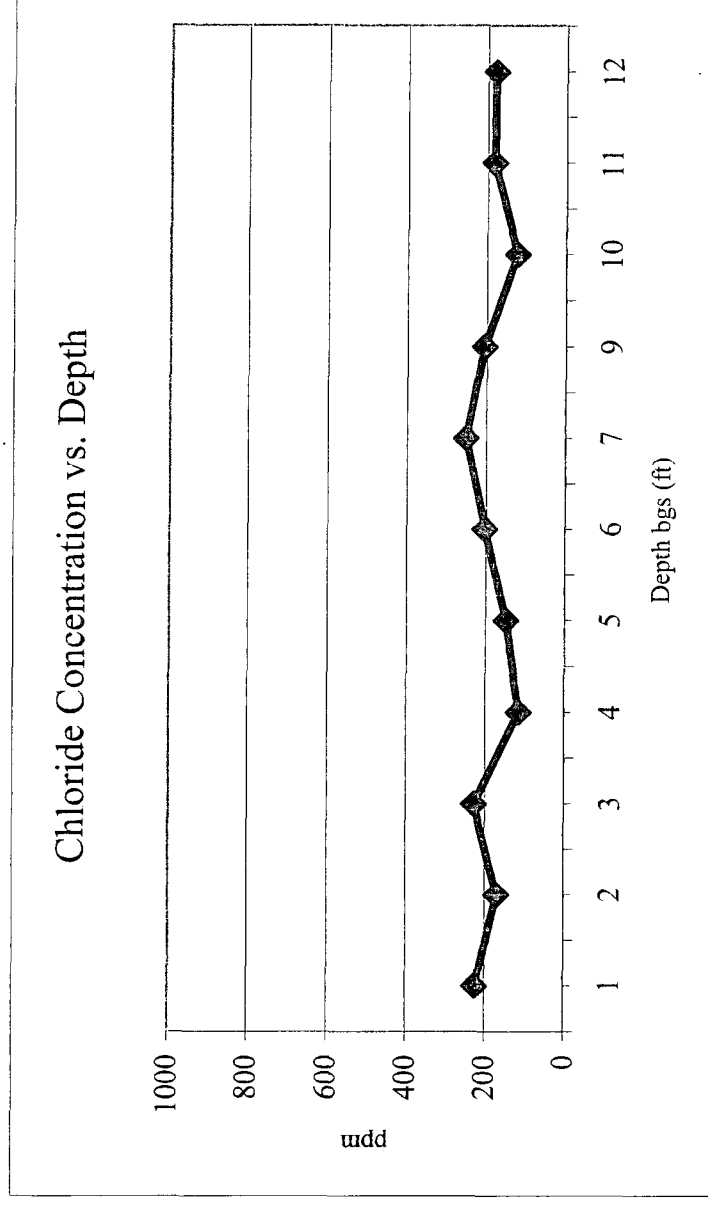
# CHLORIDE CONCENTRATION CURVE

Backhoe samples at source

Depth bgs (ft)	[Cl] ppm
1	225
2	170
3	228
4	115
5	148
6	202
7	251
9	205
10	122
11	182
12	179

Groundwater = 35 ft

LOCATION	DEPTH	mg/kg
background	6"	176
vertical delineations trench at source	1'	225
	2'	170
	3'	228
	4'	115
	5'	148
	6'	202
	7'	251
	8'	n/a
	9'	205
	10'	122
	11'	182
	12'	179
backfill comp.	n/a	90
