EME Jct O-8

RICE OPERATING COMPANY
JUNCTION BOX FINAL REPORT

Unit O, Section 8, T21S, R36E

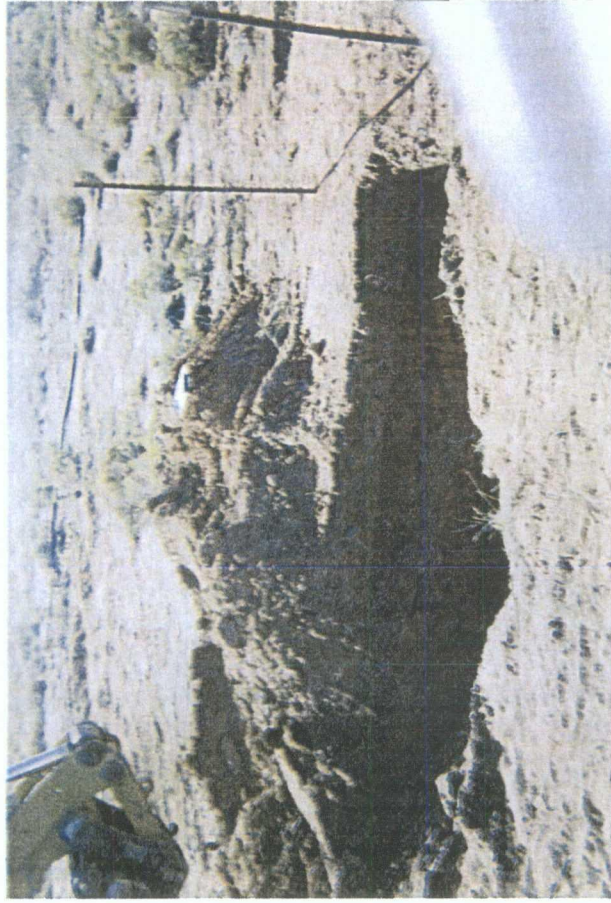
site prior to excavation, facing west

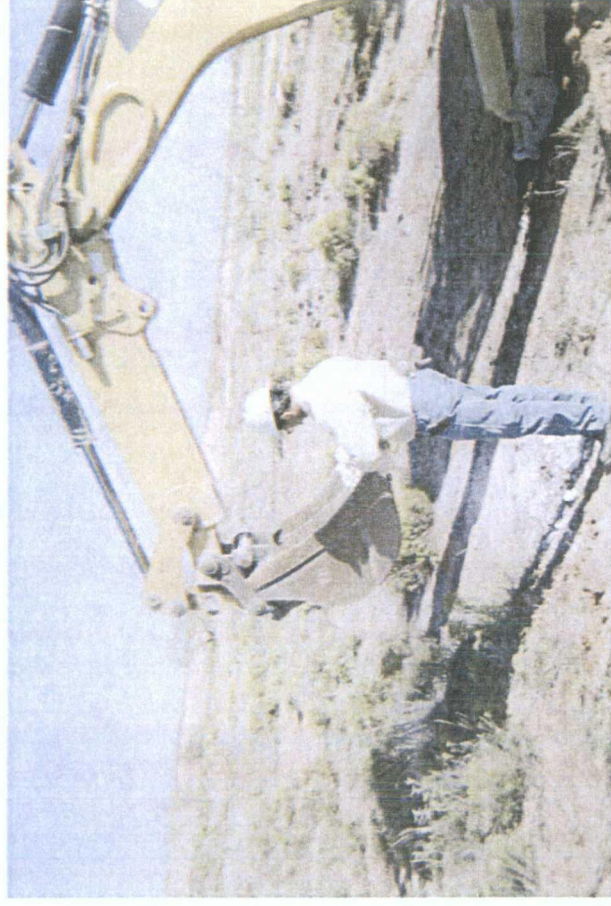
collecting a soil sample, facing east

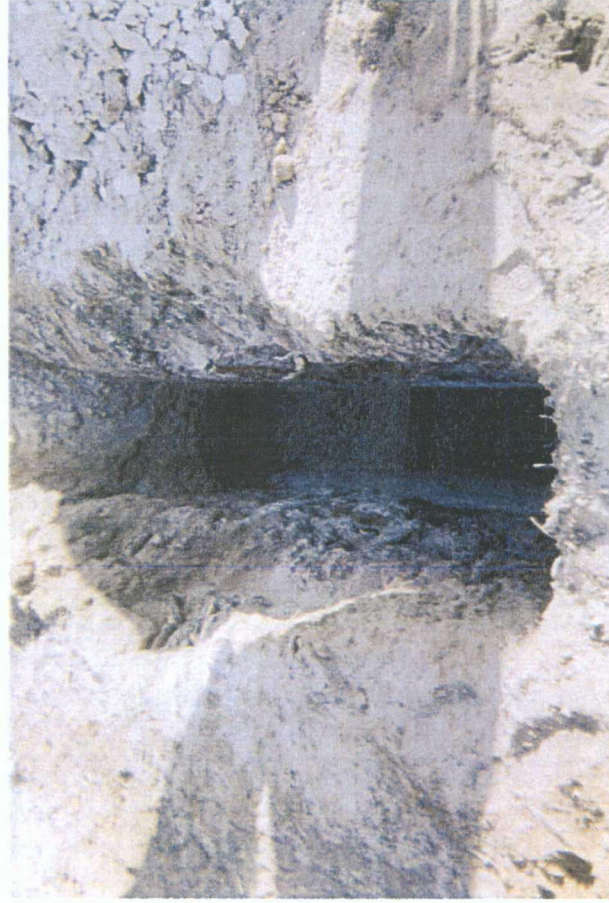
final excavation, facing south

General Description of Remedial Action: This junction was eliminated during the pipeline replacement/upgrade program. After the former junction box was removed, an investigation was conducted using a backhoe to collect soil samples at regular intervals producing a 5x3x10-ft-deep excavation. Chloride field tests performed on each sample yielded low concentrations similar to that of the background sample. Organic vapors measured with a PID also yielded low concentrations. The deepest sample, 10 ft BGS, was sent to a commercial laboratory for analysis of chloride and TPH, which confirmed low concentrations. The excavated soil was returned to the excavation to ground surface and contoured to the surrounding area. On 11/7/2008, the site was seeded with a blend of native vegetation and is expected to return to a productive capacity at a normal rate.

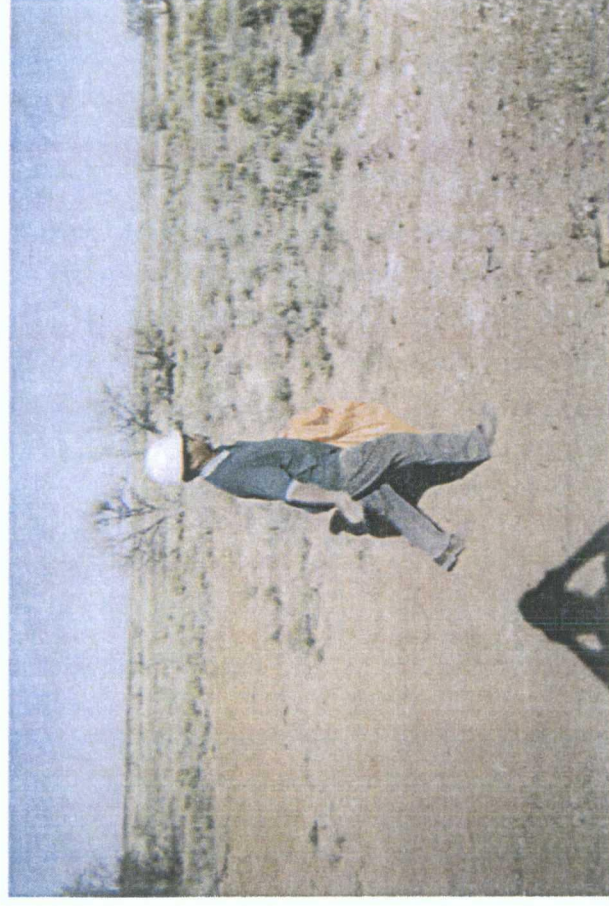
seeding backfilled site, facing east
