EME Jct D-16-1

CLOSURE

RICE OPERATING COMPANY JUNCTION BOX FINAL REPORT

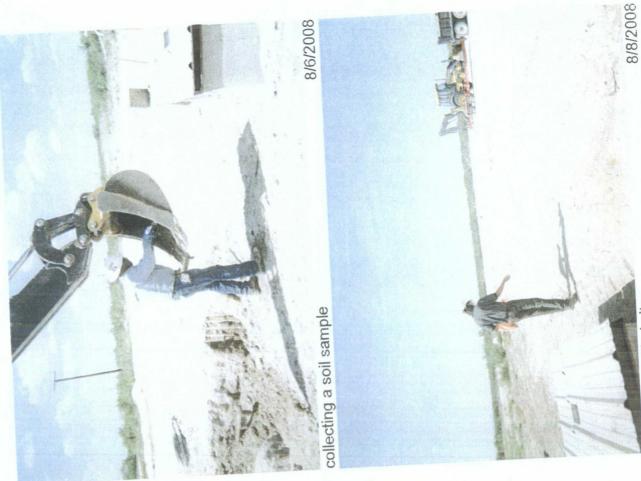
Unit D, Section 16, T20S, R37E

seeding backfilled site new, watertight junction box in left corner

General Description	of Remedia	al Action:	This junction	n was elimina	ted during th	e	delineation	4'	204
pipeline replacement/up	grade progra	am. After the	former junc	tion box was	removed, an		trench at the junction	5'	203
investigation was condu	cted using a	backhoe to	collect soil sa	amples at reg	jular intervals	-	(source)	6'	239
producing a 5x3x6-ft-de	ep excavatio	n. Chloride	field tests pe	rformed on e	ach sample				
yielded low concentratio	ns, similar to	that of the b	ackground s	ample. Orga	anic vapors w	ere meas	ured using a PII	D, which also yie	lded low
concentrations. The deepest sample, 6 ft BGS, was sent to a commercial laboratory for analysis of chloride and TPH, which confirmed low									
concentrations. The excavated soil was returned to the excavation to ground surface and contoured to the surrounding area. On 8/8/2008,									
the site was seeded with a blend of native vegetation and is expected to return to a productive capacity at a normal rate.
