CLOSURE

**RICE OPERATING COMPANY
JUNCTION BOX FINAL REPORT**

EME DCP EOL

Unit C, Section 33, T20S, R37E

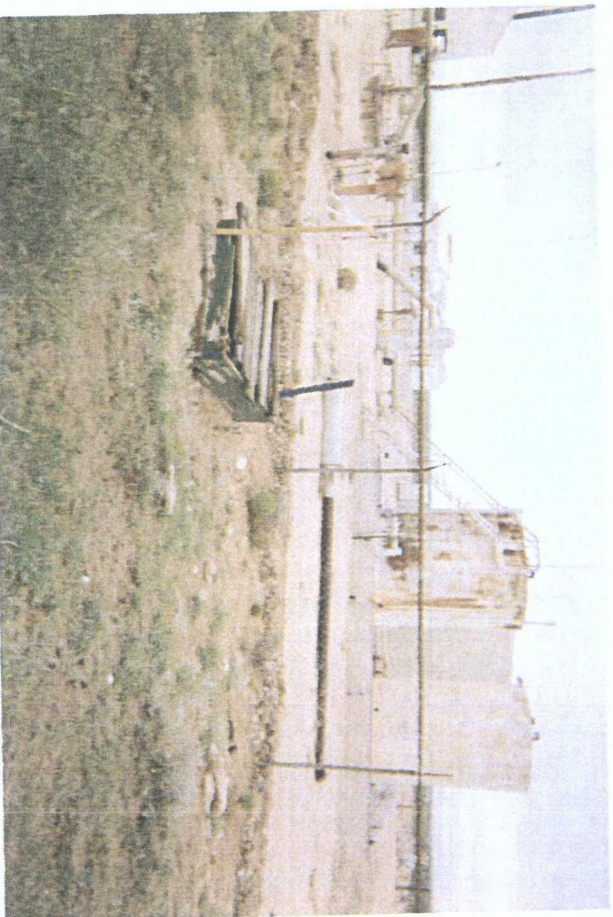
9/3/2008

former junction box, facing north

General Description of Remedial Action: This junction was eliminated during the pipeline replacement/upgrade program. After the former junction box was removed, an investigation was conducted using a backhoe to collect soil samples at regular intervals producing a 10x10x12-ft-deep excavation. Chloride field tests performed on each sample yielded generally low concentrations similar to that of the background sample. Organic vapors measured with a PID also yielded low concentrations. Representative composite samples were sent to a commercial laboratory for analysis of chloride and TPH, which confirmed low concentrations. Clean soil was imported and blended on site with the excavated soil. The blended backfill was then returned to the excavation to the ground surface and contoured to the surrounding area. On 9/24/2008, the site was seeded with a blend of native vegetation and is expected to return to a productive capacity at a normal rate.

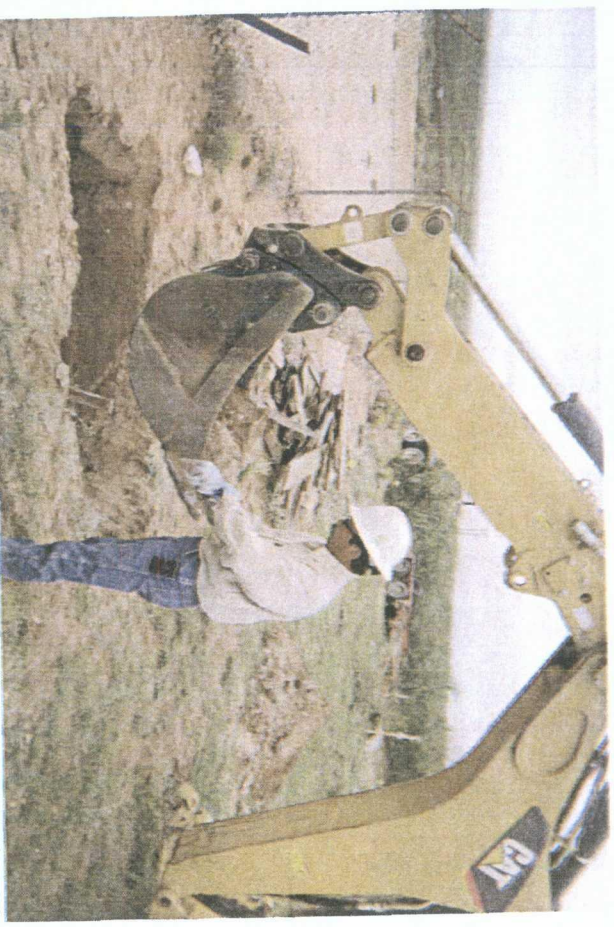
9/3/2008

collecting a soil sample, facing east

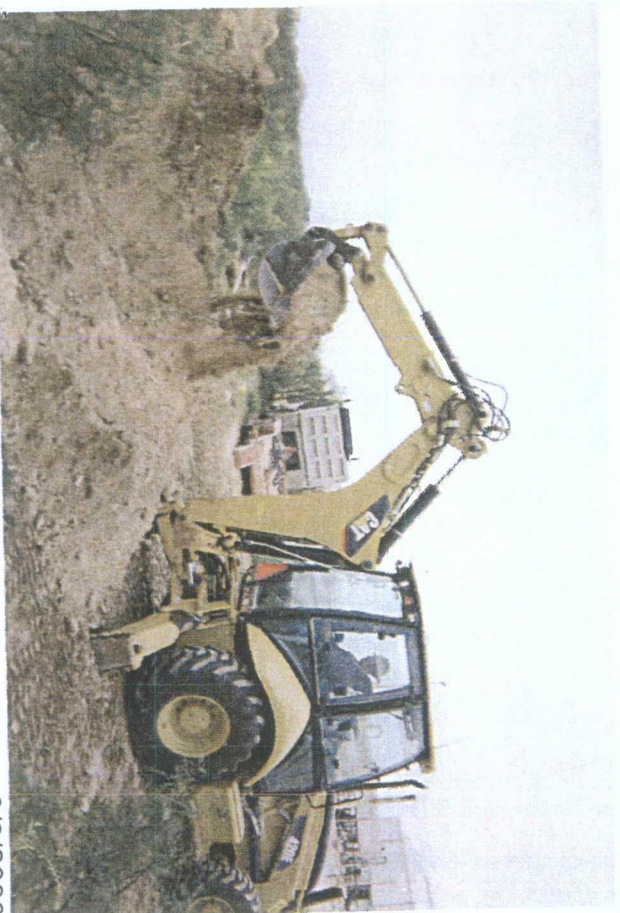
9/9/2008

blending clean, imported soil with excavated soil

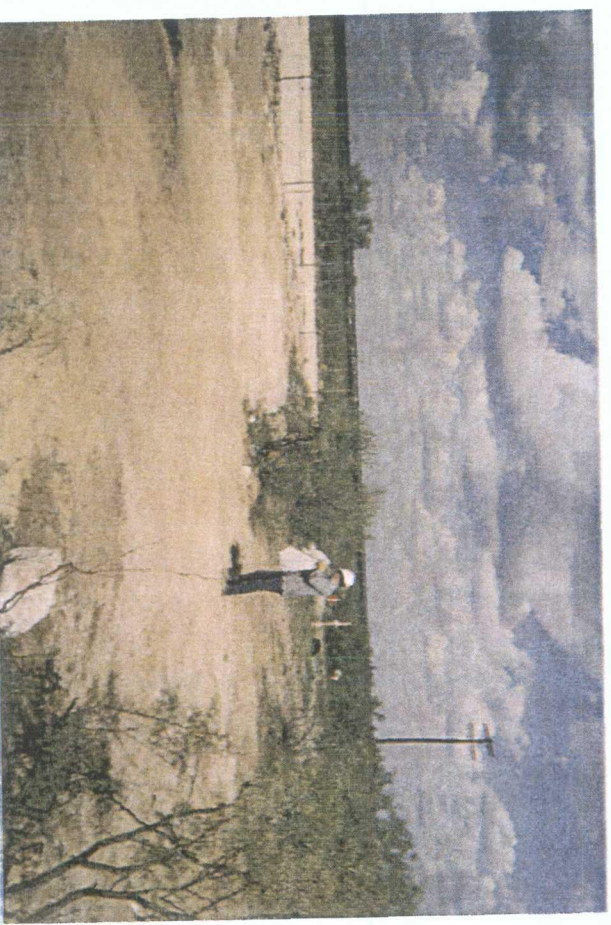
9/24/2008

seeding backfilled site
