EME L-32 Vent

**CLOSURE**

**RICE OPERATING COMPANY  
JUNCTION BOX FINAL REPORT**

Unit L, Section 32, T20S, R37E

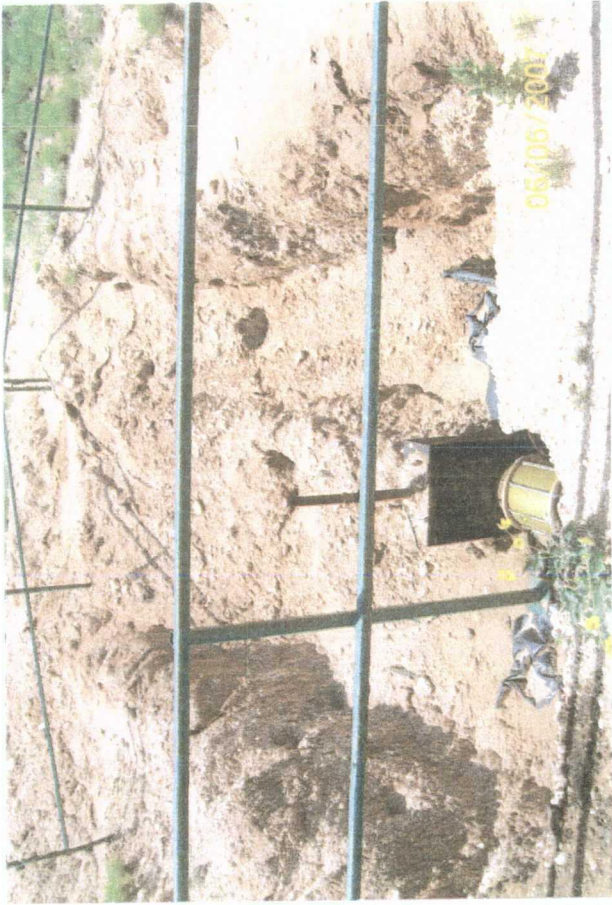
6/6/2007

site prior to excavation

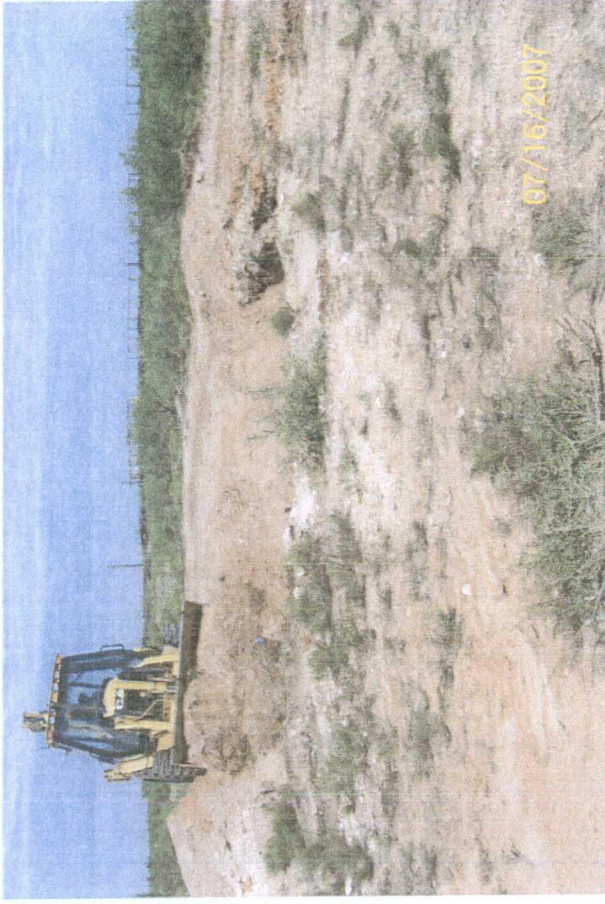
7/16/2007

backfilling excavation

**General Description of Remedial Action:** This junction was eliminated during the pipeline replacement/upgrade program. After the former junction box was removed, an investigation was conducted using a backhoe to collect soil samples at regular intervals producing a 20x10x12-ft-deep excavation. Chloride field tests were performed on each sample, which yielded generally low concentrations. Organic vapors were measured using a PID, which yielded some elevated concentrations. Representative composite samples were sent to a commercial laboratory for analysis of chloride, TPH, and BTEX; which confirmed concentrations were within NMOCD guidelines. The excavated soil was blended on-site and returned to the excavation to ground surface and contoured to the surrounding area. On 7/17/2007, the site was seeded with a blend of native vegetation and is expected to return to a productive capacity at a normal rate.
