**Below-Grade Tank  
Closure Final Report**

**XTO Energy, Inc.**

**1RP-09-11-2360**

**Eunice Monument South Unit – Satellite 6**

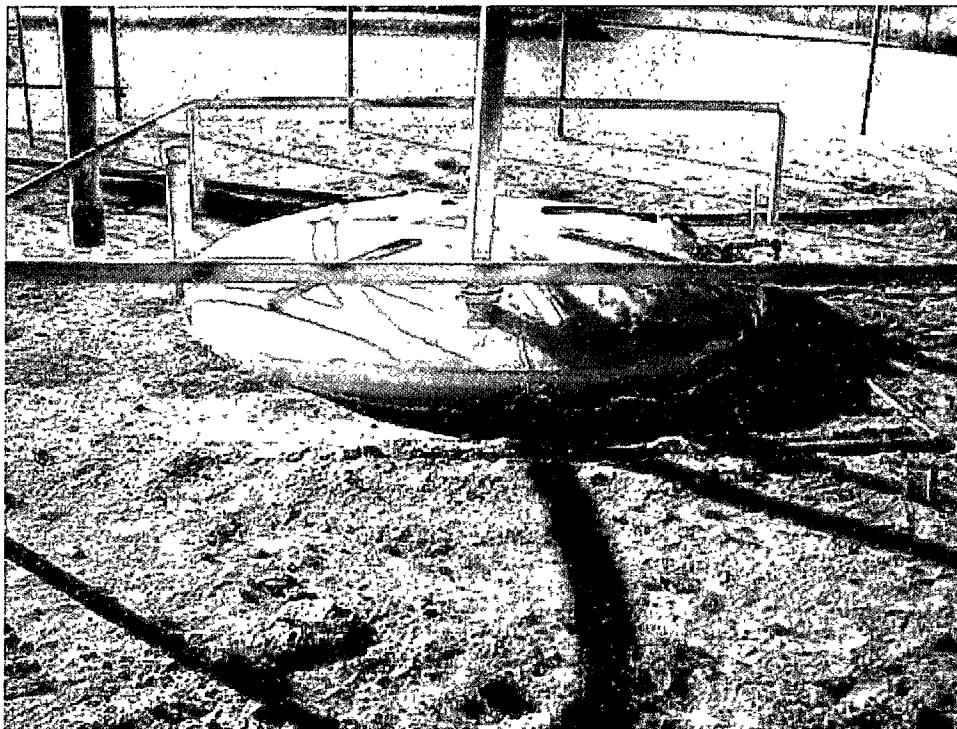
Below-grade tank prior to closure.

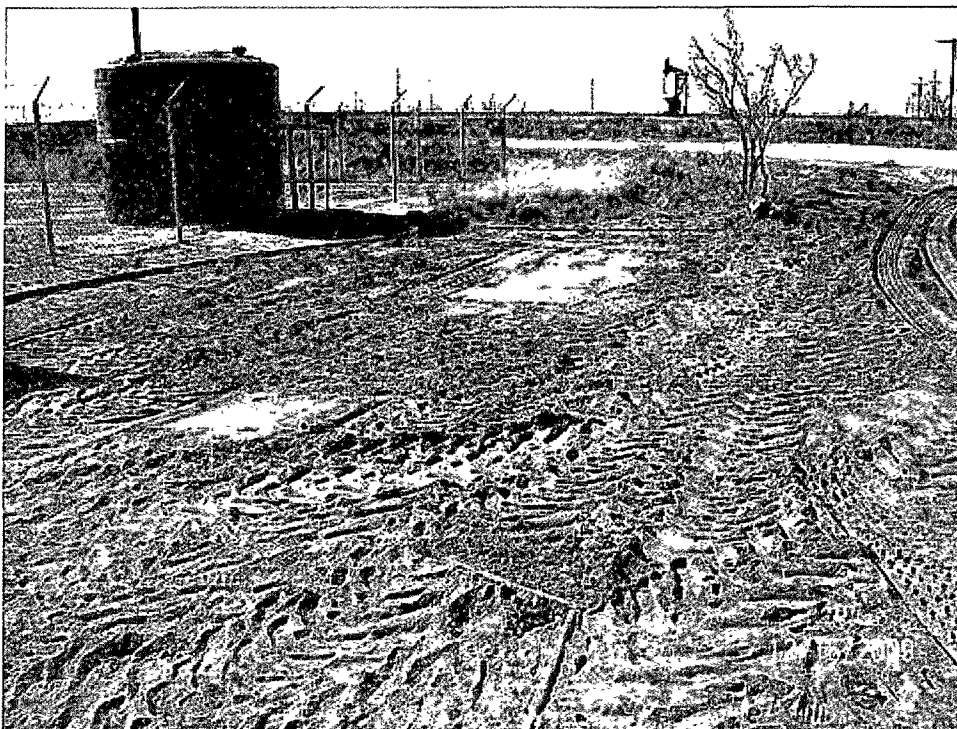
Refilled and graded former tankhold location.

Excavation backfilling consisted of compacting six- to eight-inch lifts of clean soil purchased from the State Caliche pit, a nearby supply, and compacting each lift with heavy equipment. The uppermost 18-inches consisted of topsoil purchased from the surface lease owner, Mr. Tom Pearce. The topsoil was graded to level with the surrounding surface. Since the former tank was located within an active oilfield tank battery, the site was not drilled and reseeded. See Appendix D for photographs of the entire closure process.
