Rele	ease Notific	atio	and Co	rrective A	ction					
		<b>OPERA</b>	☐ Initi	al Report	$(\boxtimes$	Final Rep	oory						
Name of Company Americo Energy Resources						Contact Ehsan Bayat							7
Address 7575 San Felipe St. Ste 200 Houston, TX 77063						Telephone No. 713 984-9700							
Facility Na	me State	Γ9		<del></del>		Facility Typ	e					·	
Surface Ow	ner S	STATE		Mineral C	)wner	-41			Lease 1	√o.			
LOCATIO						N OF REI	EASE		1QA	30	.02	5.25	5570
Unit Letter N	Section 2	Township 15S	Range 37E	Feet from the 3500		South Line	Feet from the 1650	East/W West	est Line	County LEA			
	<u>,,,,,</u>	1	La	titude		Longitud	e	<u> </u>	<del></del>	L			
				NAT	TIRE	OF RELI	EASE						
Type of Rele	ase oil			11711	OILL		Release 100bbls		Volume I	Recovered	20		
Source of Re		er Treater					our of Occurrence	e		Hour of Di	scovery		
177 T 1'	. 37	<u> </u>				7/20/07	***** O		7/20/07	· · · ·			
Was Immedi	ate Notice		Yes [	] No 🗌 Not Re	equired	If YES, To	wnom?

# Americo Energy Resources State T #9 Unit N, Section 2, Township 15S, Range 37E Lea County, New Mexico Closure Report

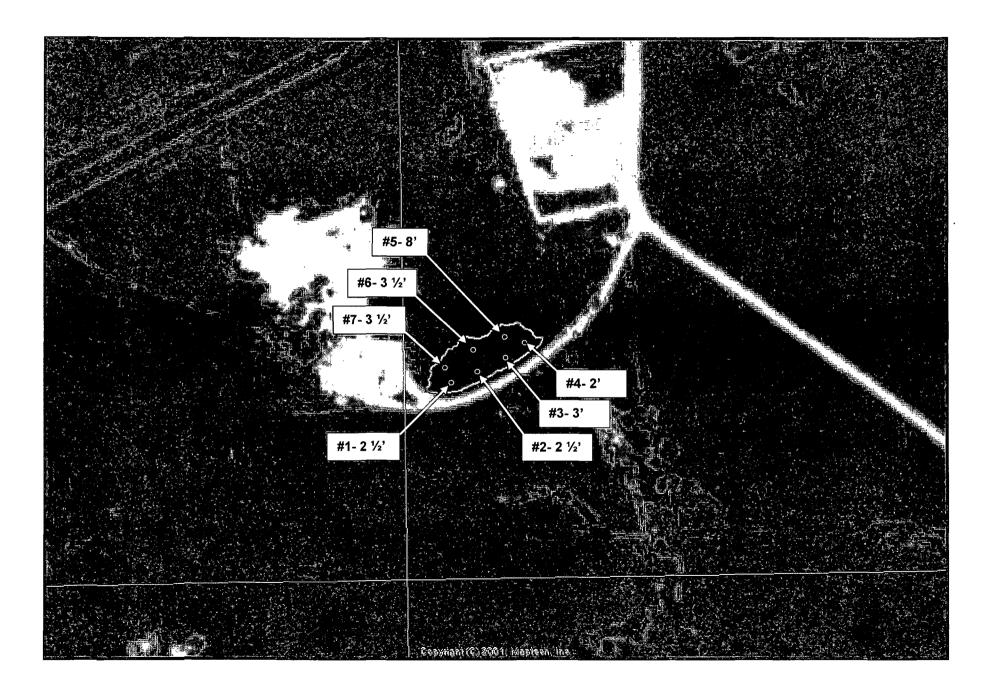
### Figure 2 Site Plan

On May 18, 2009 SESI was onsite to start excavating release area. The site was excavated to a depth three (3) feet throughout the entire excavation except for the northeast corner which was excavated to a depth of 8'. Approximately 2,120 yards of contaminated soils were disposed of at an NMOCD approved disposal facility.

Once the extent of chloride contamination had been determined, and the analytical results showed less than 1,000, the 40-mil liner was not installed per agreement with Larry Johnson of the New Mexico Oil Conservation Division. The area was then backfilled with soils from an offsite facility. Approximately 1,584 yards of caliche and top soil were used for backfill. The area was then contoured to its natural grade.
