**Vacuum Jct E-8
2009**

RICE OPERATING COMPANY
JUNCTION BOX FINAL REPORT

Vacuum Jct. E-8

Unit E, Section 8, T18S, R35E

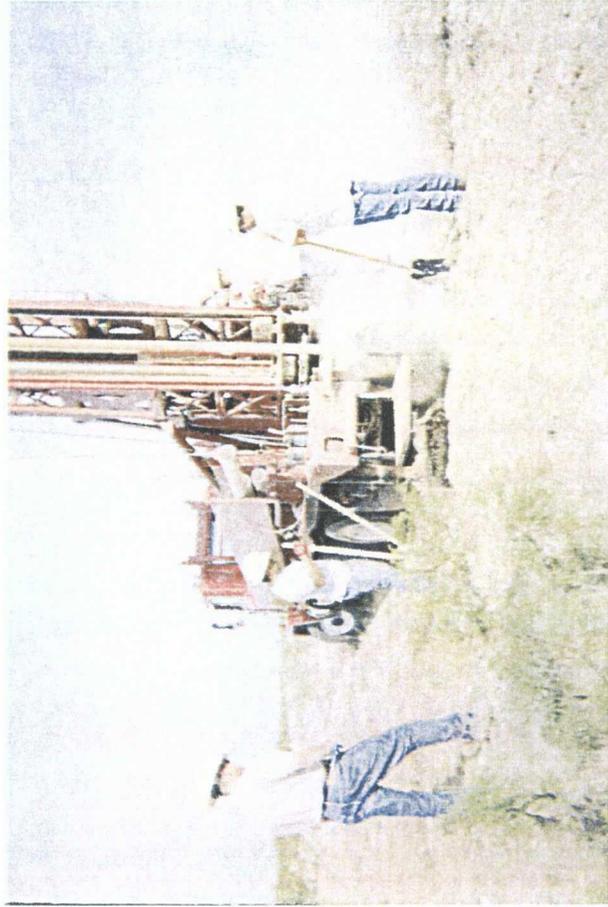
drilling SB #1 at the former junction box

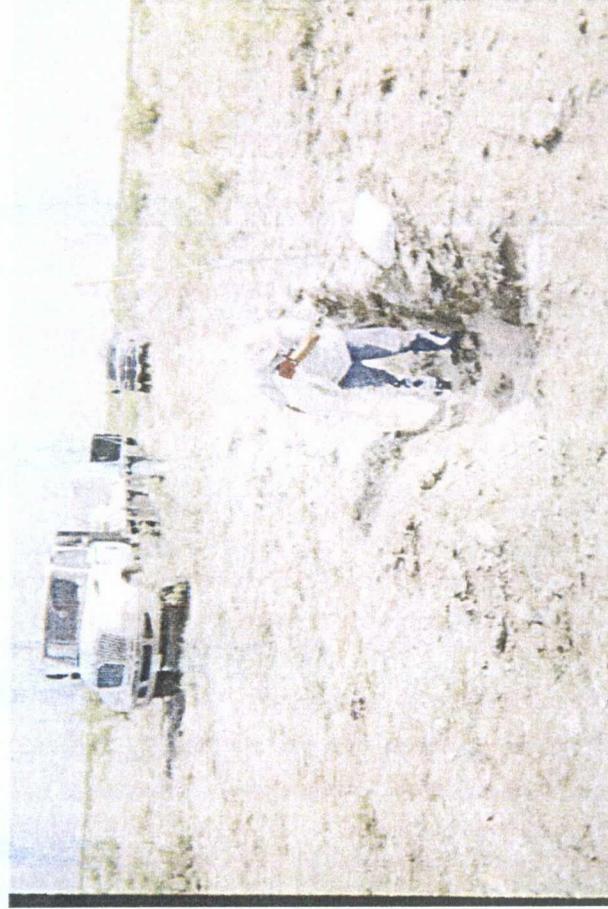
plugging SB #1 with bentonite

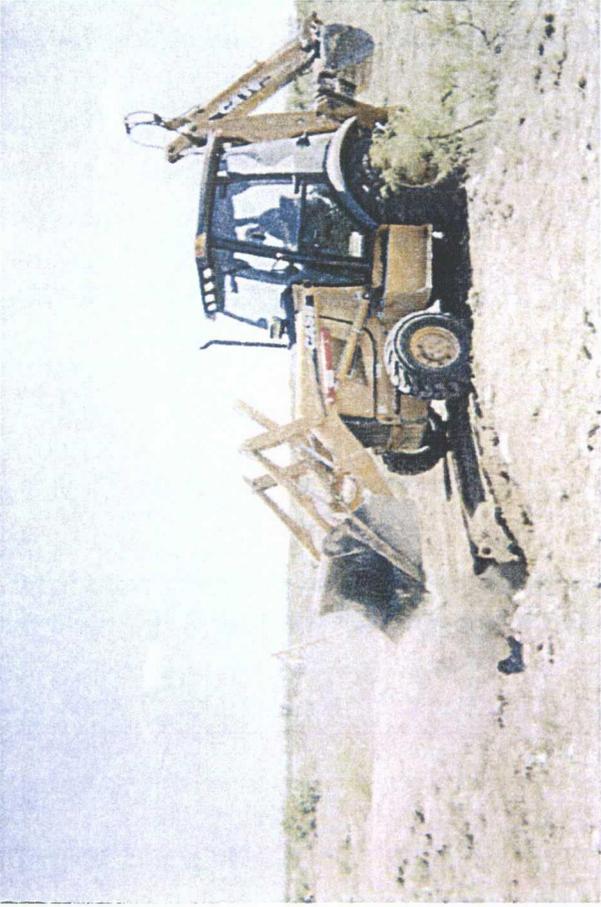
backfilling the former junction box site, facing northwest

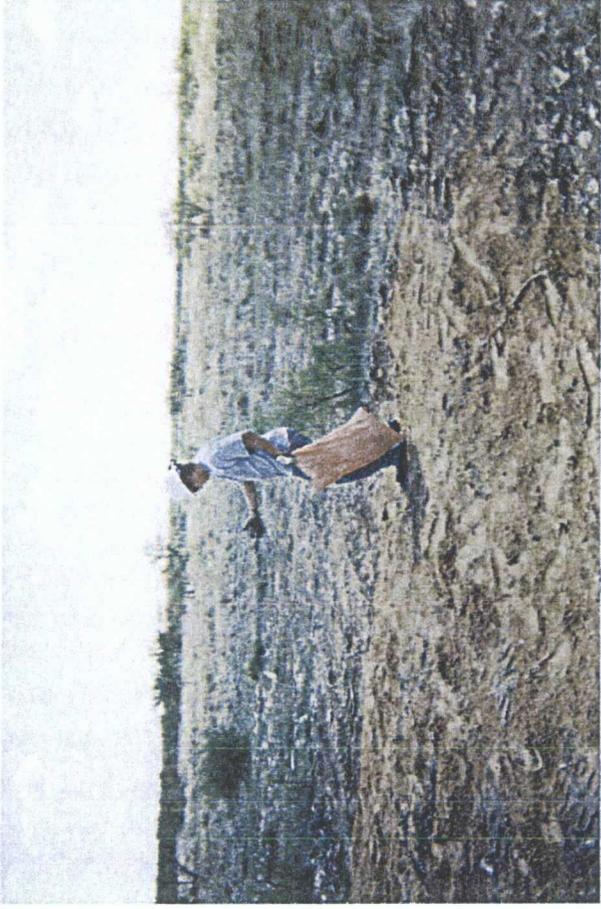
seeding backfilled site, facing east

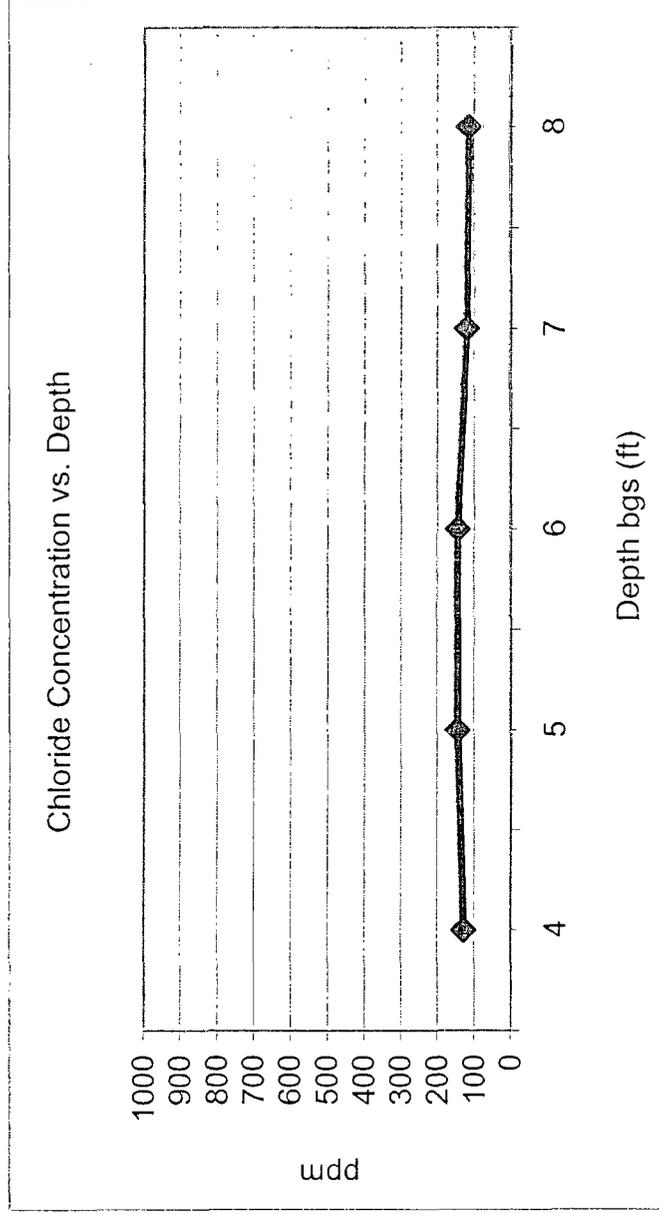
CHLORIDE CONCENTRATION CURVE

Soil Boring samples at the junction (source)

Depth bgs (ft)	Cl ⁻ ppm
4	128
5	145
6	144
7	118
8	113

Groundwater = 89 ft

LOCATION	DEPTH	mg/kg
background	6"	150
vertical delineation at the junction (source)	4'	128
	5'	145
	6'	144
	7'	118
	8'	113
