**Vacuum Jct C-36-1
2009**

**RICE OPERATING COMPANY
JUNCTION BOX FINAL REPORT**

Vacuum Jct. C-36-1

Unit C, Section 36, T17S, R34E

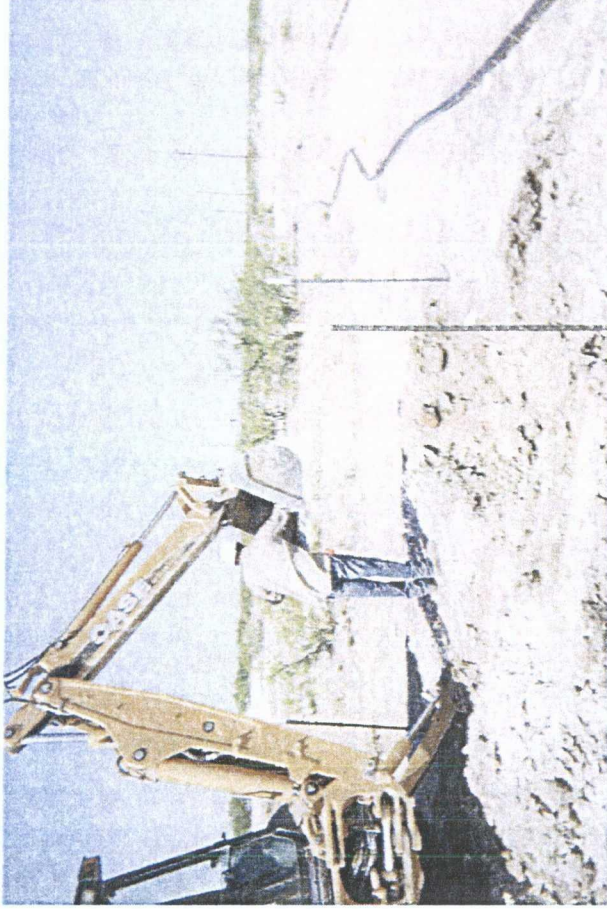
5/6/2009

collecting a sample from the source, facing west

investigation was conducted using a backhoe to collect soil sample at regular intervals

creating a 5x3x7-ft deep excavation. Each sample was field tested for chlorides and

organic vapors which yielded low concentrations similar to that of the background sample

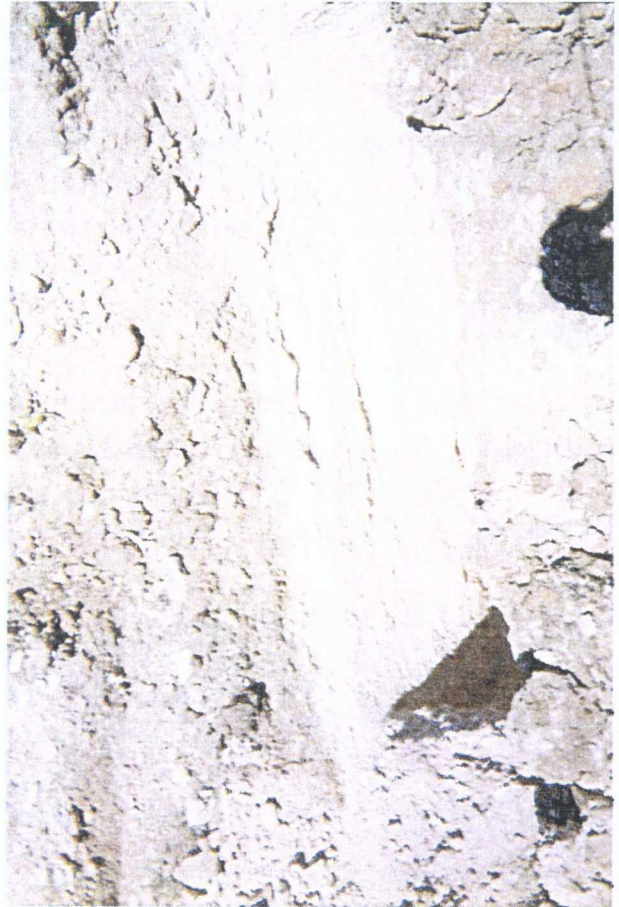
5/14/2009

final excavation, facing west

The deepest sample, 7 ft BGS, was sent to a commercial laboratory for analysis of chloride and TPH which confirmed low concentrations.
