**Vacuum A-31
2009**

**RICE OPERATING COMPANY
JUNCTION BOX FINAL REPORT**

Vacuum Jct. A-31

Unit A, Section 31, T17S, R35E

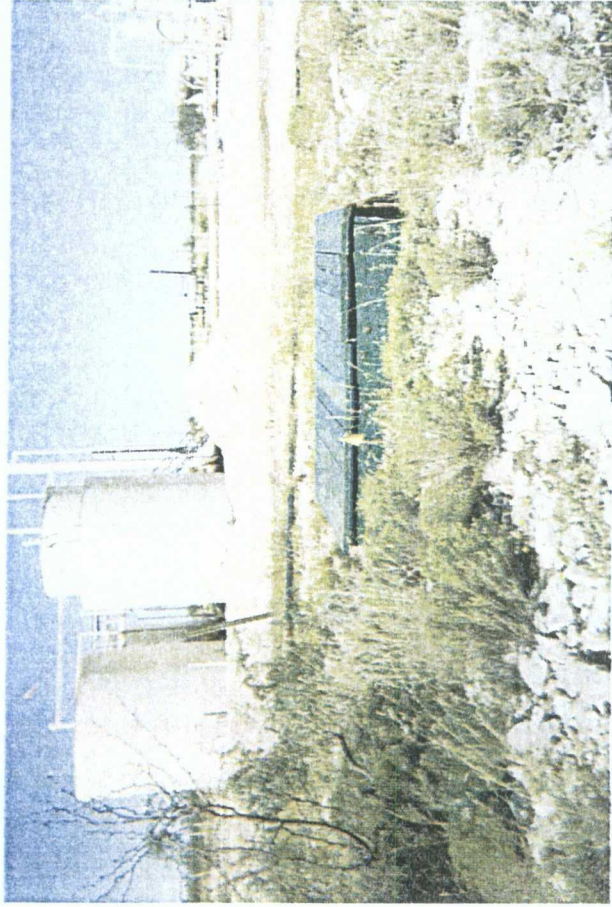
10/18/2005

former junction box

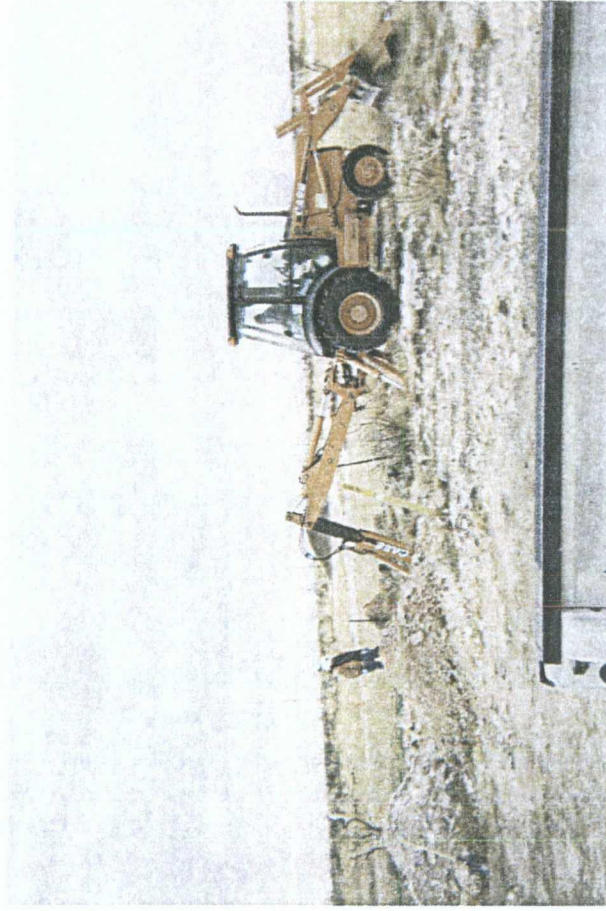
2/23/2009

excavating the former junction box site

Vacuum SWD System Abandonment. An investigation was conducted at the former junction box site using a backhoe to collect soil samples at regular intervals creating a 3x7x9-ft deep excavation. Chloride field tests were performed on each sample which yielded low concentrations similar to that of the background sample. Organic vapors were measured using a PID which also yielded low concentrations. The deepest sample, 9 ft BGS, was sent to a commercial laboratory for analysis of chloride and TPH. Laboratory analysis confirmed low concentrations of each. Clean, imported soil was used to backfill the excavation to ground surface and to contour to the surrounding area. On 4/13/2009, the site was seeded with a blend of native vegetation and is expected to return to a productive capacity at a normal rate.

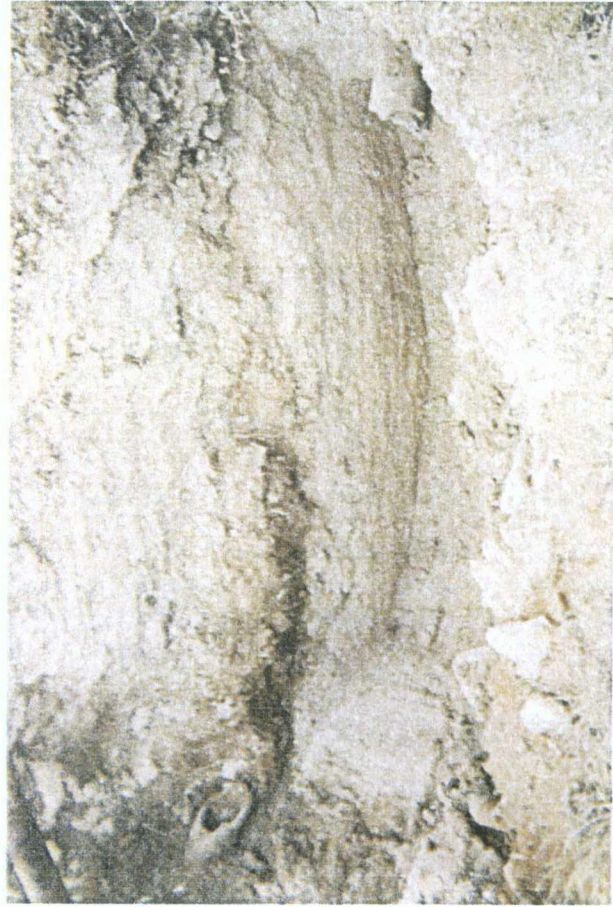
2/23/2009

excavation at the former junction box site

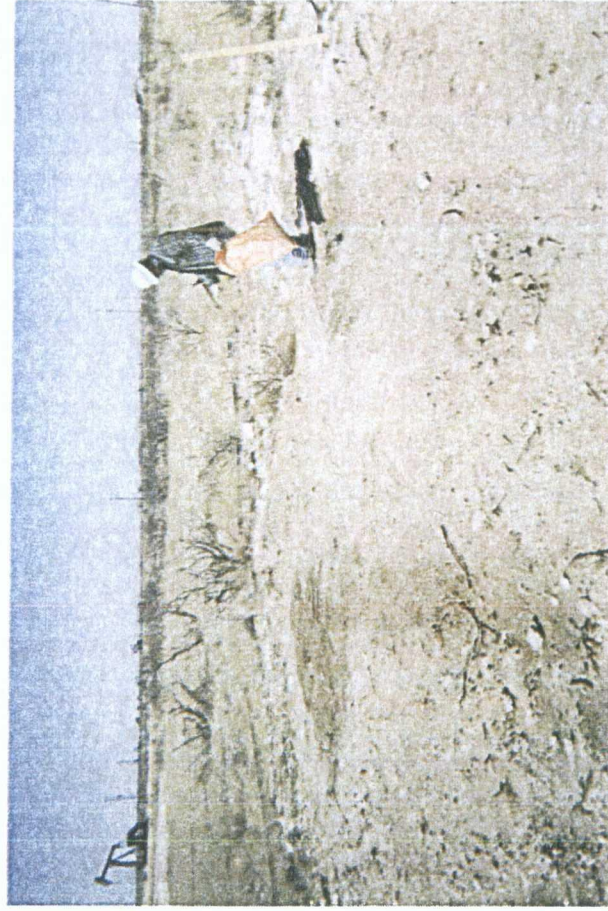
4/13/2009

seeding the backfilled site

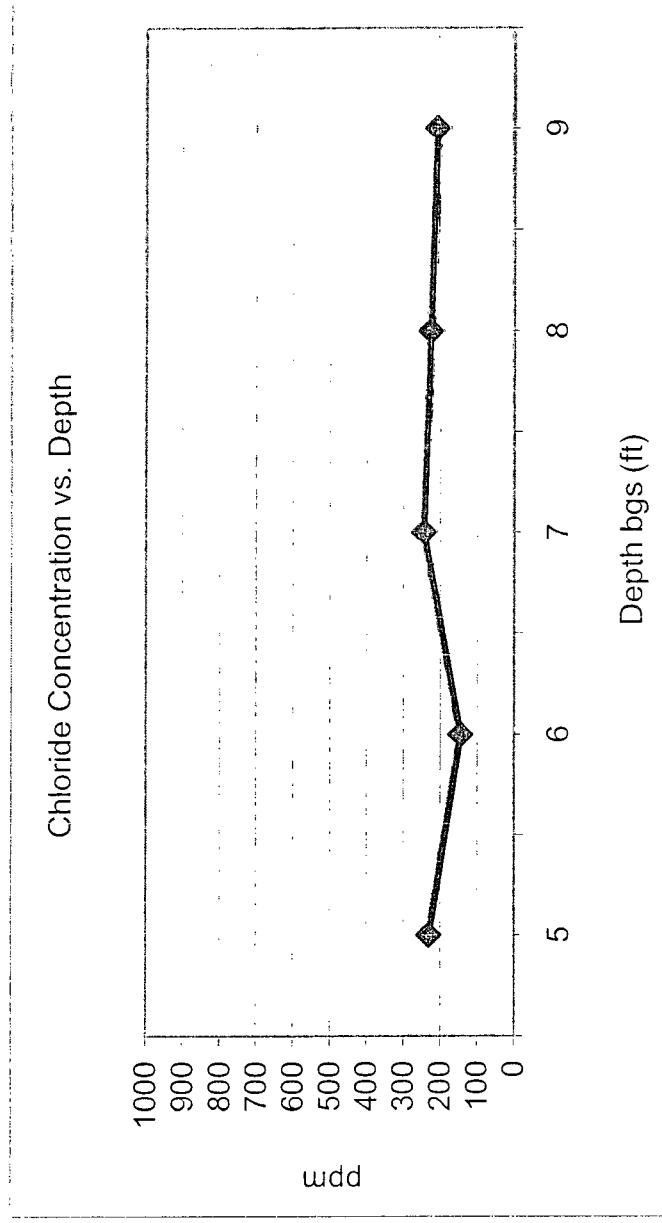
Backhoe samples at the junction (source)

Depth, bgs (ft)	[Cl ⁻] ppm
5	232
6	145
7	244
8	225
9	206

Groundwater = 117 ft

LOCATION	DEPTH	mg/kg
background	6"	143
vertical delineation trench at the junction (source)	5'	232
	6'	145
	7'	244
	8'	225
	9'	206
