**RICE OPERATING COMPANY
JUNCTION BOX DISCLOSURE* REPORT**

SWD SYSTEM	JUNCTION	UNIT	SECTION	TOWNSHIP	RANGE	COUNTY	BOX DIMENSIONS - FEET		
Vacuum	Jct. D-31	D	31	17S	35E	Lea	Length	Width	Depth
							eliminated

Vacuum Jct. D-31

Unit D, Section 31, T17S, R35E

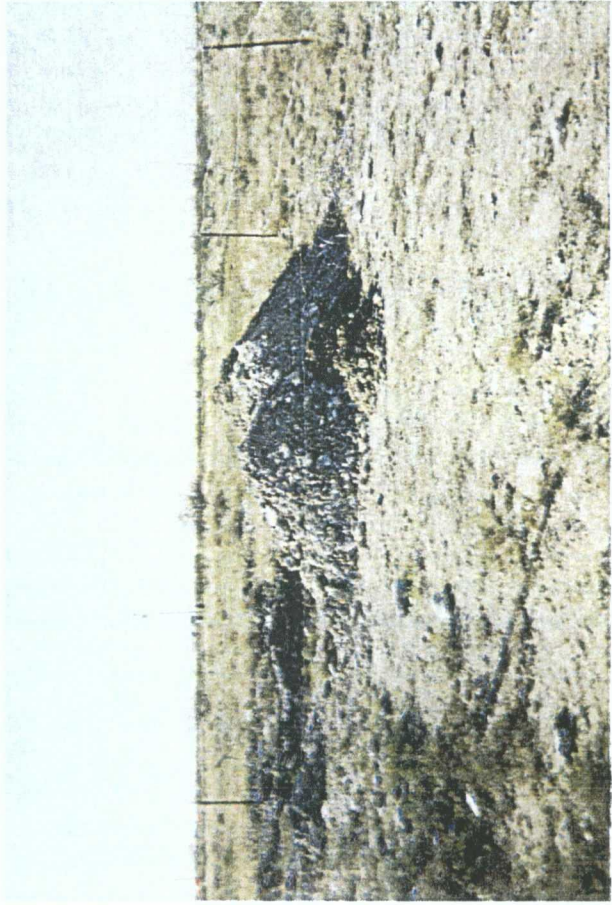
2/18/2009

site prior to excavation, facing north

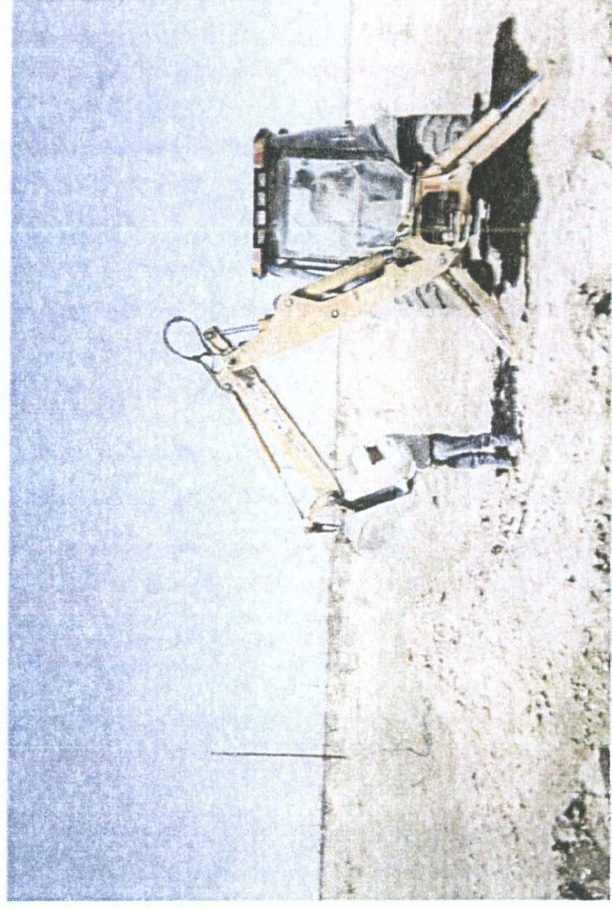
3/16/2009

collecting a soil sample, facing north

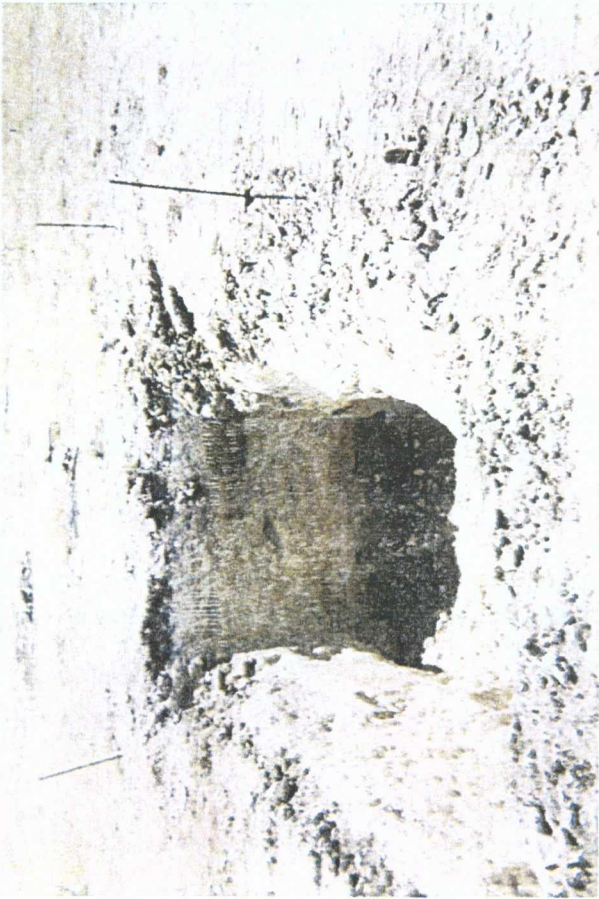
3/23/2009

final excavation, facing south

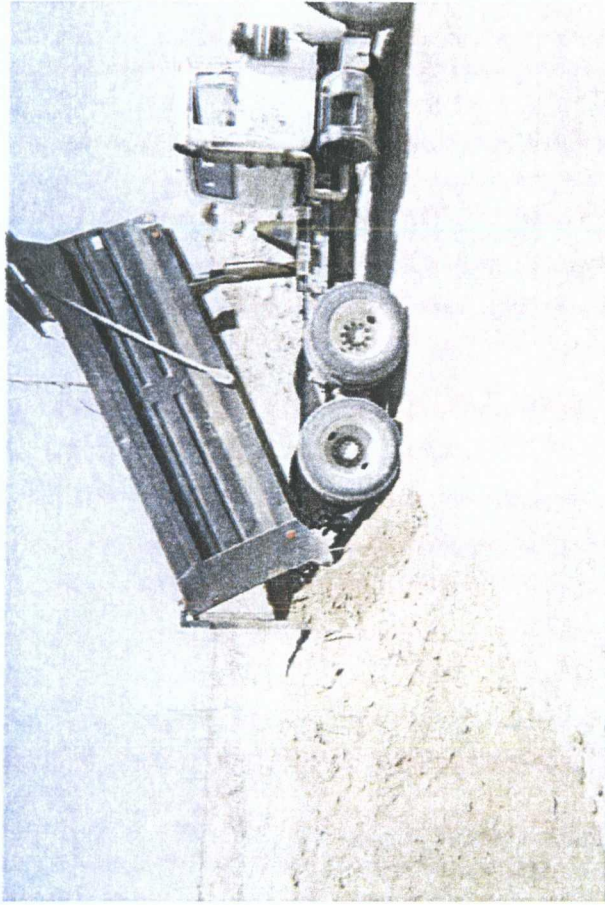
3/26/2009

hauling in fresh soil, facing east

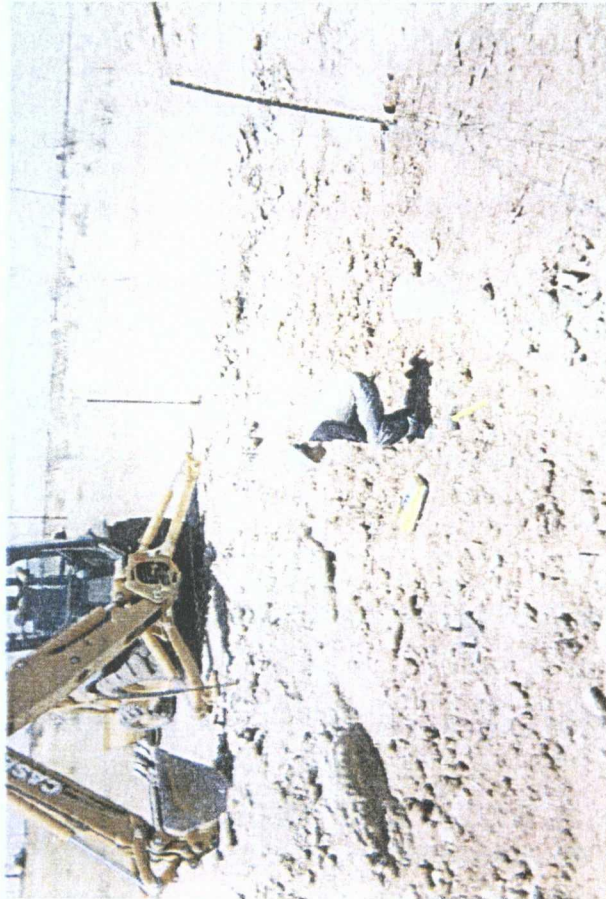
4/17/2009

compaction test of the clay barrier, facing northwest

Test No.	Location	Dry Density % Max	% Moisture	Depth
SG 12	Vacuum Jct. D/31 15' E. & 5' S. of NW Corner of Pit	91.3	10.1	3' Below Surface

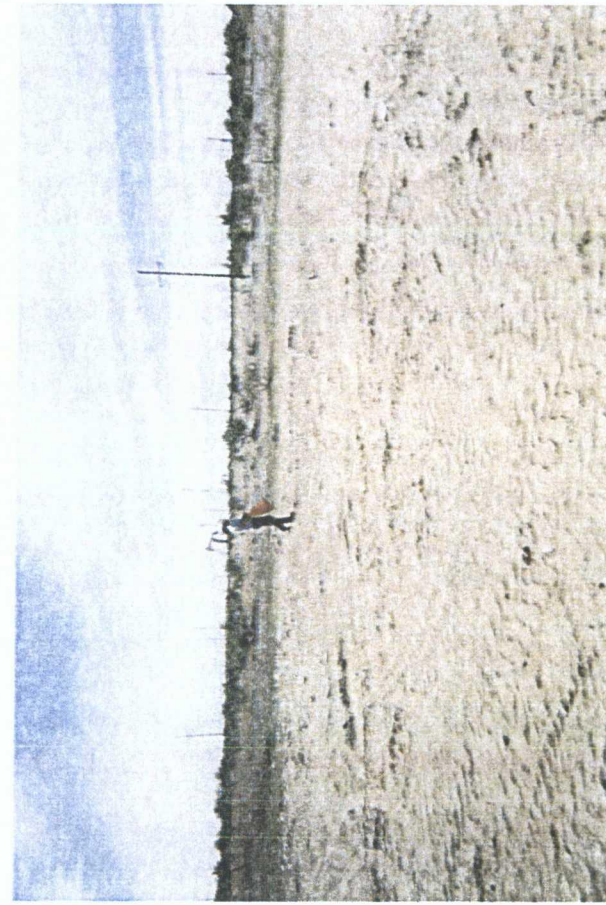
6/8/2009

seeding backfilled site, facing north

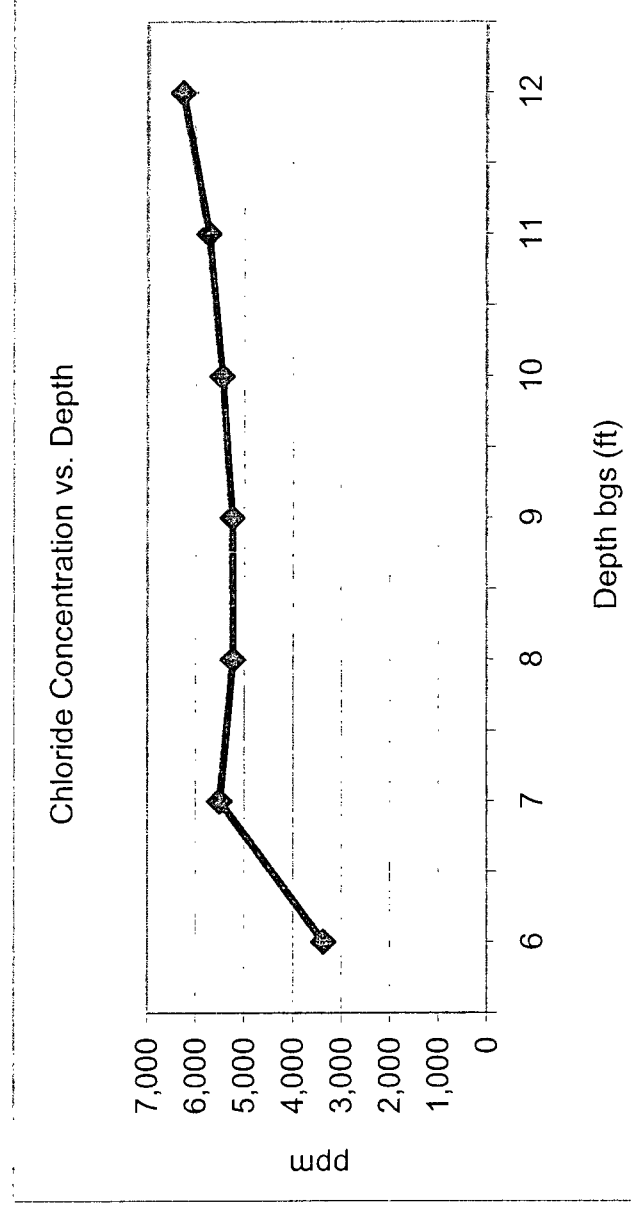
Backhoe samples at 20 ft North of the junction (source)

Depth bgs. (ft.)	[Cl] ppm
6	3,373
7	5,501
8	5,225
9	5,239
10	5,446
11	5,716
12	6,249

Groundwater = 117 ft
