**EME Jct P-19
2009**

Environmental Bureau
Oil Conservation DivisionRICE OPERATING COMPANY
JUNCTION BOX FINAL REPORT

EME Jct. P-19

Unit P, Section 19, T19S, R37E

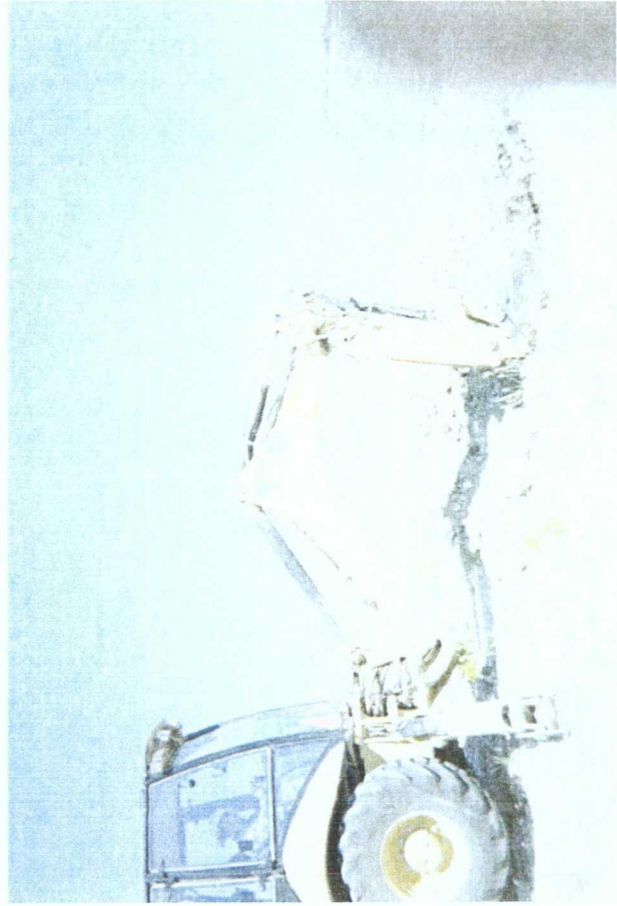
excavating the former junction box site, facing east 9/30/2008

General Description of Remedial Action: This junction box was eliminated during the pipeline replacement/upgrade program. After the former junction box was removed, an investigation was conducted using a backhoe to collect soil samples at regular intervals producing a 30x30x12-ft-deep excavation. Chloride field tests performed on each sample yielded generally low concentrations. Organic vapors, measured using a PID, yielded some elevated concentrations. Representative composite samples were sent to a commercial laboratory for analysis of chloride and TPH, which yielded elevated concentrations of DRO. The excavated soil was blended on site with clean, imported soil and returned to the excavation to ground surface and contoured to the surrounding area. On 11/26/2008, the site was seeded with a blend of native vegetation and is expected to return to a productive capacity at a normal rate. To further investigate depth of chloride presence, a soil boring was initiated on 11/3/2009 at 8 ft northeast of the former junction box site. The boring was advanced to 27 ft BGS, while soil samples were collected at every 3 ft and field tested for chlorides and organic vapors. The 24 and 27 ft samples were sent to a commercial laboratory for analysis of chloride and TPH which confirmed low concentrations of each. The entire bore hole was plugged with bentonite to the ground surface. NMOCD was notified of potential ground-water impact on 4/15/2009, but further evaluation of the site deemed no further action is required.

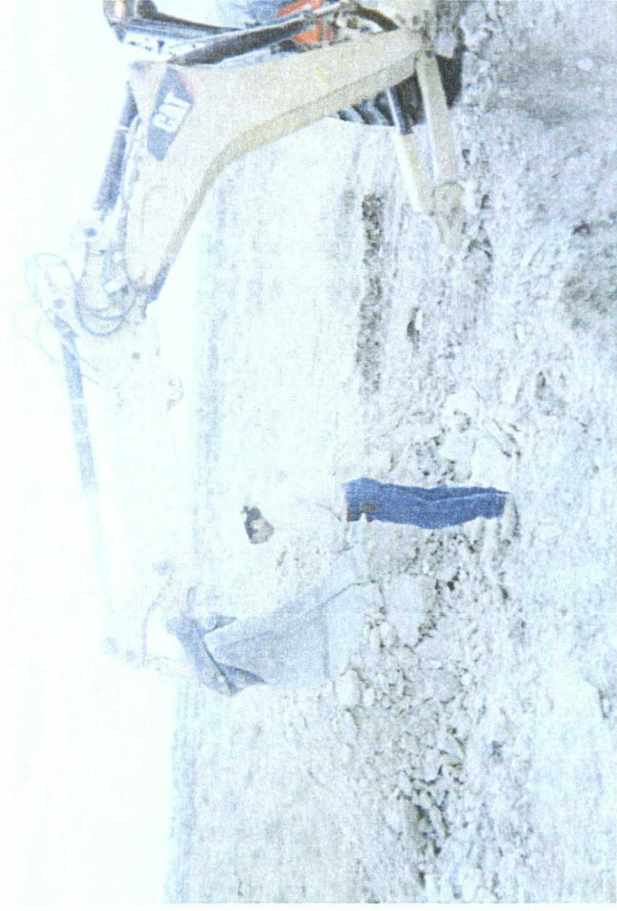
collecting a soil sample, facing southeast 10/13/2008

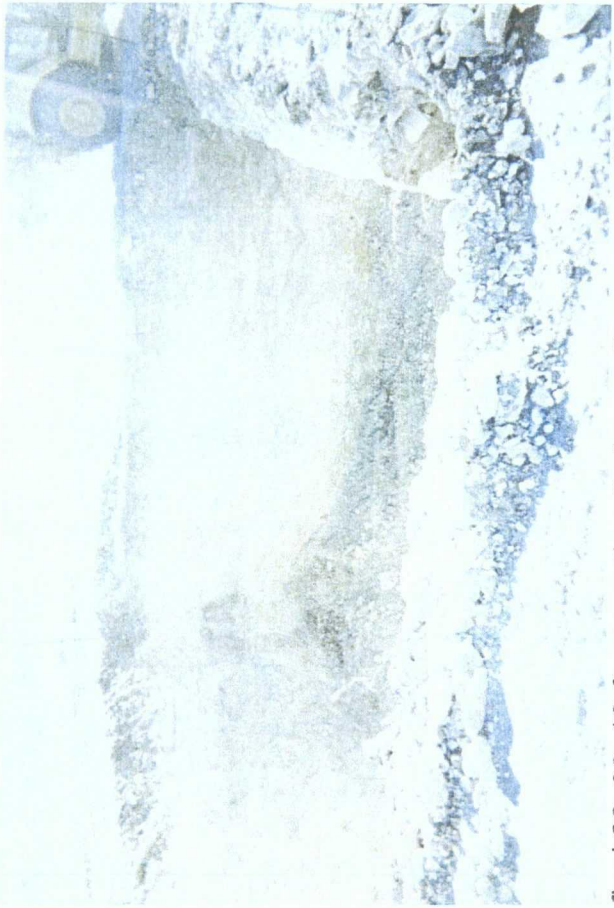
final 30x30x12-ft excavation, facing south

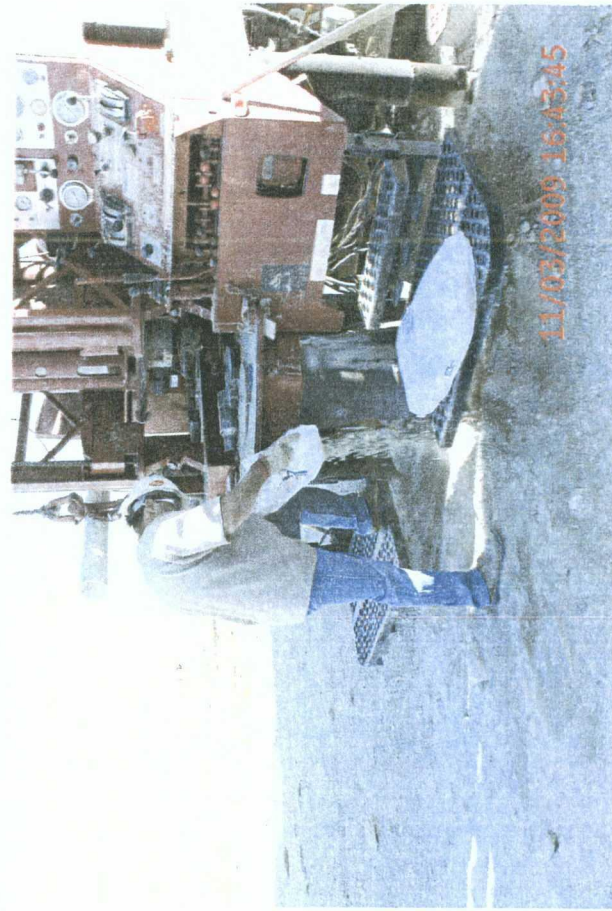
plugging SB #1 with bentonite

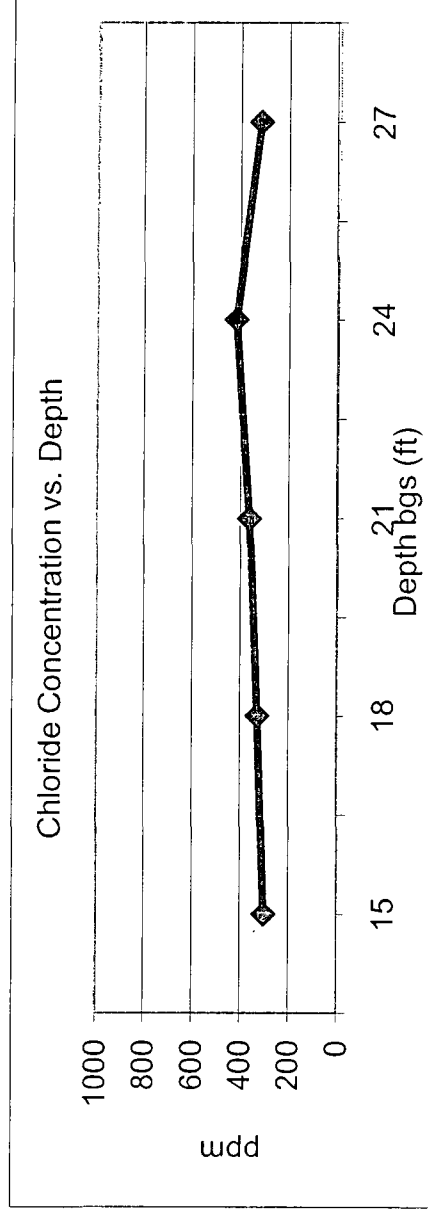
CHLORIDE CONCENTRATION CURVE

SOIL BORING samples at 8 ft northeast of the junction (source)

Depth bgs (ft)	[Cl] ppm
15	302
18	329
21	362
24	420
27	317

Groundwater = 40 ft
