**EME Jct I-1-2 Boot
2009**

**RICE OPERATING COMPANY
JUNCTION BOX FINAL REPORT**

EME Jct I-1-2 boot

Unit I, Section 1, T20S, R36E

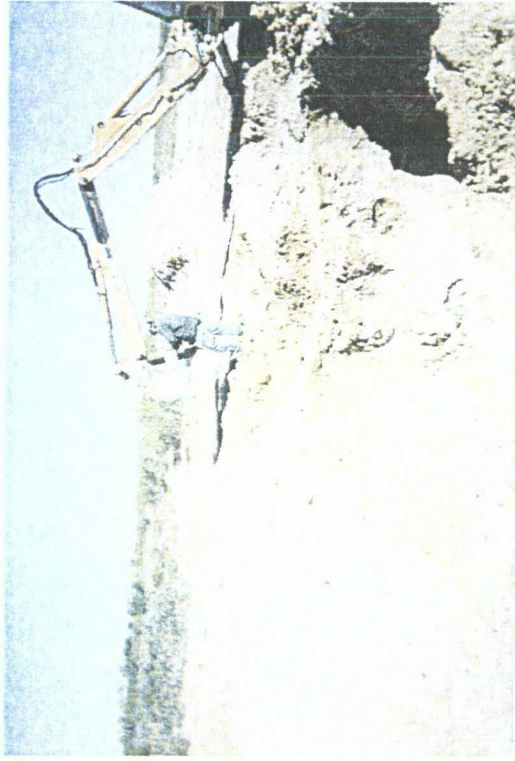
collecting a soil sample

10/31/2006

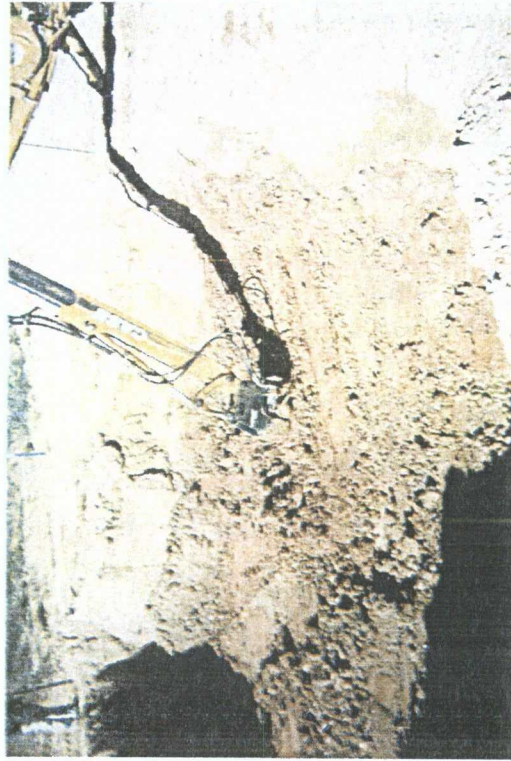
installing the clay barrier

11/15/2006

General Description of Remedial Action: This junction was eliminated during the pipeline replacement/upgrade program. An investigation was conducted at the former junction box site using a backhoe to collect soil samples at regular intervals producing a 30x30x12-ft-deep excavation. Chloride field tests were performed on each sample which yielded generally low concentrations. Organic vapors, measured using a PID, yielded low concentrations. Representative composite samples were collected from the excavated soil, the excavation walls, and the bottom of the excavation. The representative composite samples sent to a commercial laboratory for analysis of chloride and TPH. The excavated soil was returned to the excavation up to 6 ft below ground surface (BGS). At 6-5 ft BGS, a clay barrier was installed. The remaining soil was returned to the excavation to ground surface and contoured to the surrounding area. On 11/20/2006, the site was seeded with a blend of native vegetation and is expected to return to a productive capacity at a normal rate. This junction box was then encompassed in the EME I-1 SWD major project (1R336) which received termination through NMOCD on 3/11/2009.
