Environmental Bureau
Oil Conservation DivisionRICE OPERATING COMPANY
JUNCTION BOX FINAL REPORT

SWD SYSTEM	JUNCTION	UNIT	SECTION	TOWNSHIP	RANGE	COUNTY	BOX DIMENSIONS - FEET		
Eunice-Monument-Eumont (EME)	Q-6 EOL	Q	6	21S	36E	Lea	Length	Width	Depth
							Eliminated

EME Q-6 EOL

Unit Q, Section 6, T21S, R37E

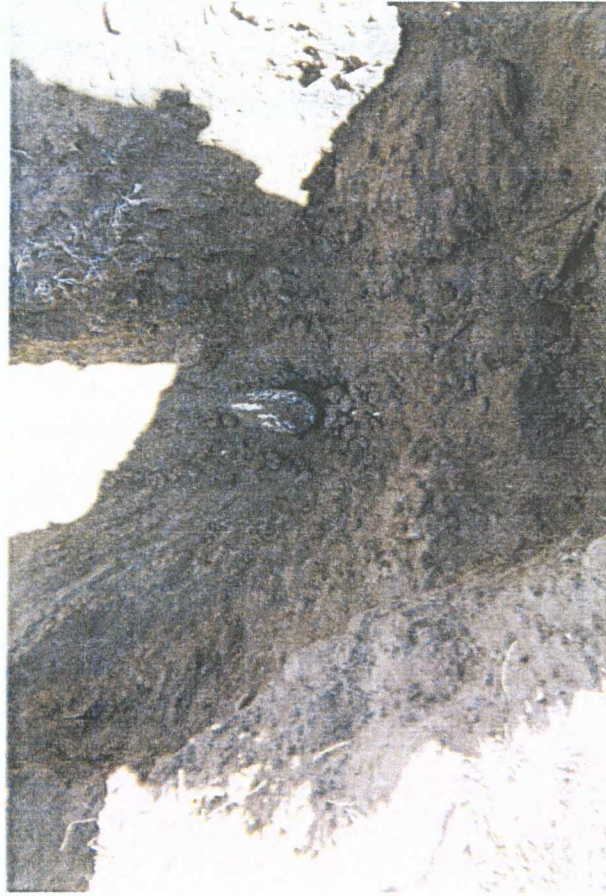
photo of EOL facing west

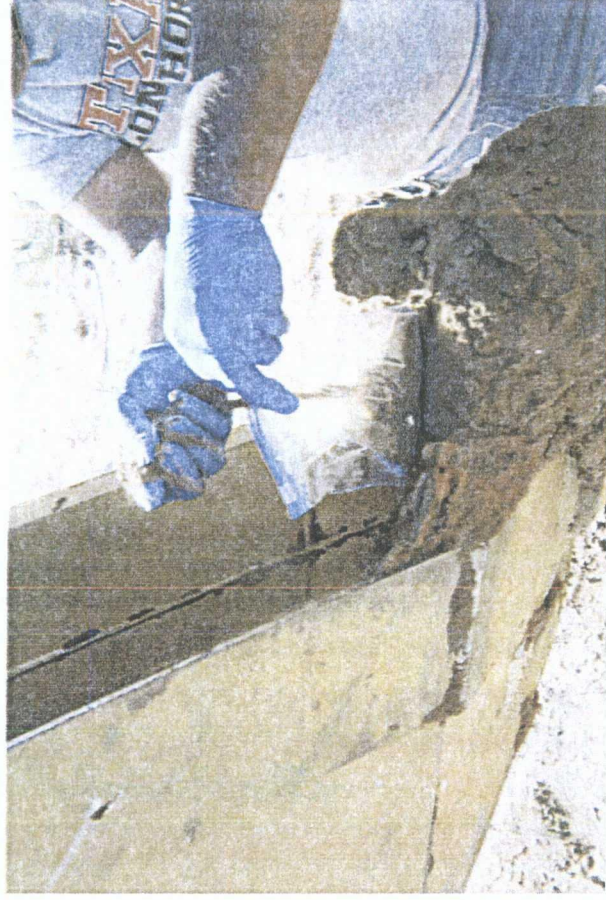
sampling source (south)

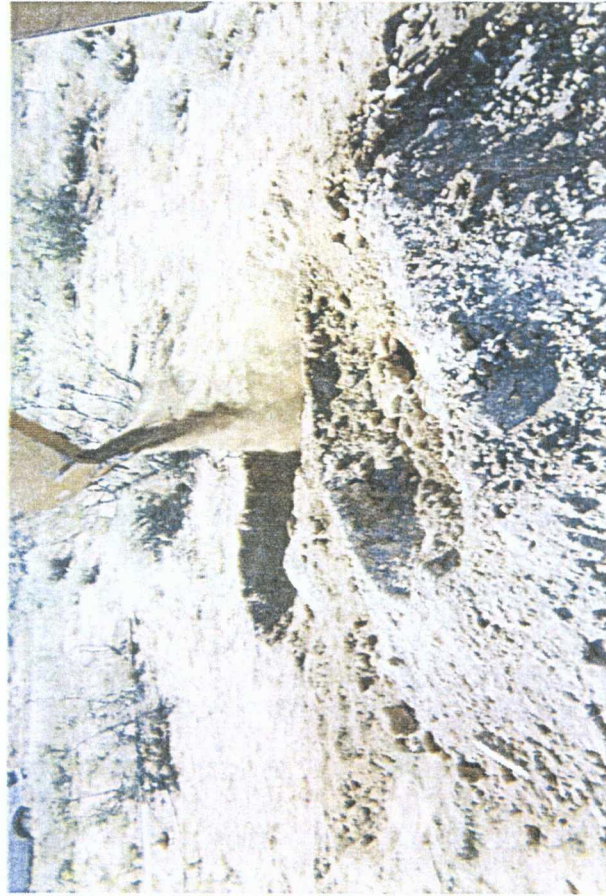
backfilling (south)

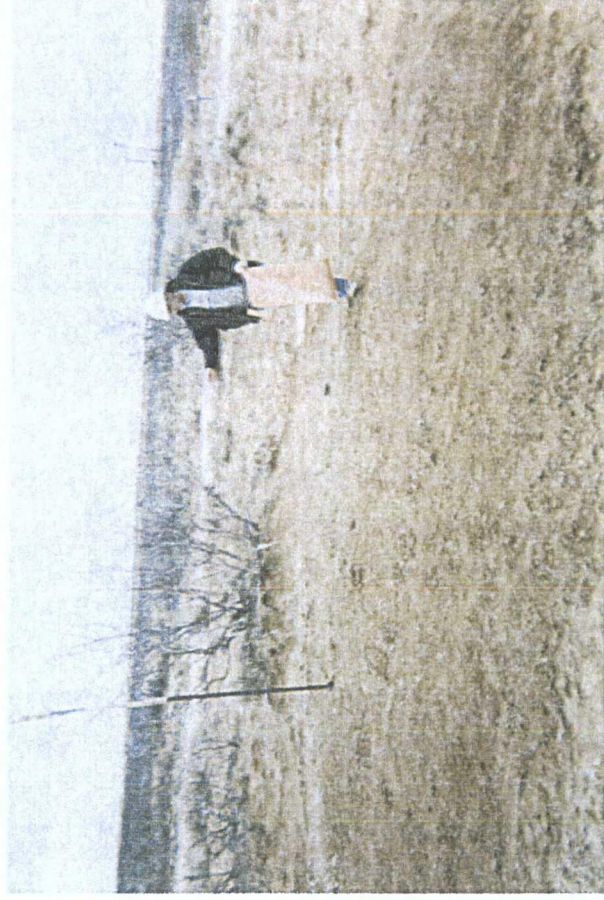
seeding backfilled site
