**RICE OPERATING COMPANY  
JUNCTION BOX FINAL REPORT**

SWD SYSTEM	JUNCTION	UNIT	SECTION	TOWNSHIP	RANGE	COUNTY	BOX DIMENSIONS FEET		
Blinebry-Drinkard (BD)	B-17 EOL	B	17	22S	37E	Lea	Length 5'	Width 6'	Depth 6'
							same location

## BD B-17 EOL

Unit B, Section 17, T22S, R37E

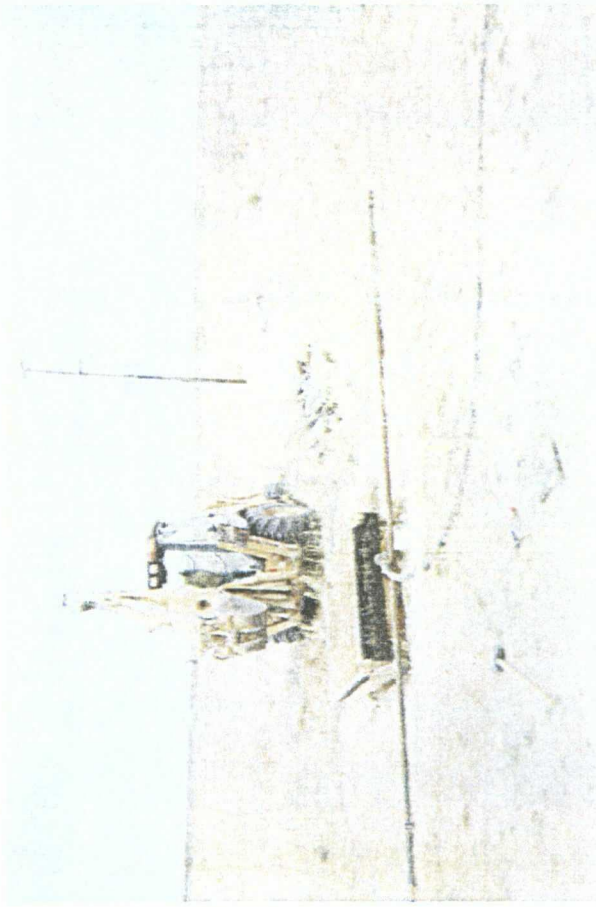
former junction box, facing west

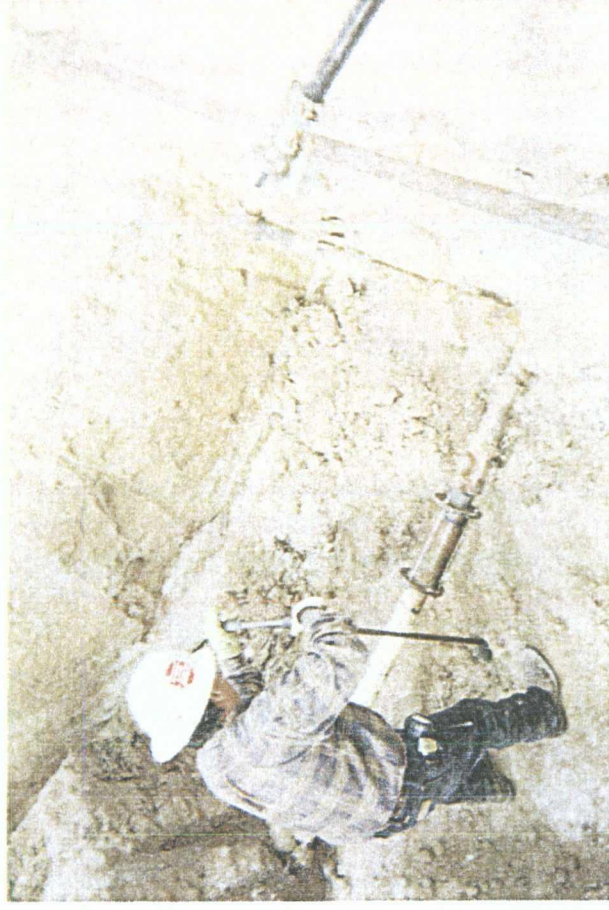
hand auger at the source, facing north

**General Description of Remedial Action:** This junction box was addressed during the pipeline replacement/upgrade program. After the former junction box was removed, an investigation was conducted using hand auger at the source to collect soil samples at regular intervals. Chloride field tests were performed on each sample, which yielded low concentrations. Organic vapors were measured using a PID, which also yielded low concentrations. Laboratory analysis of chloride and TPH confirmed low concentrations. A new, watertight junction box was built in the same location.

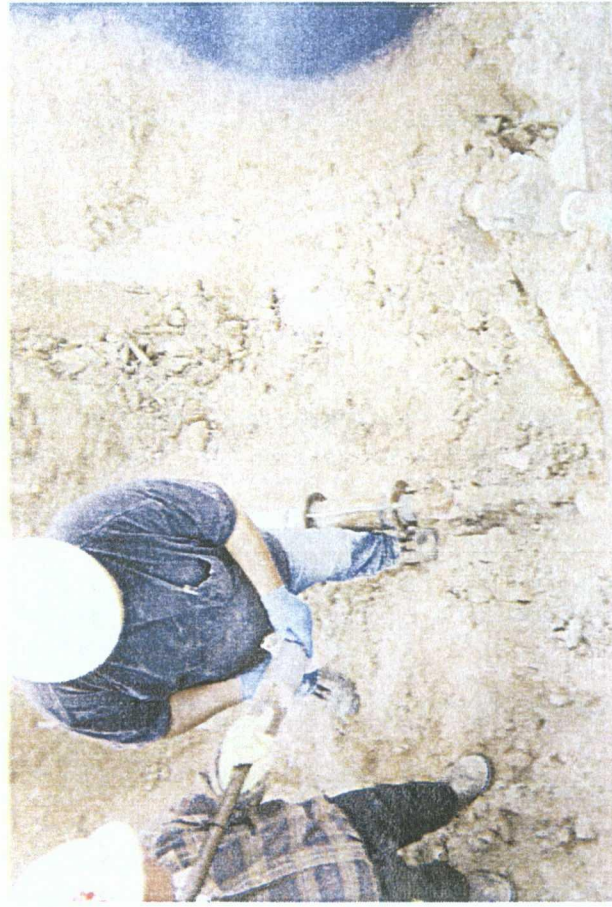
collecting a soil sample, facing west

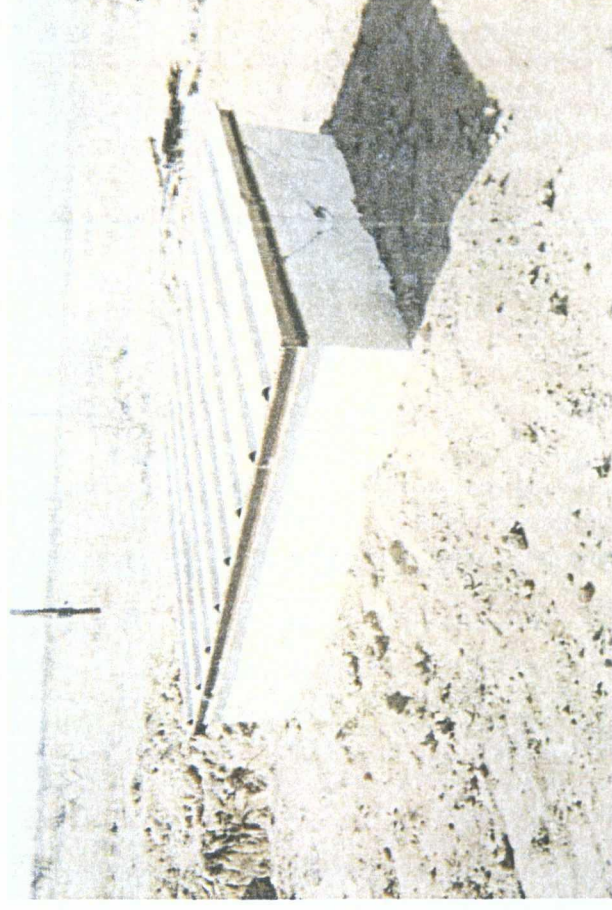
new, watertight junction box

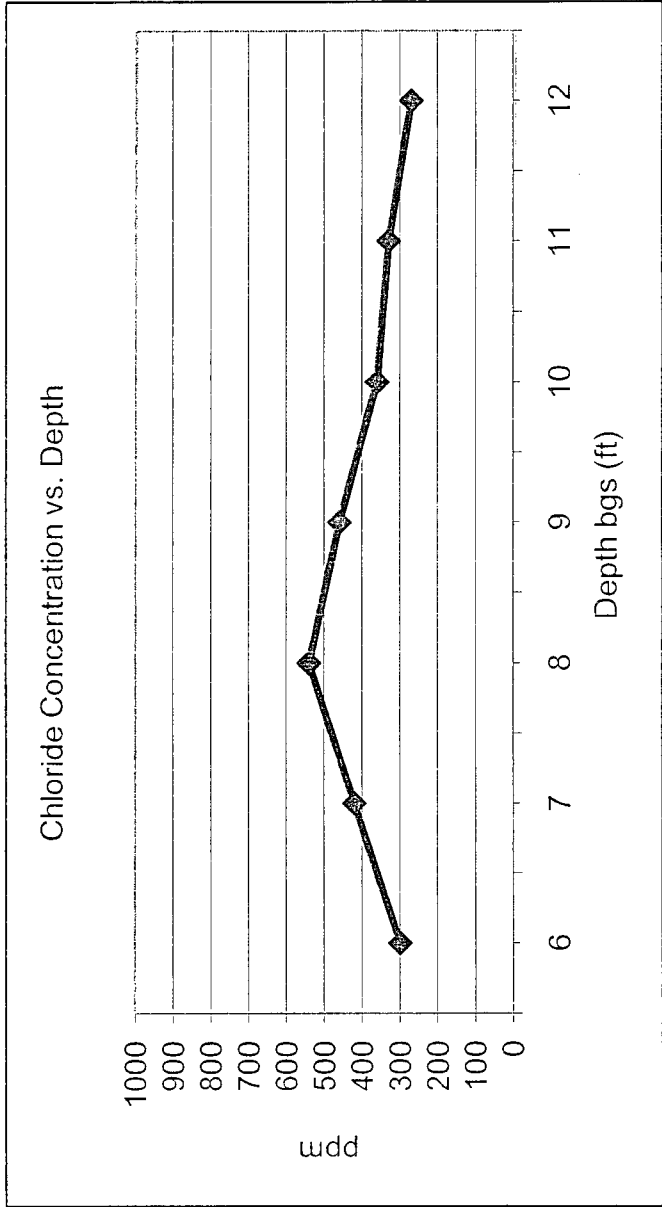
CHLORIDE CONCENTRATION CURVE

Hand auger samples at the junction (source)

Depth bgs (ft)	[Cl <sup>-</sup> ] ppm
6	300
7	420
8	540
9	460
10	360
11	330
12	270

Groundwater = 75 ft

LOCATION	DEPTH	mg/kg
background	6"	180
hand auger samples collected at the junction (source)	6'	300
	7'	420
	8'	540
	9'	460
	10'	360
	11'	330
	12'	270
