RICE OPERATING COMPANY
JUNCTION BOX FINAL REPORT

BD Jct. G-30-1

Unit G, Section 30, T21S, R37E

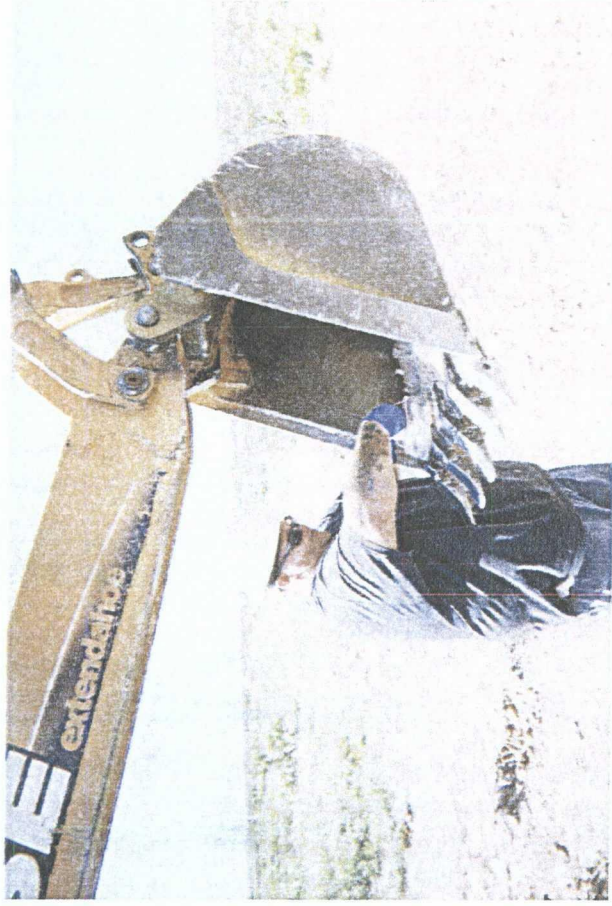
collecting a soil sample from the source, facing south 6/26/2009

General Description of Remedial Action: This junction was addressed during the pipeline replacement/upgrade program. After the former junction box was removed, an investigation was conducted using a backhoe to collect soil samples at regular intervals creating a 3x5x10-ft deep excavation. Chloride field tests were performed on each sample which yielded low concentrations similar to that of the background. Organic vapors were measured using a PID which also yielded low concentrations. The deepest sample, 10 ft BGS, was sent to a commercial laboratory for analysis of chloride and TPH. Lab analysis confirmed low concentrations of each. The excavated soil was returned to the excavation to ground surface and contoured to the surrounding area. On 8/13/2009, the site was seeded with a blend of native vegetation and is expected to return to a productive capacity at a normal rate.

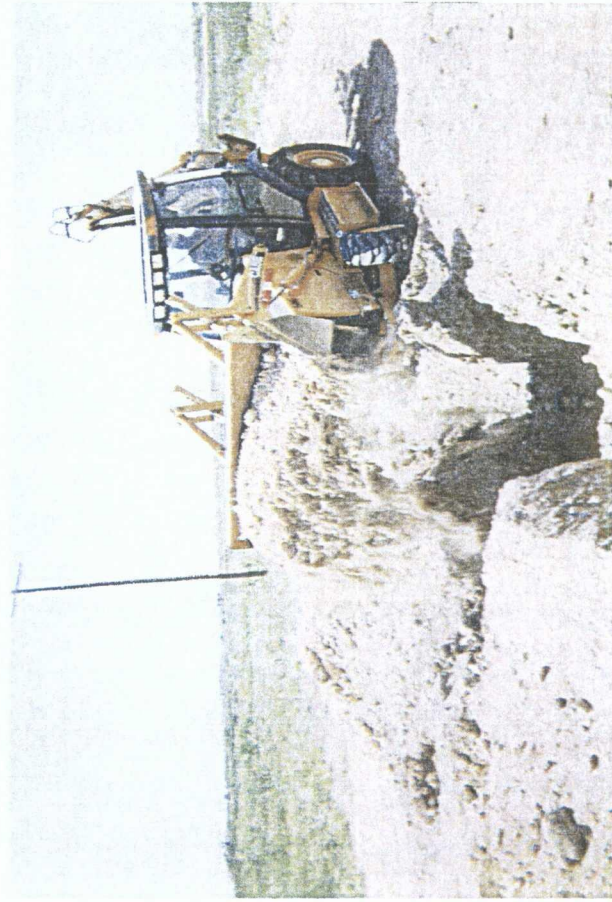
8/13/2009

backfilling the excavation, facing south

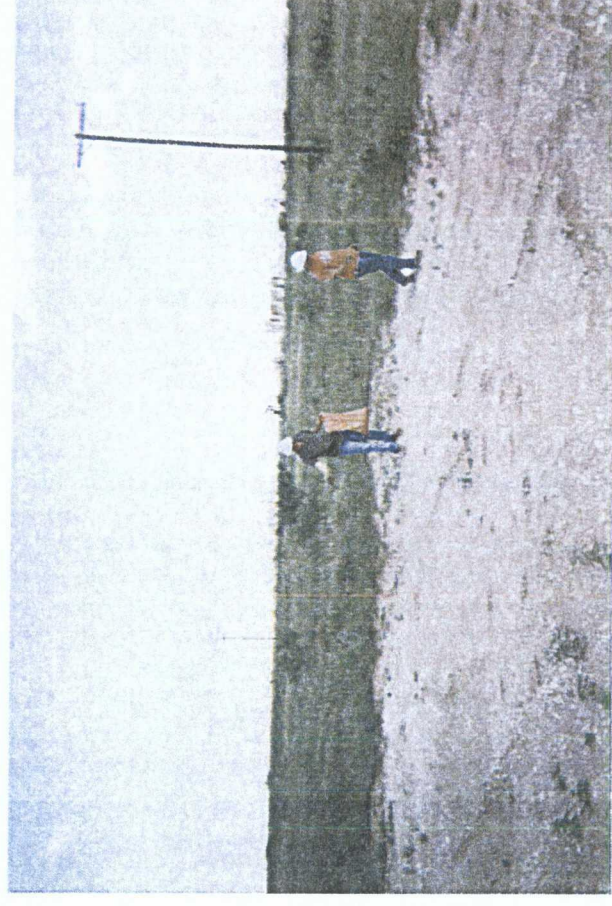
8/13/2009

seeding the backfilled site, facing south
