RICE OPERATING COMPANY
JUNCTION BOX FINAL REPORT

SWD SYSTEM	JUNCTION	UNIT	SECTION	TOWNSHIP	RANGE	COUNTY	BOX DIMENSIONS - FEET		
							Length	Width	Depth
Blinebry-Drinkard (BD)	J-25 EOL	J	25	21S	36E	Lea	eliminated

BD J-25 EOL

Unit J, Section 25, T21S, R36E

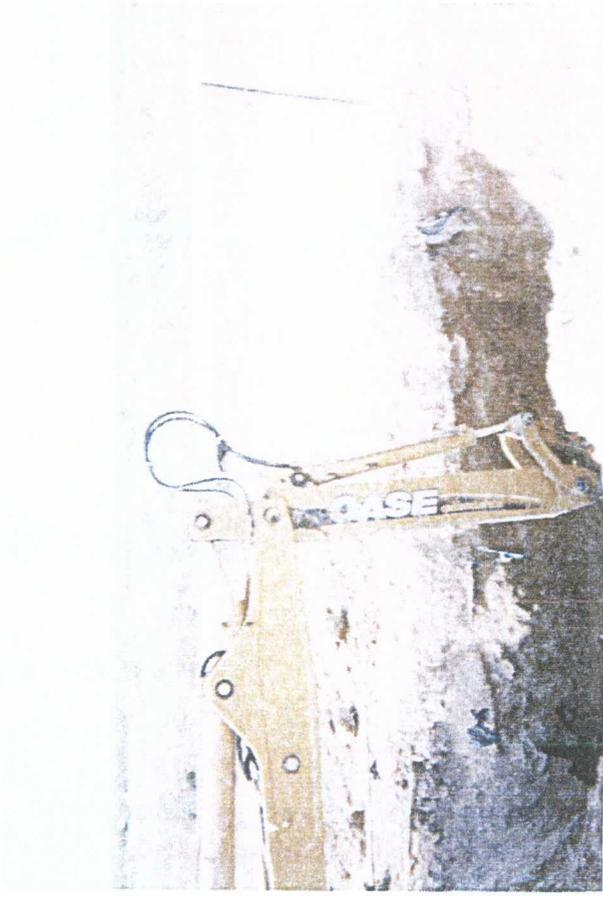
7/20/2009

excavating the former junction box site, facing north

General Description of Remedial Action: This junction was eliminated during the pipeline replacement/upgrade program. After the former junction box was removed, an investigation was conducted using a backhoe to collect soil samples at regular intervals. Chloride field tests performed on each sample yielded low concentrations similar to that of the background. Organic vapors were measured using a PID, which also yielded low concentrations. The deepest sample, 9 ft BGS, was sent to a commercial laboratory for analysis of chloride and TPH, which confirmed low concentrations. The excavated soil was returned to the excavation to ground surface and contoured to the surrounding area. On 8/13/2009, the site was seeded with a blend of native vegetation and is expected to return to a productive capacity at a normal rate.

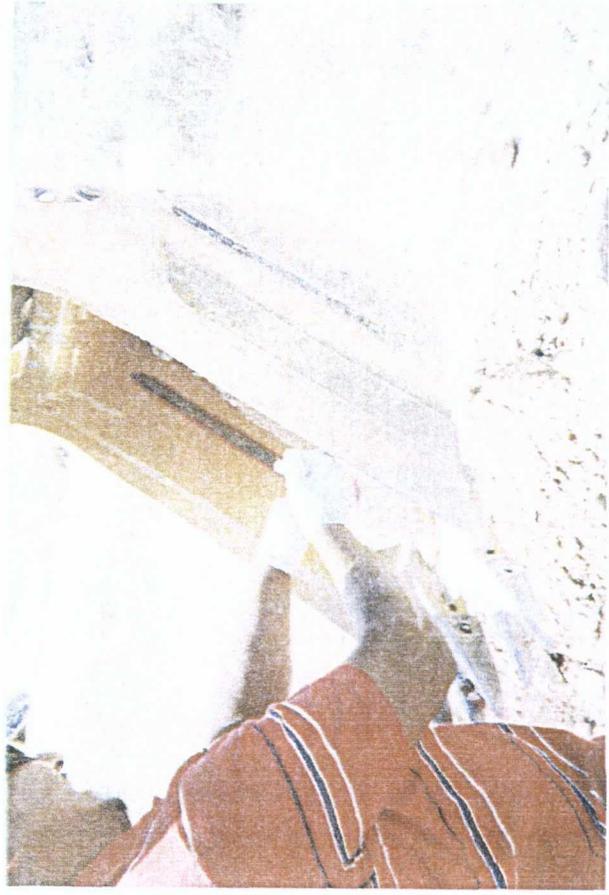
7/20/2009

collecting a soil sample, facing south

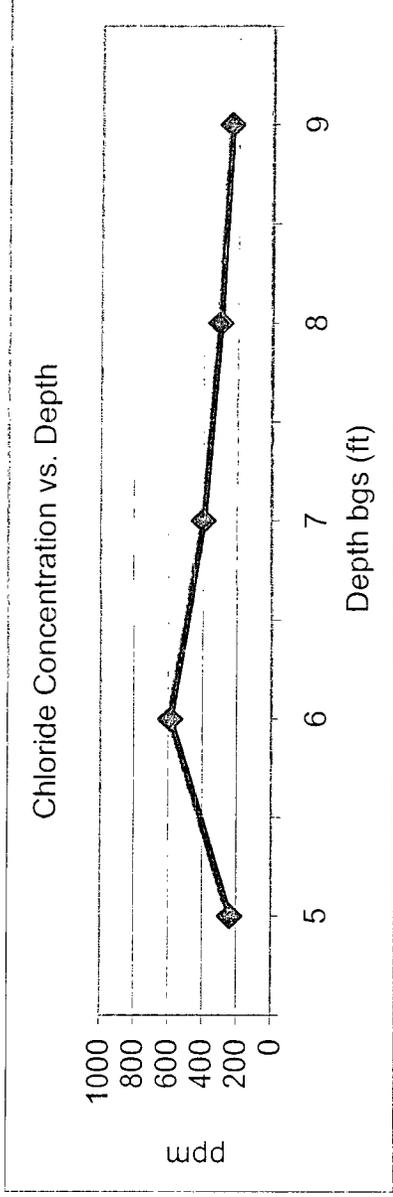
CHLORIDE CONCENTRATION CURVE

Backhoe samples at the junction (source)

Depth bgs (ft)	[Cl] ppm
5	239
6	588
7	396
8	299
9	236

Groundwater = 148 ft

LOCATION	DEPTH	mg/kg
background	6"	120
vertical delineation trench at the junction (source)	5'	239
	6'	588
	7'	396
	8'	299
	9'	236
