CLOSURE

SWD SYSTEM	JUNCTION	UNIT	SECTION	TOWNSHIP	RANGE	COUNTY	BOX DIMENSIONS - FEET		
Blinebry-Drinkard (BD)	D-1 EOL	D	1	22S	36E	Lea	Length 7'	Width 5'	Depth 3'
							moved 15 ft southeast

BD D-1 EOL

Unit D, Section 1, T22S, R36E

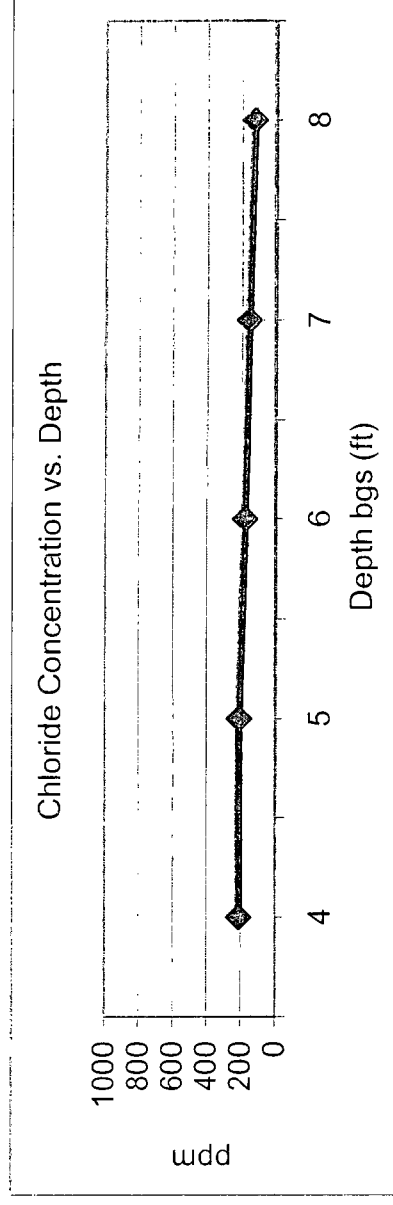
CHLORIDE CONCENTRATION CURVE

Backhoe samples at the junction (source)

Depth bgs (ft)	Cl ⁻ ppm
4	211
5	209
6	176
7	151
8	120

Groundwater = 137 ft
