**RICE OPERATING COMPANY
JUNCTION BOX FINAL REPORT**

General Description of Remedial Action: This junction was eliminated during the pipeline replacement/upgrade program. After the former junction box was removed, an investigation was conducted using a backhoe to collect soil samples at regular intervals producing a 30x30x12-ft deep excavation. Chloride field tests performed on each sample yielded slightly elevated concentrations. Organic vapors, measured using a PID, yielded low concentrations. Representative composite samples were sent to a commercial laboratory for analysis of chloride and TPH, which confirmed slightly elevated concentrations of chloride and low concentrations of TPH. The excavated soil was blended on site with clean, imported soil and returned to the excavation up to 5 ft below ground surface (BGS). At 5-4ft BGS, a 1-ft thick clay barrier was installed with a compaction test performed on 8/13/2009. The remaining fill was used to backfill the excavation to ground surface and to contour to the surrounding area. On 8/17/2009, the site was seeded with a blend of native vegetation and is expected to return to a productive capacity at a normal rate. To further inves

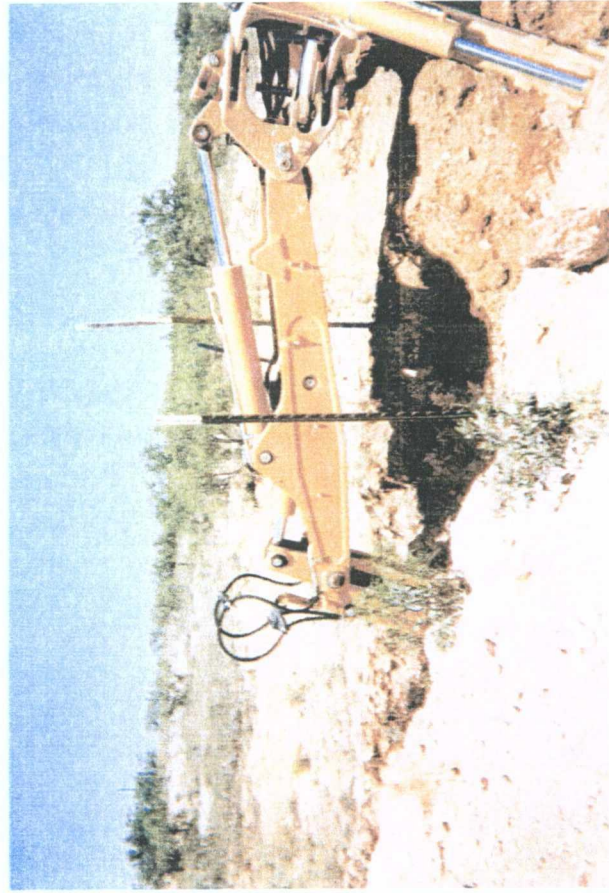
excavating the former junction box site, facing north 7/20/2009

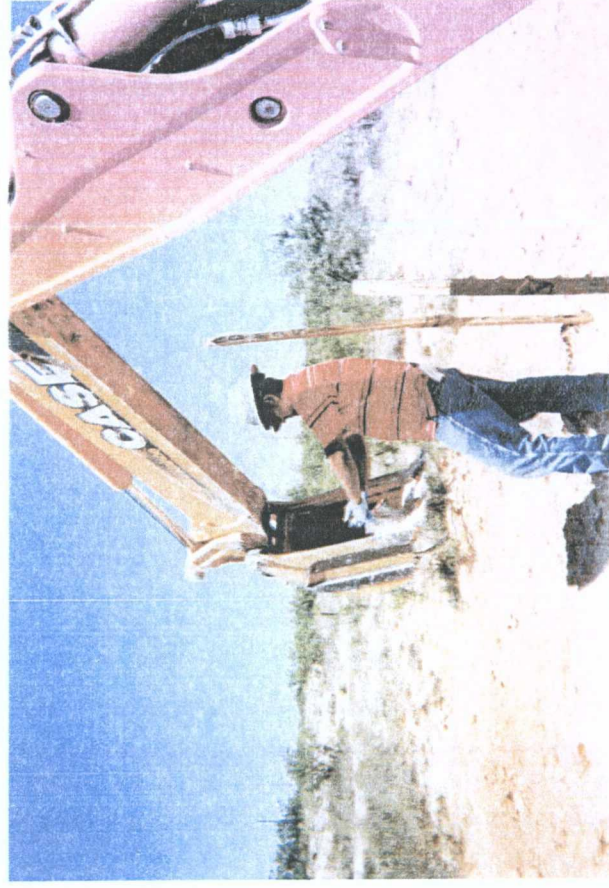
7/20/2009

collecting a soil sample, facing north

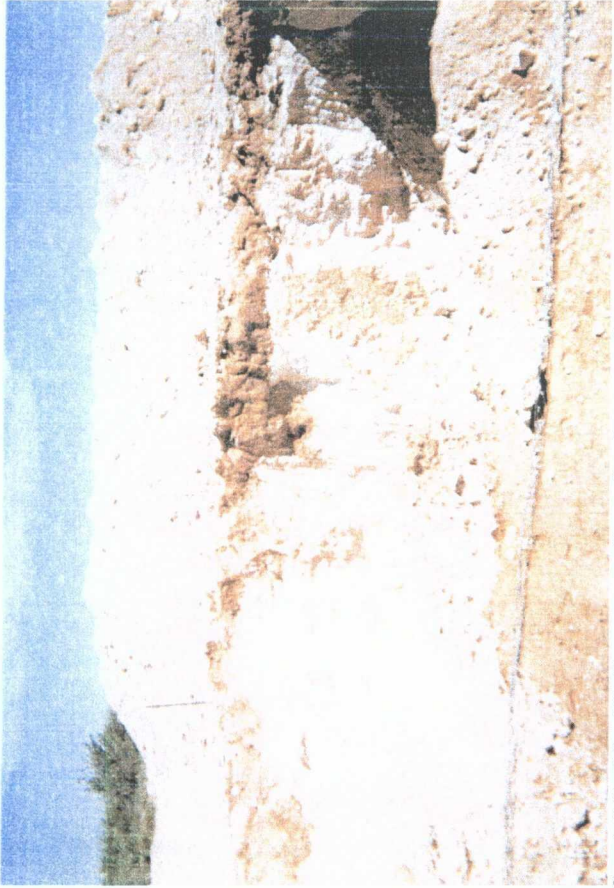
8/11/2009

final 30x30x12-ft excavation, facing north

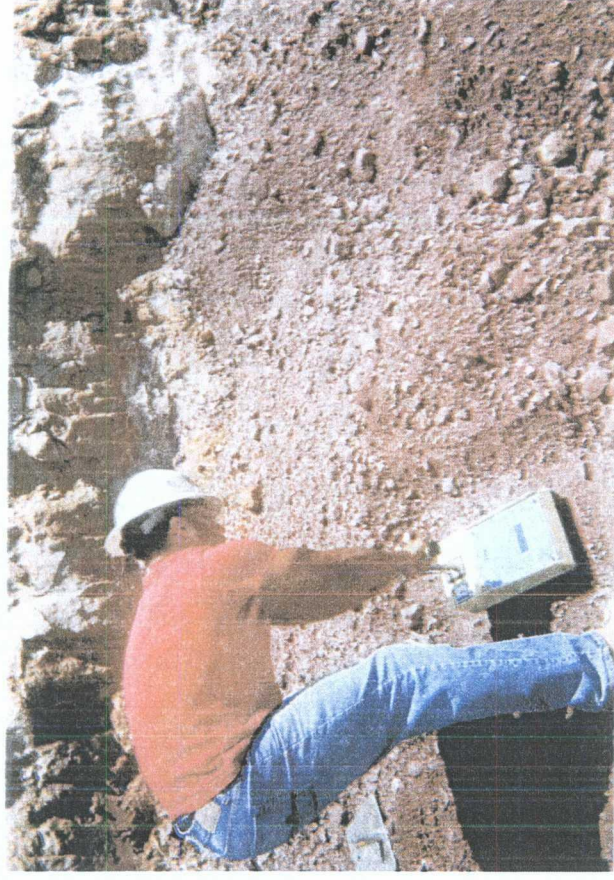
8/13/2009

compaction test of the clay barrier

Test No.	Location	Dry Density		Depth
		% Max	% Moisture	
SG 19	Junction Box - 15' W. & 40' S. of NE Corner	92.6	14.1	5' Below Surface

Required Compaction: 90 - 95%

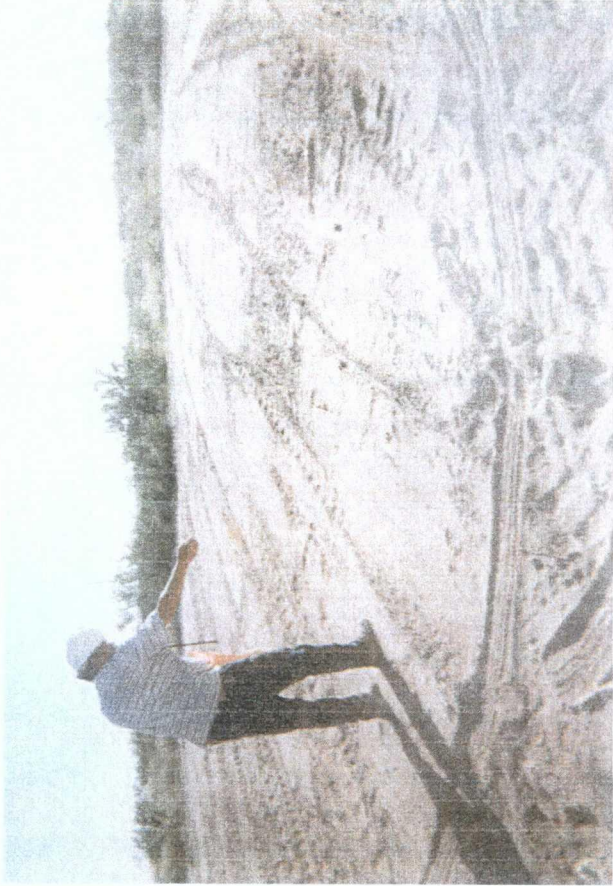
8/17/2009

seeding backfilled site, facing south

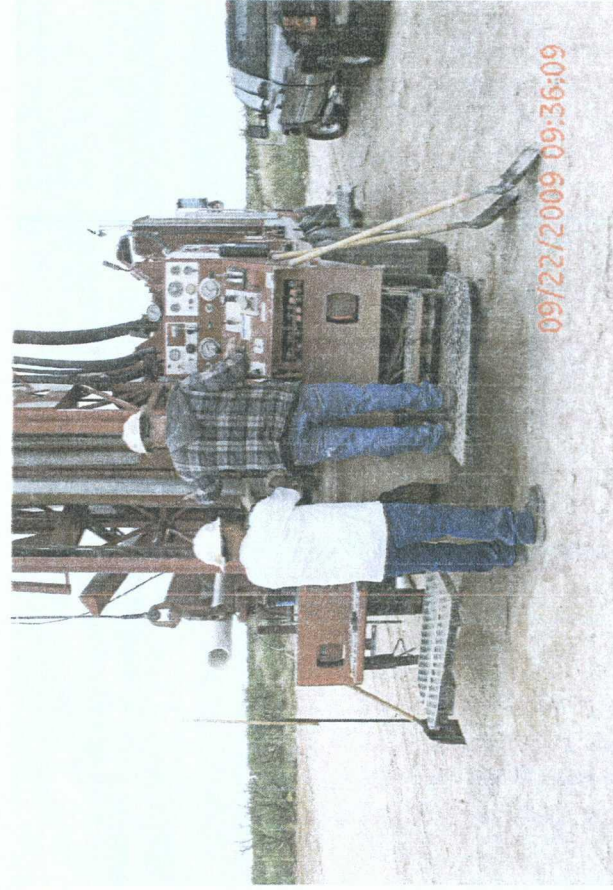
9/22/2009

drilling SB #1 at the former junction box site

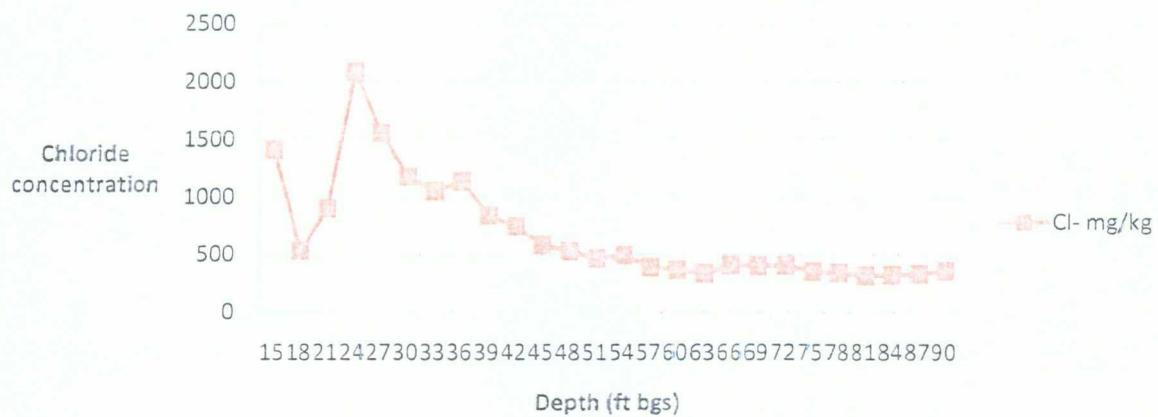
Chloride concentration versus depth

Abandoned box location

⑤ SB-1

ROC abandoned line

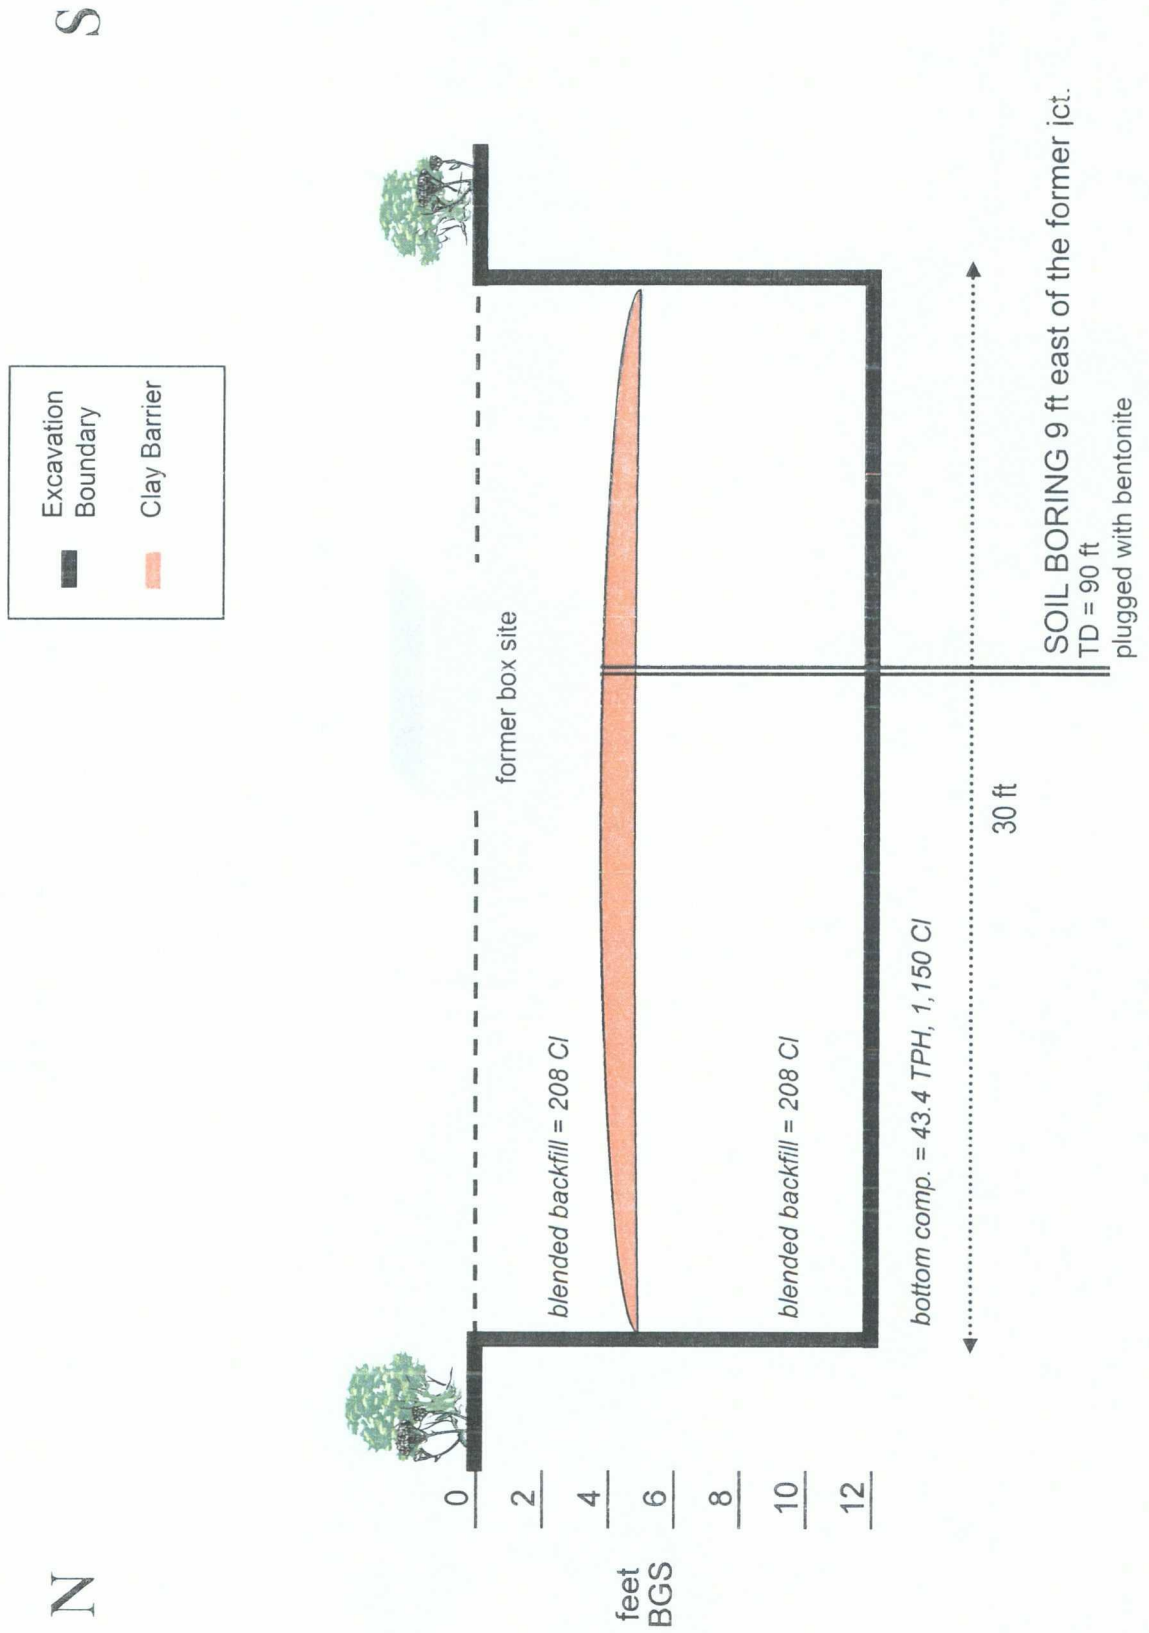
Excavation Cross-Section

BD M-25 EOL
Unit 'M', Sec. 25, T21S, R36E

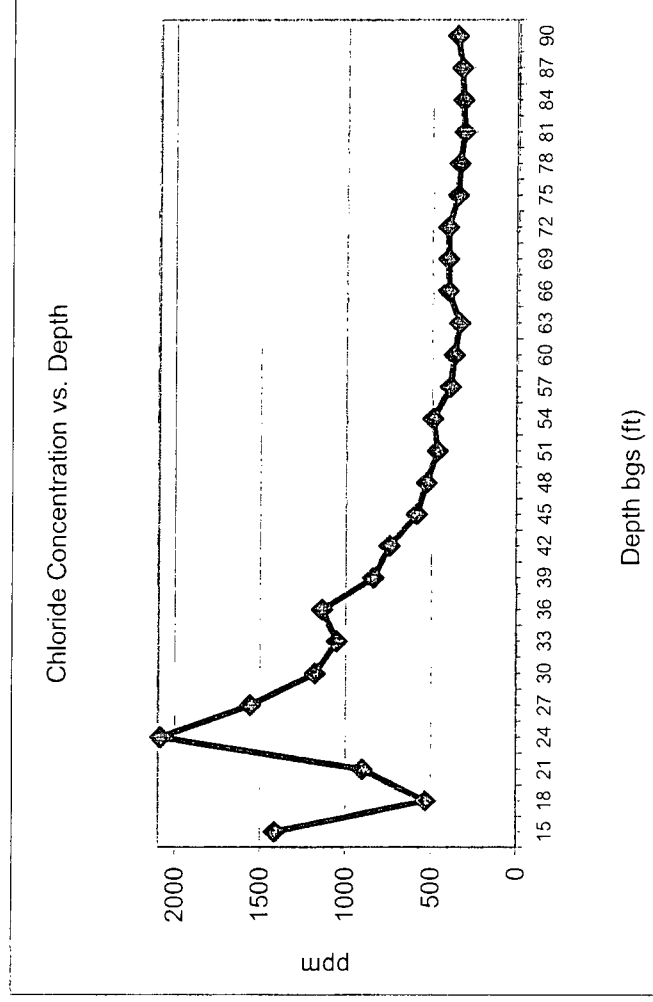
Soil Boring samples at 9 ft east of the junction (source)

Depth bgs (ft)	[Cl ⁻] ppm
15	1415
18	531
21	902
24	2087
27	1559
30	1180
33	1052
36	1138
39	840
42	745
45	586
48	530
51	466
54	493
57	391
60	368
63	338
66	405
69	404
72	405
75	350
78	340
81	314
84	322
87	328
90	355

Groundwater = 150 ft
