**BD Jct I-2
2009**

**RICE OPERATING COMPANY
JUNCTION BOX FINAL REPORT**

BD Jct. I-2

Unit I, Section 2, T22S, R36E

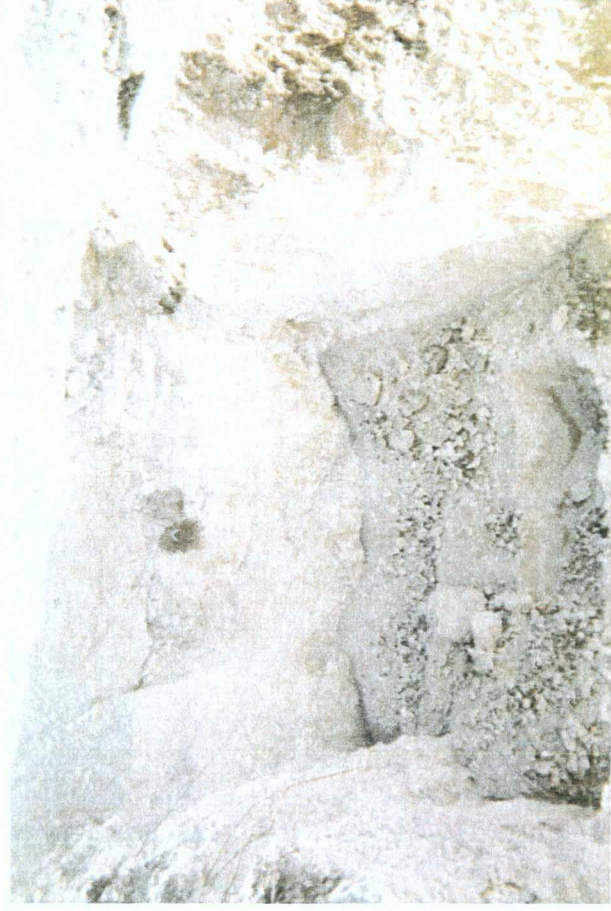
7/17/2009

final 10x10x12-ft excavation, facing east

This junction was addressed during the pipeline replacement/upgrade program. A new, watertight junction box was built 30 ft south of the former. After the former box was removed, an investigation was conducted using a trackhoe to collect soil samples at regular intervals producing a 10x10x12-ft deep excavation. Chloride field tests performed on each sample yielded slightly elevated concentrations. Organic vapors were measured using a PID which yielded low

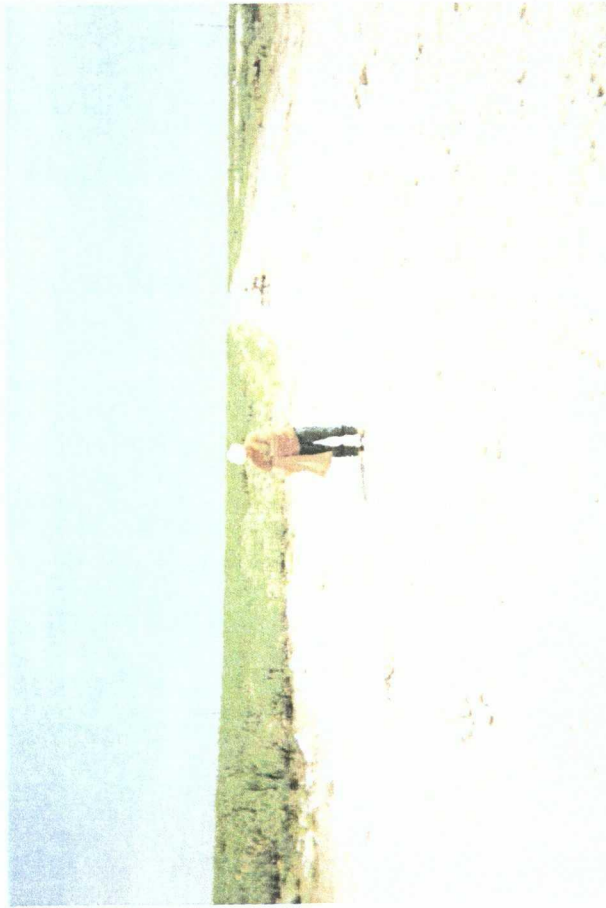
8/13/2009

seeding the backfilled site, facing east

On 8/13/2009, the site was seeded with a native blend of vegetation and is expected to return to a productive capacity at a normal rate. To

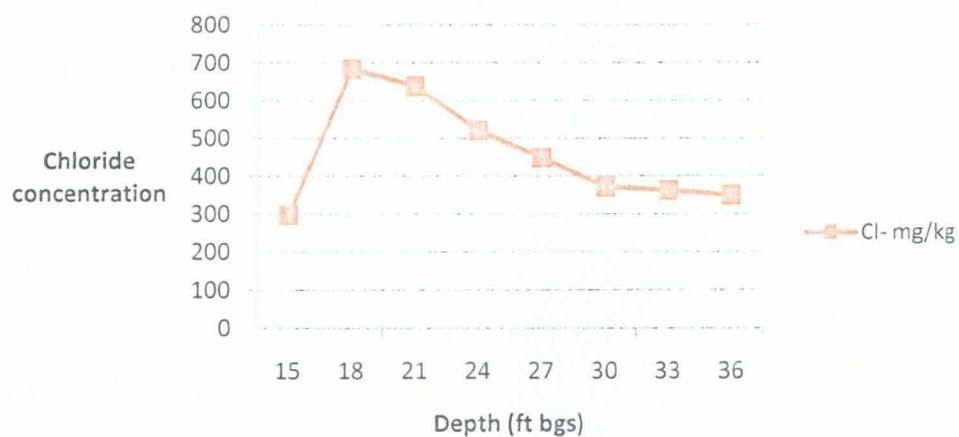
Chloride concentration versus depth

Depth (feet)	chloride field tests	LAB	PID	Description	Lithology	Well Construction
15	297		0.8	<div>15 - 36 ft</div> <div>VERY FINE TO FINE SAND</div> <div>brownish-orange, dry</div>		<div>bentonite seal</div>
18	683	CI- 512	0.3			
		GRO <10.0				
		DRO 12.6				
21	638	CI- 1280	6			
		GRO <10.0				
		DRO 13.1				
24	520		0.2			
27	448		0.2			
30	371		0			
33	362		0			
36	349	CI- 182	0			
		GRO <10.0				
		DRO 12.5

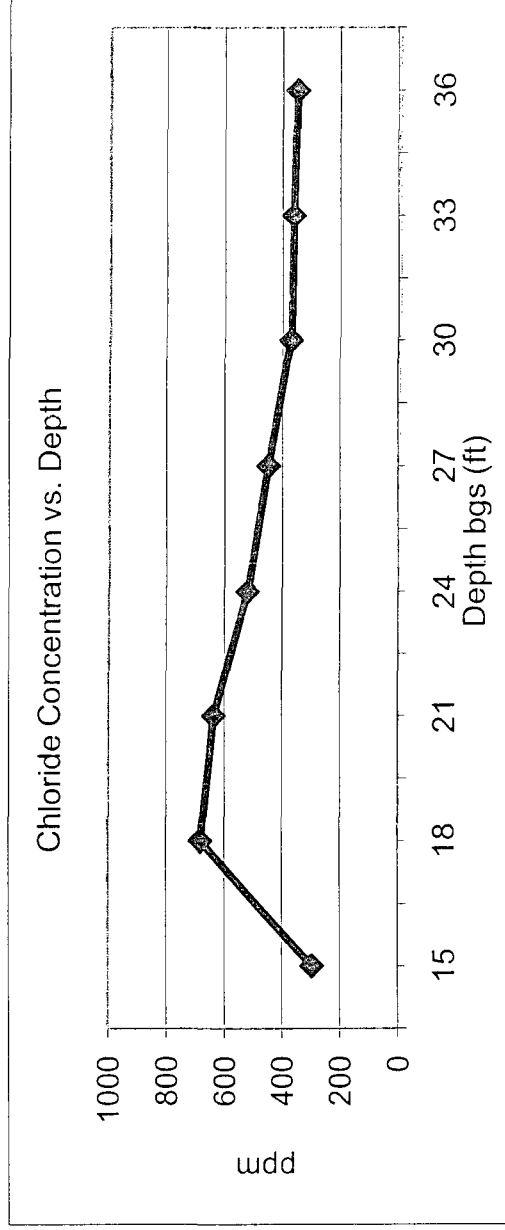
CHLORIDE CONCENTRATION CURVE

Soil Bore samples at 7 ft northeast of the junction (source)

Depth bgs (ft)	Cl ⁻ ppm
15	297
18	683
21	638
24	520
27	448
30	371
33	362
36	349

Groundwater = 130 ft
