RICE OPERATING COMPANY  
JUNCTION BOX DISCLOSURE REPORT

SWD SYSTEM	JUNCTION	UNIT	SECTION	TOWNSHIP	RANGE	COUNTY	BOX DIMENSIONS (FEET)
Blinberry-Drinkard (BD)	O-36 EOL	O	36	21S	36E	Lea	Length 6' Width 7' moved 40 ft west

# **BD O-36 EOL**

Unit O, Section 36, T21S, R36E

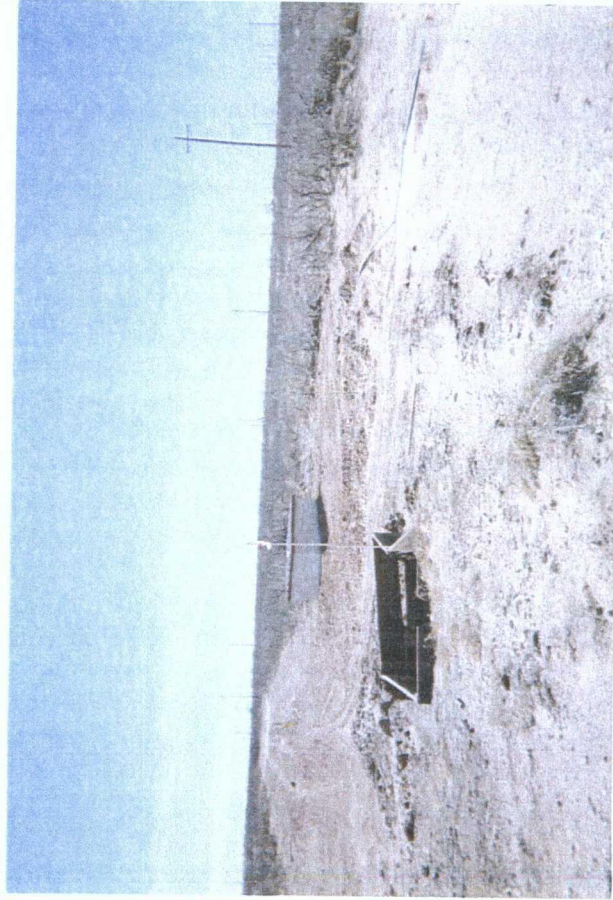
site prior to excavation with a new,  
watertight junction box 40 ft west

3/2/2009

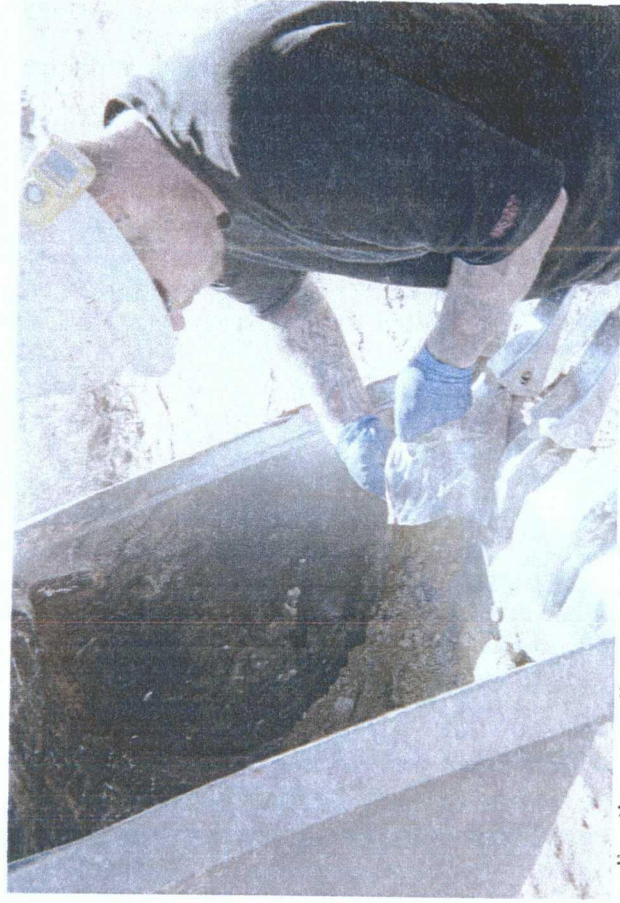
collecting a soil sample, facing west

3/2/2009

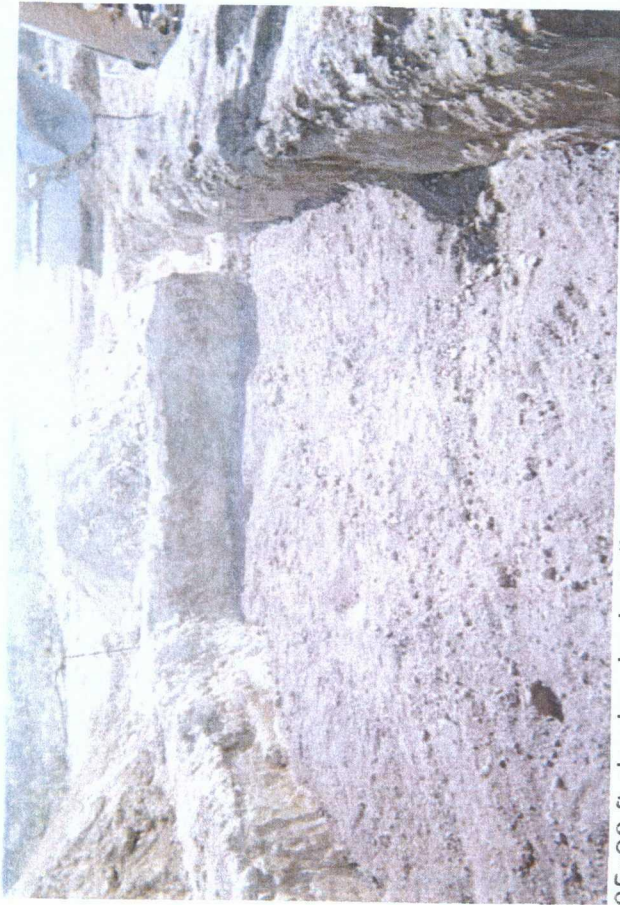
35x20 ft clay barrier installed, facing west 3/18/2009

**General Description of Remedial Action:** This junction was eliminated during the pipeline replacement/upgrade program. After the former junction box was removed, an investigation was conducted using a backhoe to collect samples at regular intervals producing a 30x10x12-ft deep excavation. Chloride field tests performed on each sample yielded elevated concentrations. Organic vapors were measured using a PID which yielded generally low concentrations. The excavated soil was blended on site and representative composite samples were collected from the blended backfill, the bottom of the excavation, and the excavation walls. The representative samples were sent to a commercial laboratory for analysis of chloride and TPH. The excavated soil was blended on site and returned to the excavation up to 5 ft below ground surface(BGS). A 5-ft-deep shelf was excavated extending 5 ft out from the North, South, and West walls to prepare the surface for the clay barrier. At 5-4 ft BGS, a 1-ft thick clay barrier was installed with a compaction test performed on 3/18/2009. The remaining fill was used to backfill the excavation to ground surface and to contour to the surrounding area. An identification plate was placed on the surface at the former junction site to mark the presence of clay below. On 3/31/2009, the site was seeded with a blend of native vegetation and is expected to return to a productive capacity at a normal rate. A new, water-tight junction box was built 40 ft west of the former. To further investigate the depth of chloride presence, a soil bore was initiated on 9/25/2009 at 15 ft southwest of the former junction box. The boring was advanced to 100 ft BGS, while soil samples were collected every 3 feet from 15 to 60 ft BGS and every 5 ft from 60 to 100 ft BGS. Chloride field tests yielded elevated concentrations that did not sufficiently relent with depth. The 30 and 100 ft samples were sent to a commercial laboratory for analysis of chloride and TPH. The entire borehole was plugged with bentonite to the ground surface. NMOCD was notified of potential groundwater impact on 2/26/2010.

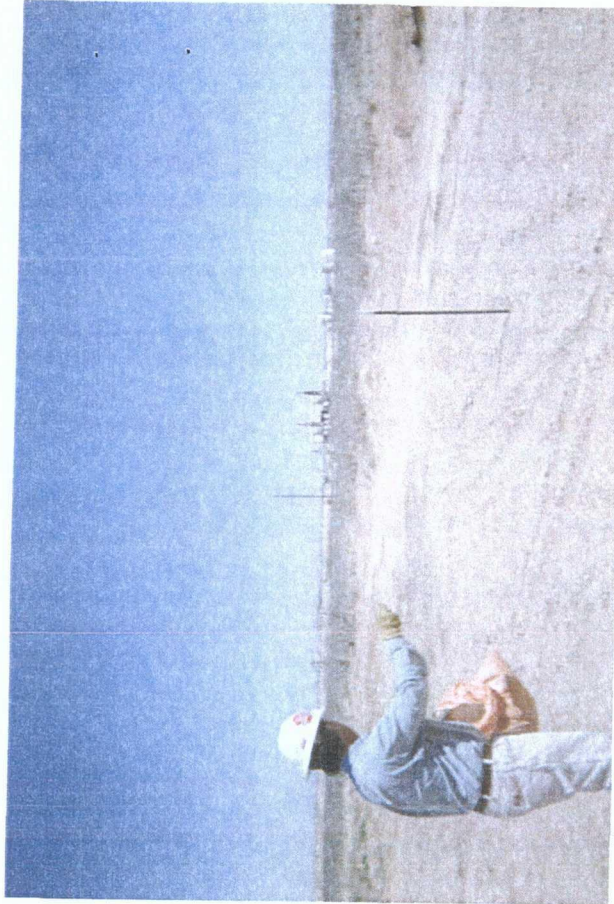
seeding the backfilled site, facing east 3/31/2009

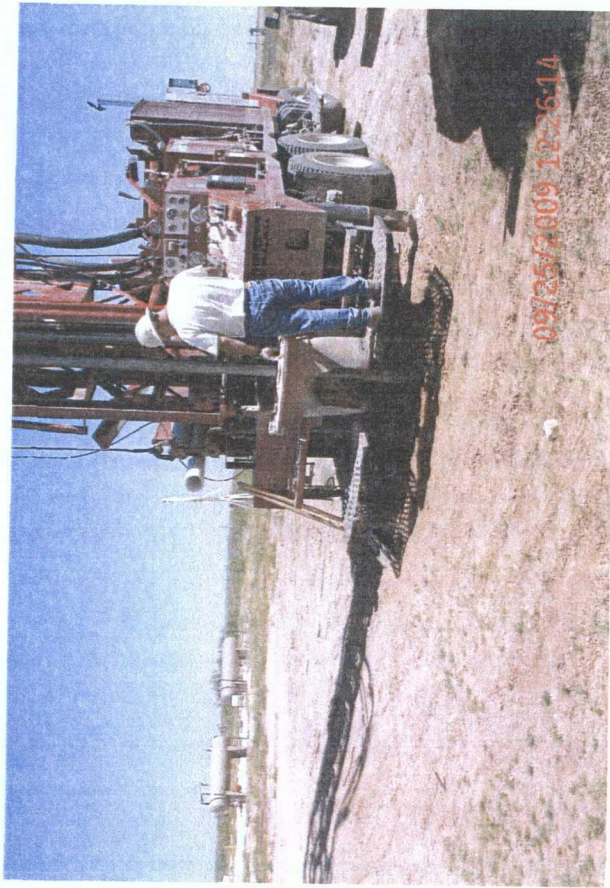
drilling SB #1 15 ft southwest of the former junction 9/25/2009

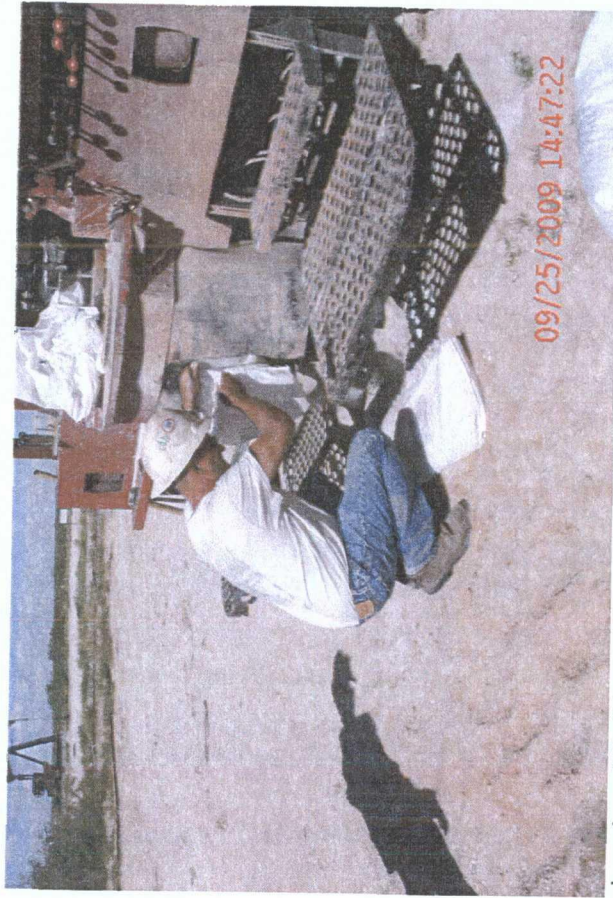
plugging SB #1 with bentonite 9/25/2009

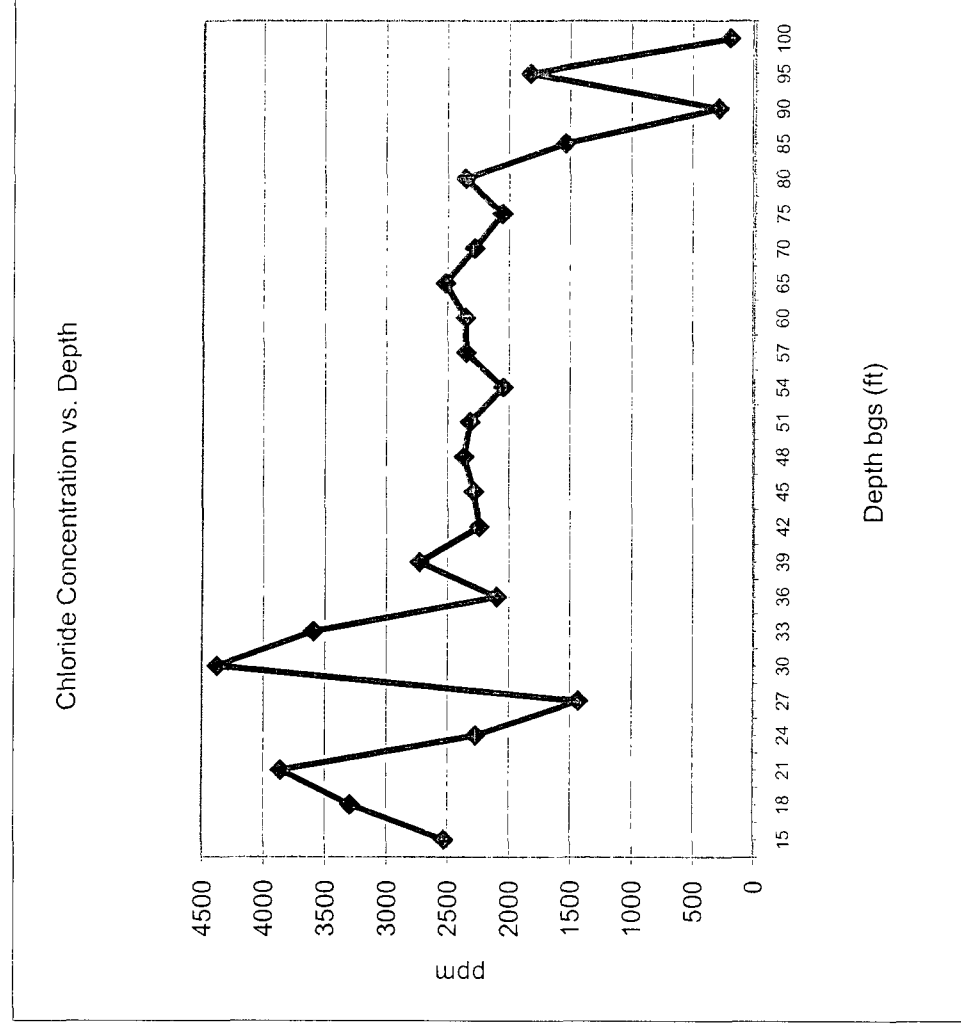
# CHLORIDE CONCENTRATION CURVE

SOIL BORING samples at 15 ft southwest of the junction (source)

Depth bgs (ft)	Chloride (ppm)
15	2532
18	3296
21	3863
24	2274
27	1435
30	4379
33	3596
36	2102
39	2732
42	2247
45	2286
48	2367
51	2319
54	2051
57	2353
60	2353
65	2519
70	2282
75	2057
80	2356
85	1539
90	286
95	1829
100	195

Groundwater = 134 ft
