Release Notification and Corrective Action

REMEDIATION SUMMARY

SITE CLOSURE REQUEST

Southern Union Gas Services MA-4 8" (2010-004) Lea County, New Mexico UNIT N (SE/SW), Section 35, Township 23 South, Range 36 East Latitude 32° 15' 25.787" North, Longitude 103° 14' 23.204" West NMOCD Reference # 1RP-2335

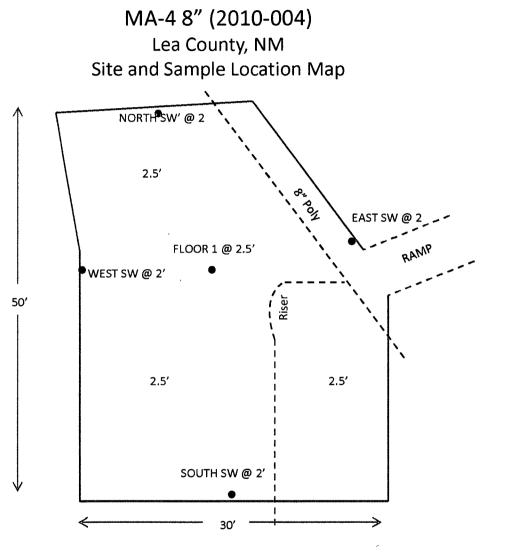
Figure 1 – Site Location Map Figure 2 – Site and Sample Location Map

Basin Environmental Consulting, LLC (Basin), on behalf of Southern Union Gas Services (Southern Union), has prepared this Remediation Summary and Site Closure Request for the release site known as MA-4 8" (2010-004). The site is located in Unit Letter N (SE ¼ SW ¼), Section 35, Township 23 South, Range 36 East, in Lea County, New Mexico. The property is owned by Mr. Kelly Myers. The site latitude is 32° 15' 25.787" North, and the longitude is 103° 14' 23.204" West. The Site Location and Site and Sample Location Maps are provided as Figure 1 and Figure 2, respectively.

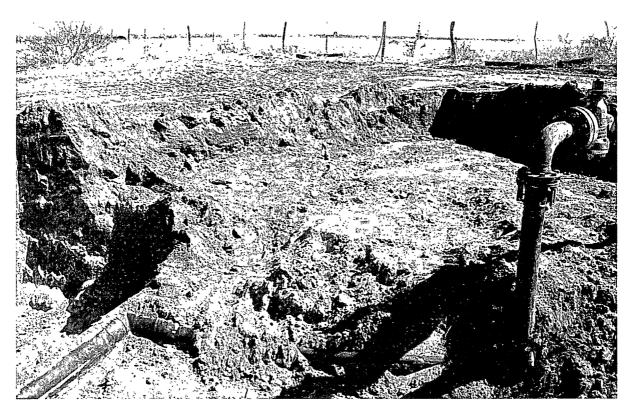
Site Photograph of Excavation and exposed 8 " Pipeline at the MA-4 8" release site.

On October 19, 2009, Southern Union was informed a release had occurred at the MA-4 8" site. The release was due to the failure of an eight (8)-inch natural gas pipeline. On discovery of the release, a section of the pipeline was replaced. The Release Notification and Corrective Action (NMOCD Form C-141) indicated approximately three (3) barrels of crude oil, produced water and natural gas was released from the Southern Union pipeline, with no recovery. The Release Notification and Corrective Action Form is provided in Appendix C.

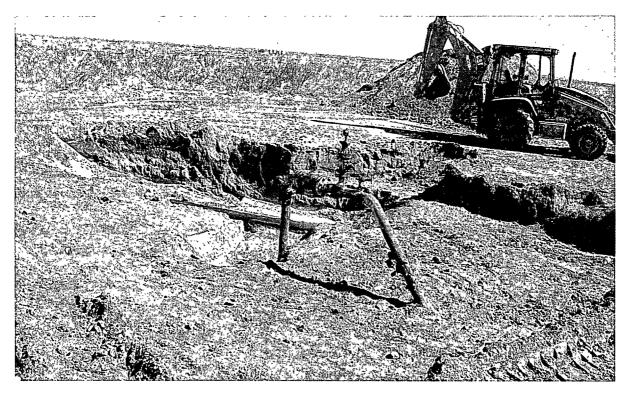
Site Photograph of Excavation and Sample Locations at the MA-4 8" release site.

On March 4 and March 5, 2010, five (5) soil samples (NORTH SW @ 2', SOUTH SW @ 2', EAST SW @ 2', WEST SW @ 2' and FLOOR 1 @ 2.5') were collected from the excavation. The soil samples were analyzed for concentrations of benzene, toluene, ethylbenzene and xylene (BTEX) using method EPA 8021b, concentrations of total petroleum hydrocarbons (TPH) using method SW-8015 modified and chloride concentration using method 4500 Cl. A summary of BTEX, TPH and Chloride concentrations are included in Table 1. Laboratory analytical reports are provided as Appendix A.

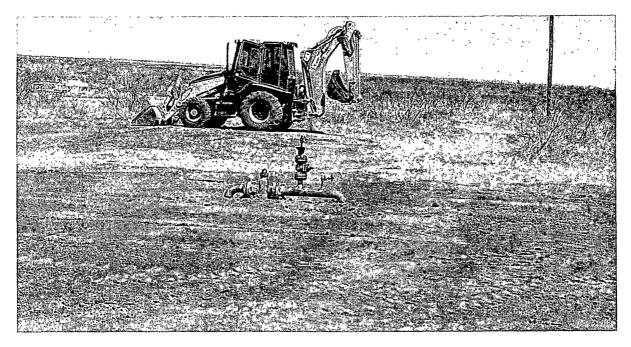
Site Photograph of the MA-4 8" release site upon completion of remediation activities.

On March 2, 2010, Basin transported approximately one hundred-forty (140) cy of impacted soil to Sundance Services, Inc. for disposal. Approximately one hundred fifty-six (156) cy of topsoil was purchased locally and transported to the site. The excavation was backfilled with native soil and contoured to fit the surrounding topography.

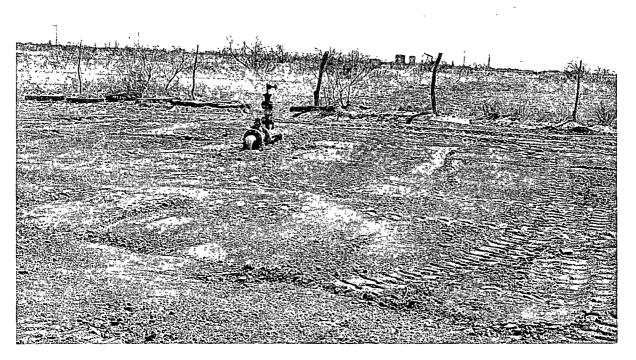
Site Photograph of the MA-4 8" release site upon completion of remediation activities.
