**Re: CAP REPORT AND TERMINATION REQUEST
C-4-3 JUNCTION BOX, BD SWD SYSTEM
UNIT "C", SEC. 4, T22S, R37E
LEA COUNTY, NEW MEXICO
NMOCD #1R426-105**

Rice Operating Company (ROC) has completed the implementation of the Corrective Action Plan (CAP) dated February 13, 2008 at the above mentioned site. The NMOCD granted verbal approval of the CAP in the 4th Quarterly Meeting between ROC and NMOCD, which was confirmed via email on February 4, 2010. The site location is shown on Figures 1 and 2.

APPENDIX B SITE PHOTOGRAPHS

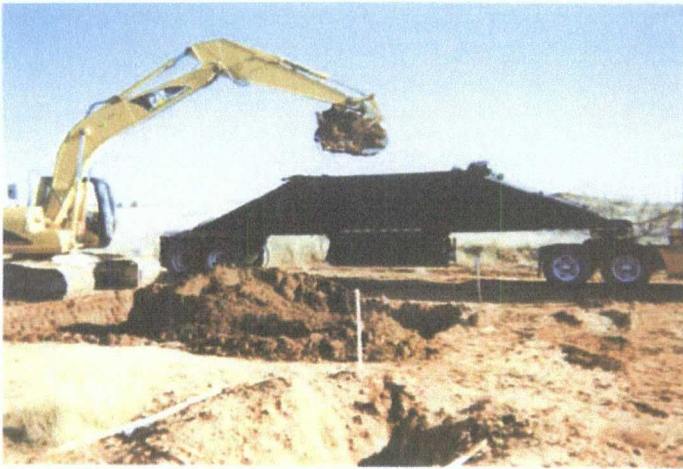
Excavating BD jct. C-4-3

As per the CAP, ROC was onsite February 18, 2010 to excavate chloride impacted soils within the former C-4-3 Junction Box area. An area measuring 22 feet wide by 28 feet long by 4 feet deep was excavated and approximately 100 cubic yards of impacted soils were transported offsite for disposal at Sundance Services, Inc. in Eunice, New Mexico. Upon completion of the excavation, a 20 mil polyethylene liner was installed at 4 feet in order to impede further migration of the remaining chlorides within the soil. Approximately 120 yards of clean soil was imported and placed over the 20-mil liner. Between March 8 and March 18, 2010, clean imported soils along with hay were brought to the site, blended and placed over the site to surface grade and a silk netting fence was built around the site. (See Appendix A – Laboratory Data for analysis on the imported clean

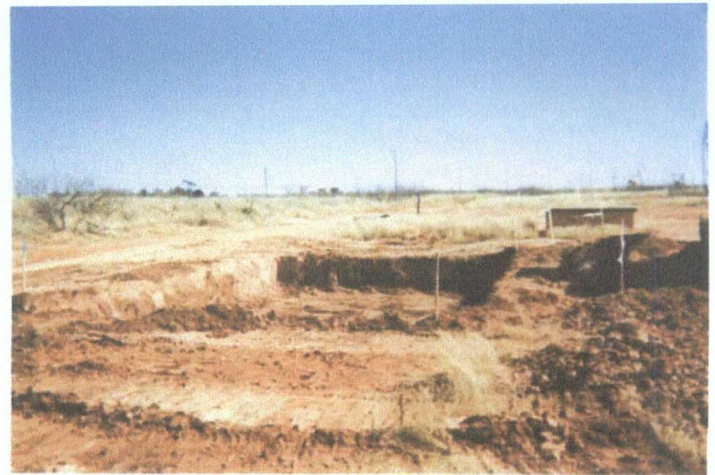
Completed excavation (22' X 28' X 4')

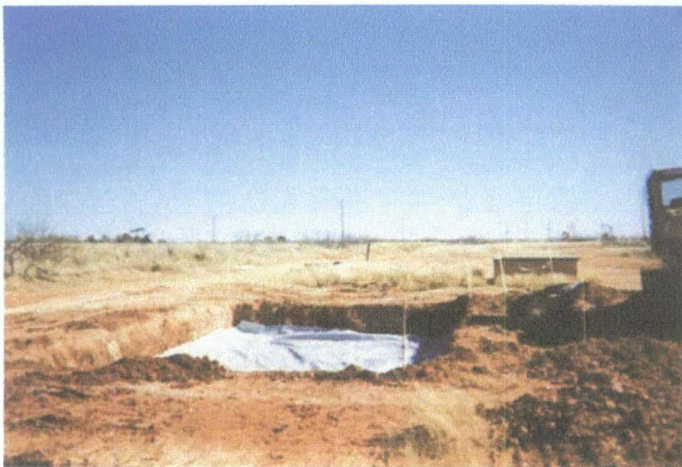
Placement of the liner in the excavation

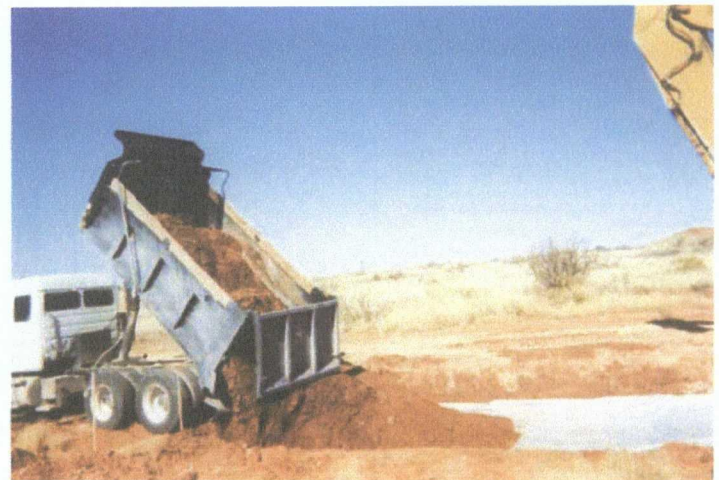
Backfilling the site with clean imported soil.

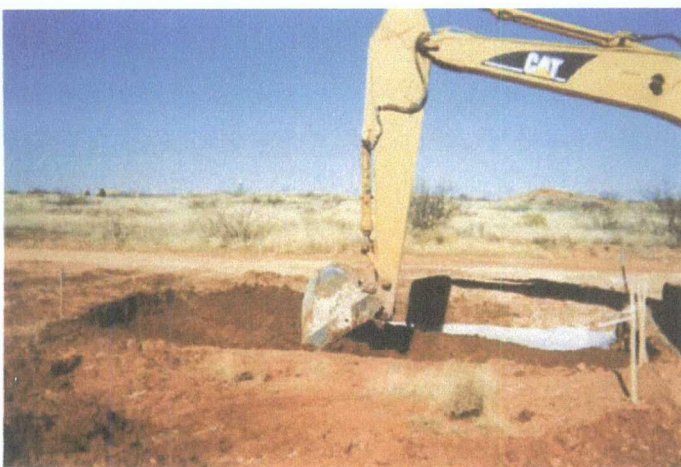
Backfilling the site with the imported soil

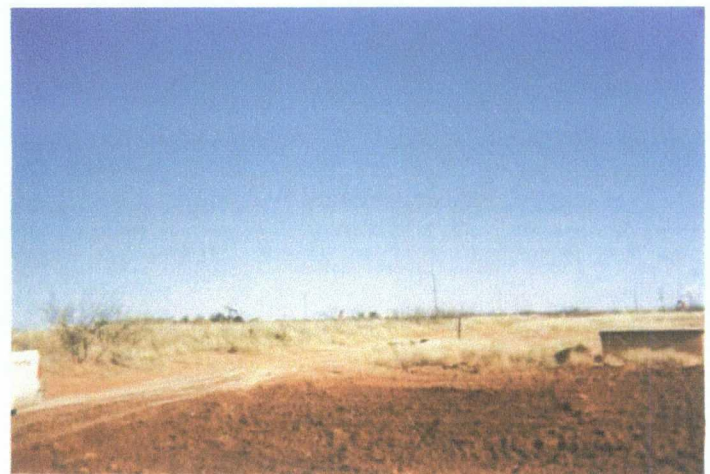
Completed excavation of BD jct. C-4-3

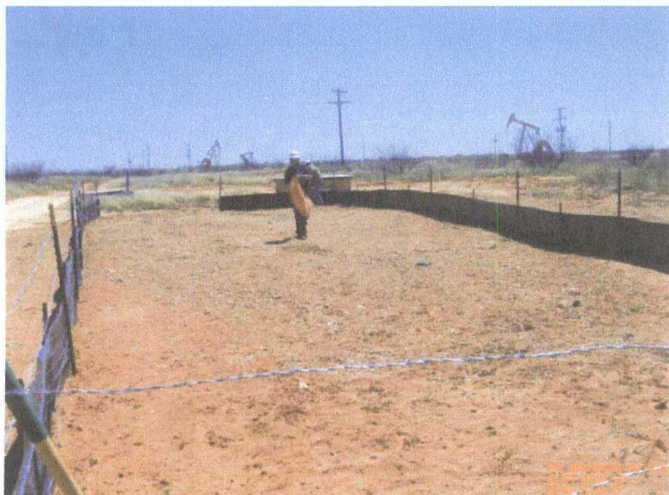
Seeding the site with native seed

soils). On April 8, 2010, the site was seeded with native vegetation (See Appendix B – Site Photographs).

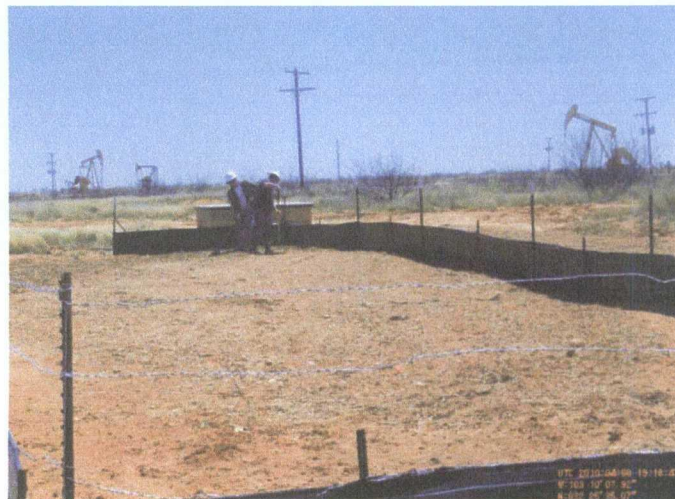
Raking the seed into the site
