# DISCLOSURE REPORT

**RICE OPERATING COMPANY  
JUNCTION BOX DISCLOSURE FORM**

## BD vent G-16

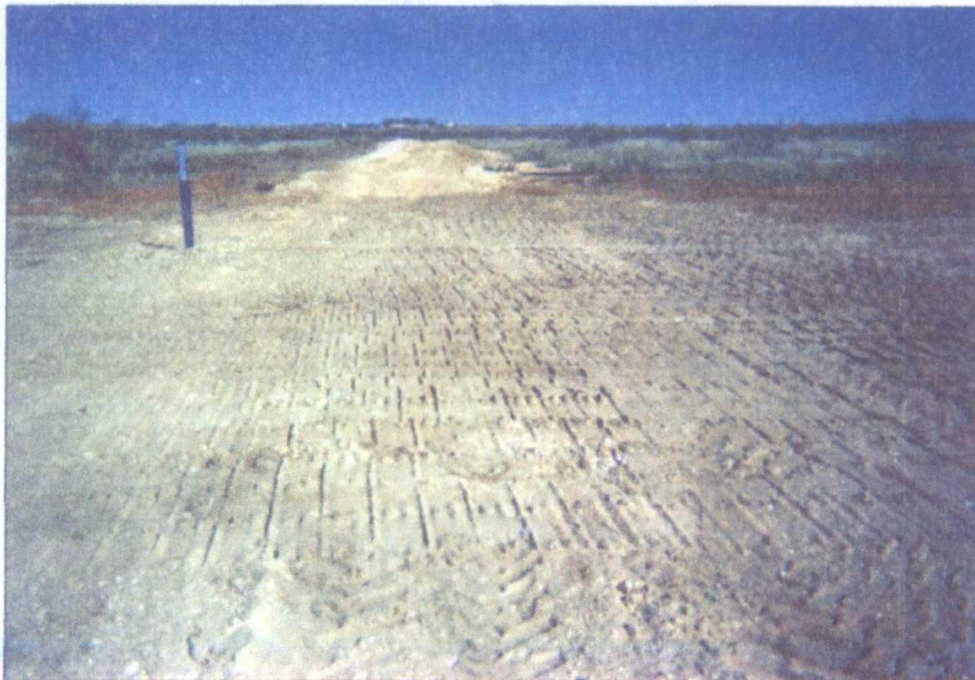
Backfilled

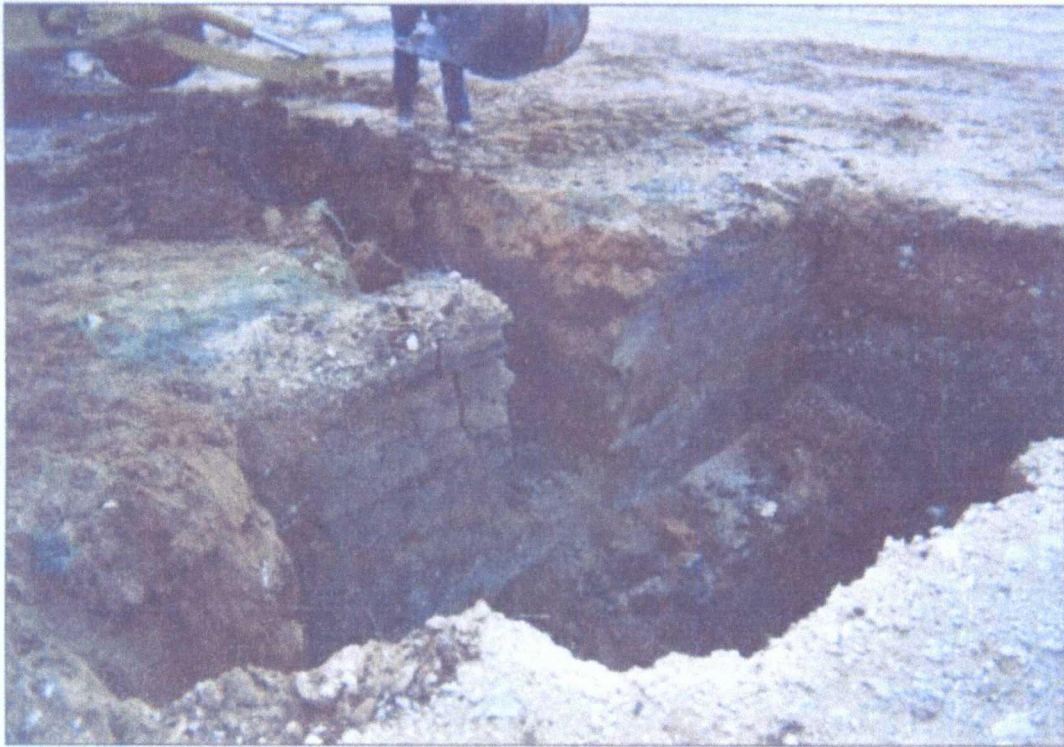
Beginning Excavation

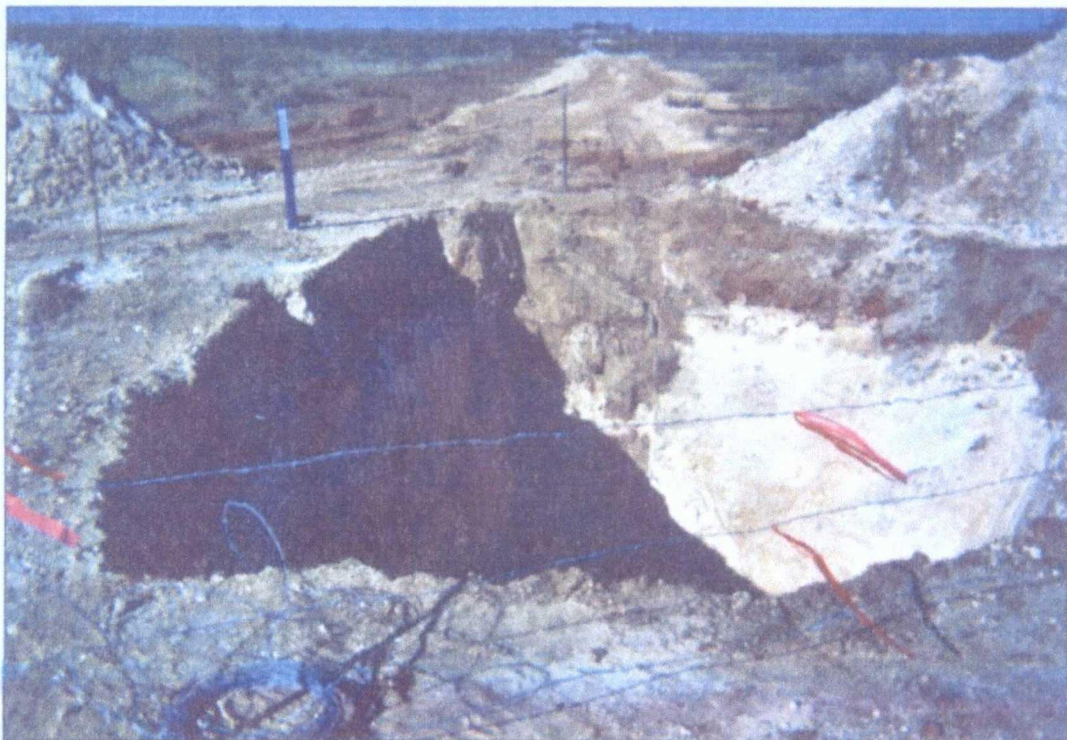
Excavation

The junction box contained a vent and exhibited TPH impact to 12' below the box. A 16' x 16' area around the center of the box was excavated to 16' bgs to completely remove the visible TPH. At 16', a 1' clay liner was installed at the bottom of the excavation to slow vertical migration of the remaining impact. The excavated soil was blended and backfilled on top of the clay liner and contoured to the surrounding terrain. A junction box is no longer required at this location. NMOCD TPH guidelines were met at the 16' bottom composite and the wall composite. The north and east directions exhibited higher chloride impact at 14' bgs perhaps due to historical leaks in the area. Historical evidence has shown that G-16 and the Cole 'A' EOL to the south both may have had boots at different times in the past 50 years.
