RE: **Rice Operating Company**
Justis P-2 Leak
REMEDIATION REPORT and TERMINATION REQUEST
Unit Letters I & P, Sec. 2, T25S, R37E
Lea County, New Mexico

Background and Previous Work

Remediation Activities

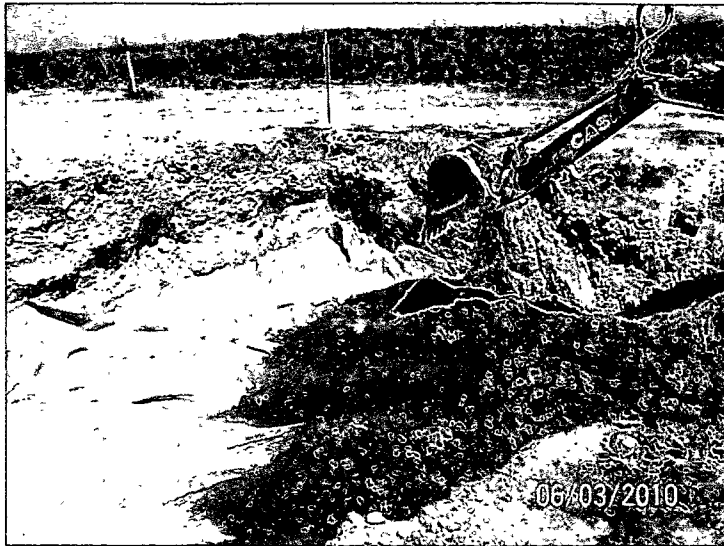
blow sand padding above the 20-mil poly liner

On June 3, 2010, blow sand was hauled to the site and 6" of sand was placed at the bottom of the 25' x 25' excavation. A 20 mil plastic liner was installed above the sand, and another 6" of blow sand was installed above the plastic liner to prevent puncturing. The excavation was then backfilled with blended soil, from a depth of 5' bgs to 3' bgs. Peanut hay was blended with additional imported soil and used to backfill the excavated areas around soil borings SB-7, SB-4 and SB-8, as well as the upper 3' of the 25' x 25' excavation. All backfilled areas were graded to surface and the entire site was re-seeded with a blend of native vegetation on June 14, 2010. A total of 312 yards of chloride impacted soil was hauled to Sundance Disposal, and a total of 310 yards of clean soil was imported to the site for backfill purposes. Photographs of the remediation activities are included in Appendix B.

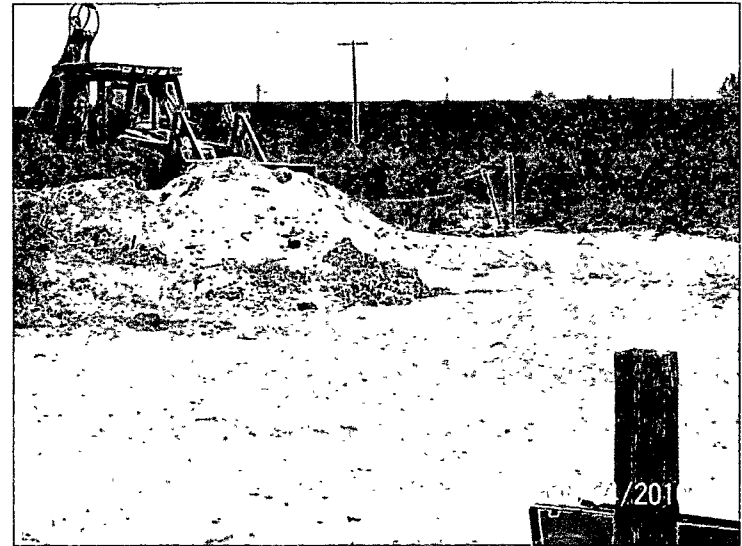
blending clean, imported soil with hay
to be utilized as backfill
