AP-062

2008 Annual Monitoring Report

**Samson Livestock "30" Reserve Pit
2008 Annual Monitoring Report
NMOCD Case #AP-62**

Location: T-21-S, R-35-E, Sec 30, Unit P
Latitude: North 32° 26' 41.2"
Longitude: West 103° 24' 6.9"
NMOCD#: AP-62

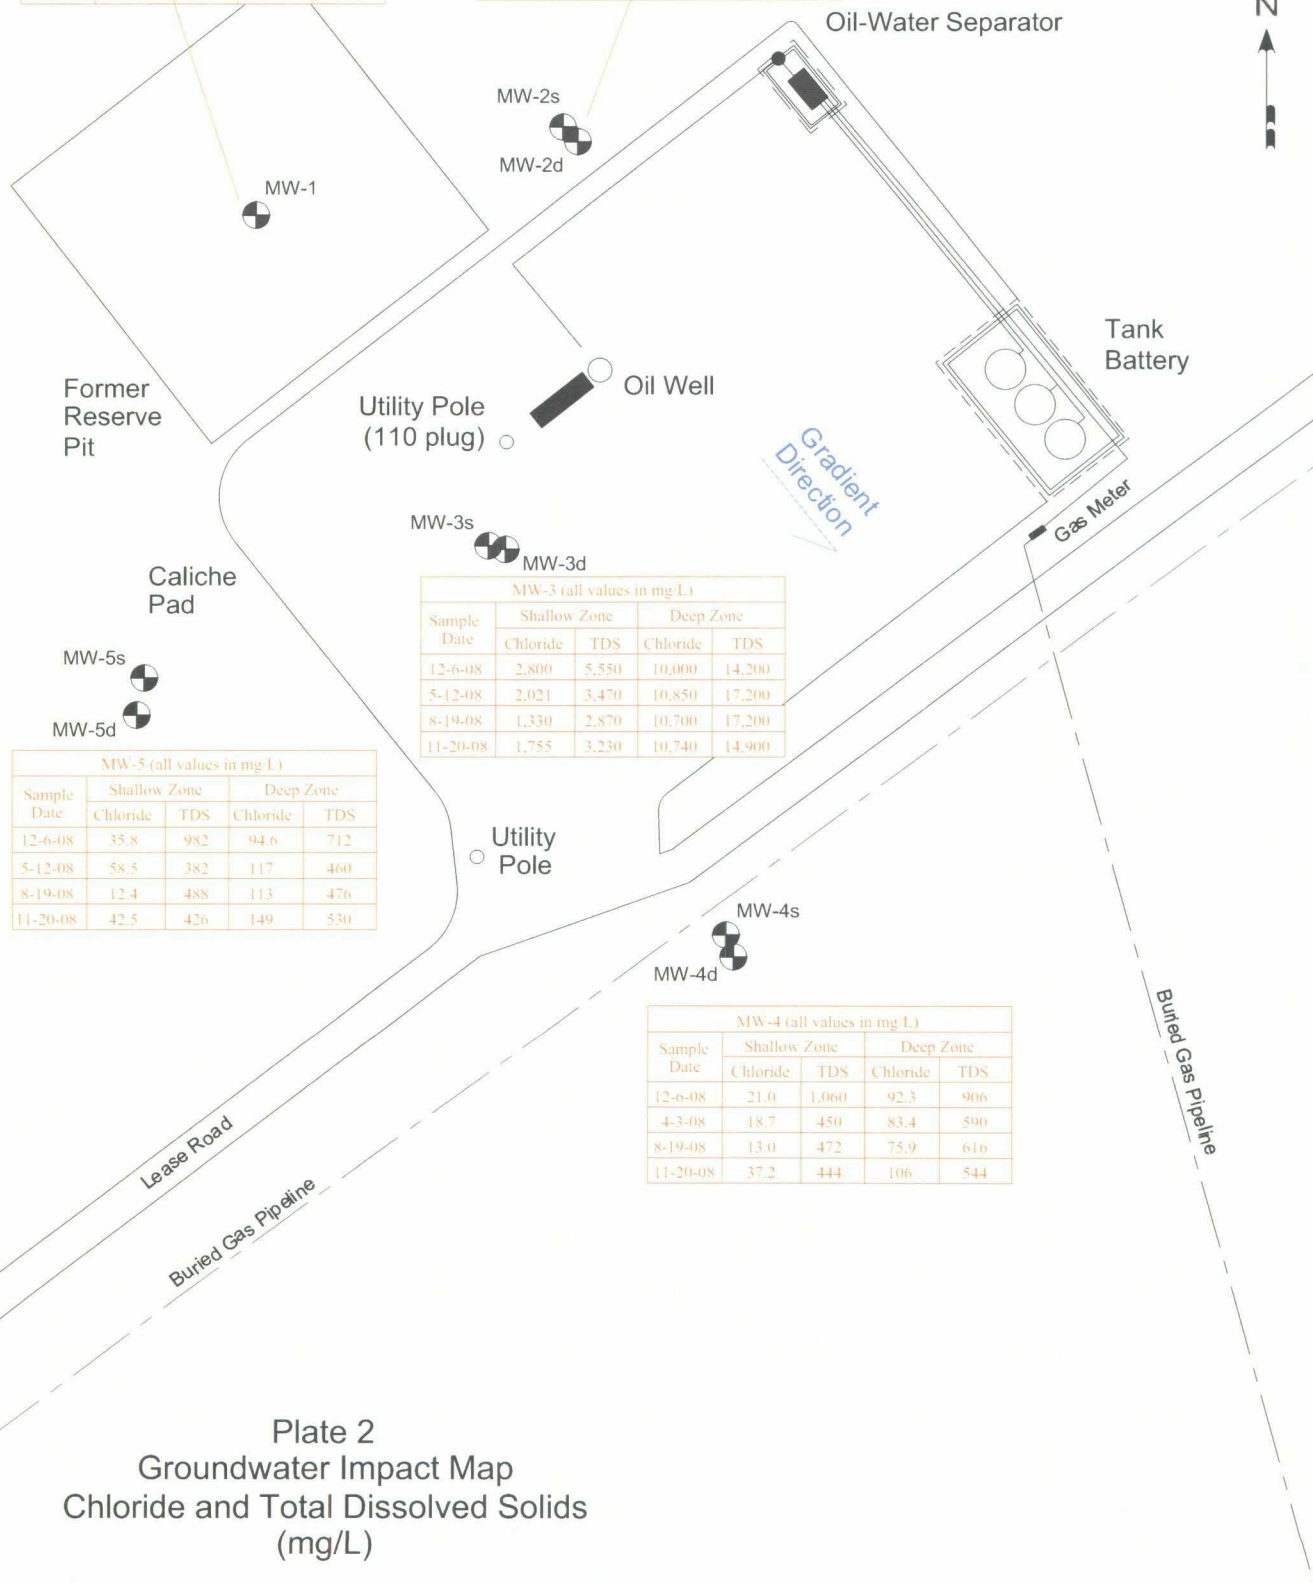
Plate 2
Groundwater Impact Map
Chloride and Total Dissolved Solids
(mg/L)

MW-1 (all values in mg/L)				
Sample Date	Shallow Zone		Deep Zone	
	Chloride	TDS	Chloride	TDS
12-6-08	440	1,310	4,090	13,800
5-12-08	745	1,160	4,254	6,490
8-19-08	470	1,150	3,960	6,200
11-20-08	681	1,450	4,626	5,680

MW-2 (all values in mg/L)				
Sample Date	Shallow Zone		Deep Zone	
	Chloride	TDS	Chloride	TDS
12-6-08	142	634	1,640	3,160
5-12-08	53.2	314	1,170	2,200
8-19-08	7.9	360	2,190	4,080
11-20-08	42.5	384	2,552	3,410

MW-3 (all values in mg/L)				
Sample Date	Shallow Zone		Deep Zone	
	Chloride	TDS	Chloride	TDS
12-6-08	2,800	5,550	10,000	14,200
5-12-08	2,021	3,470	10,850	17,200
8-19-08	1,330	2,870	10,700	17,200
11-20-08	1,755	3,230	10,740	14,900

MW-5 (all values in mg/L)				
Sample Date	Shallow Zone		Deep Zone	
	Chloride	TDS	Chloride	TDS
12-6-08	35.8	982	94.6	712
5-12-08	58.5	382	117	460
8-19-08	12.4	488	113	476
11-20-08	42.5	426	149	530

MW-4 (all values in mg/L)				
Sample Date	Shallow Zone		Deep Zone	
	Chloride	TDS	Chloride	TDS
12-6-08	21.0	1,060	92.3	906
4-3-08	18.7	450	83.4	590
8-19-08	13.0	472	75.9	616
11-20-08	37.2	444	106	544

Plate 2 depicts the laboratory results for both the shallow and deep zones for each 2008 sampling event.
