**RE: CAP Report and Termination Request, Rice Operating Company, Blinebry Drinkard (BD) Saltwater Disposal System (SWD) K-4 Release, Unit K, Section 4, T-22-S, R-37-E, Lea County, New Mexico, NMOCD CASE #1R0459**

Tetra Tech, Inc. (Tetra Tech) submits the following CAP and Termination Request for the Rice Operating Company (ROC), Blinebry Drinkard (BD) Salt Water Disposal (SWD) System K-4 Release, NMOCD Case #1R0459. ROC is the service provider (agent) for the BD SWD System and has no ownership of any portion of the pipeline, well or facility. The BD SWD system is owned by a consortium of oil producers, System Parties, who provide all operating capital on a percentage ownership/usage basis. The site is shown on Figures 1 and 2.

**APPENDIX B**  
**SITE PHOTOGRAPHS**

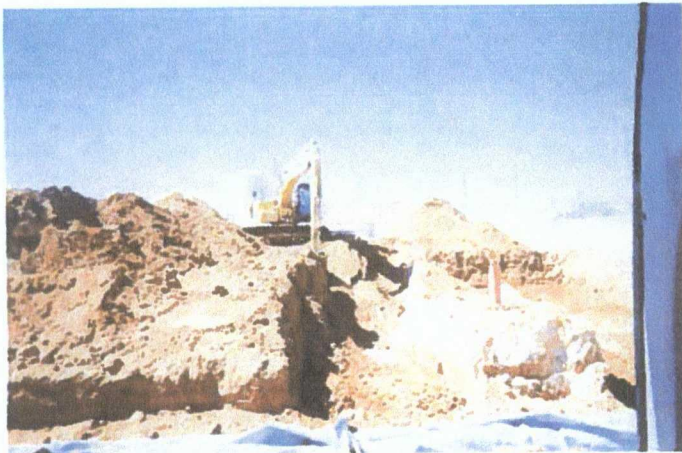
Excavating BD K-4 leak to 4' bgs

As part of the Corrective Action Plan (CAP), ROC was onsite February 22 through March 5, 2010, to excavate chloride impacted soils from the K-4 release area. An area measuring 68 feet wide by 120 feet long by 4 feet deep was excavated. Two feet of topsoil was removed and stockpiled onsite. A topsoil composite sample was collected and analyzed by Cardinal Laboratory, with the resulting chloride concentration of <16 mg/Kg. The site was excavated further and twelve (12) cubic yards of soil were disposed of at the NMOCD approved Sundance facility, with the remaining soils stockpiled and blended onsite. An east side blended backfill composite and a west side blended backfill composite sample were also analyzed by Cardinal Laboratory resulting in chloride concentrations of 16 mg/Kg and 64 mg/Kg, respectively. Upon completion of the excavation, a 20-mil polyethylene liner was installed at 4 feet in order to impede further migration of the remaining chlorides within the soil. See Figure 4 for liner location and dimensions. The east and west blended backfill soils were placed over the 20-mil liner. Between March 8 and March 10, 2010, clean offsite soils were brought to the site to continue backfilling. Imported hay was blended with the existing excavated topsoil, placed over the site and brought up to surface grade. (See Appendix A – Laboratory Data for analysis on the imported clean soils, topsoil and blended excavated soils). Silt net fencing was placed around the site and on April 8, 2010, the site was reseeded with native vegetation. (See Appendix B – Site Photographs)

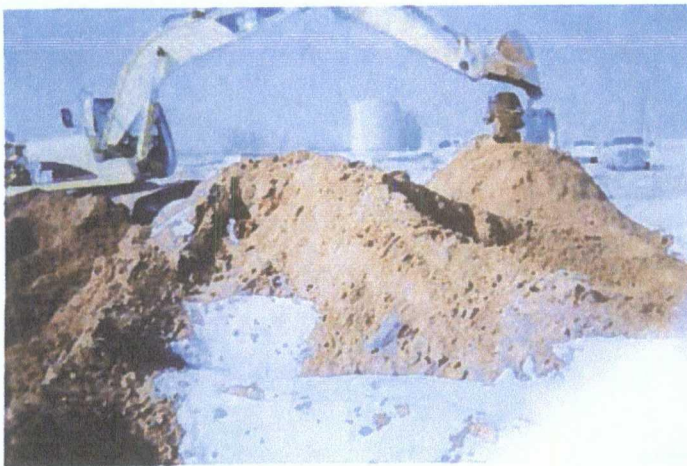
Backfilling the site with clean topsoil

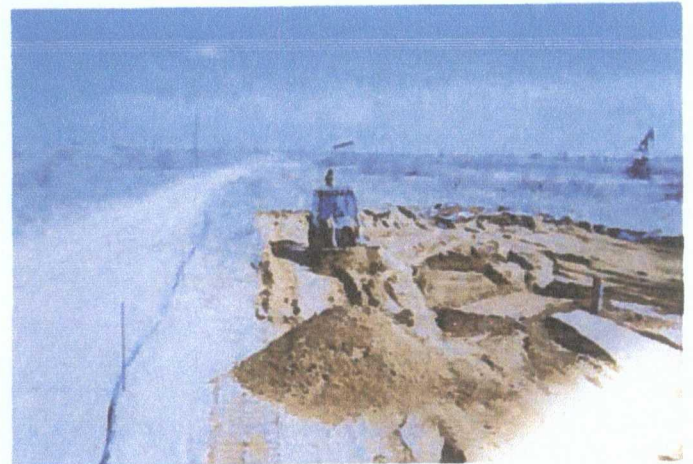
Overview of site being backfilled

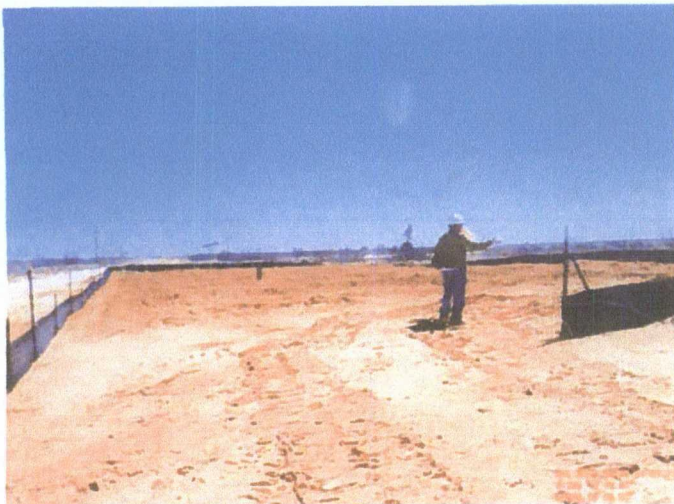
Seeding the site with native vegetation

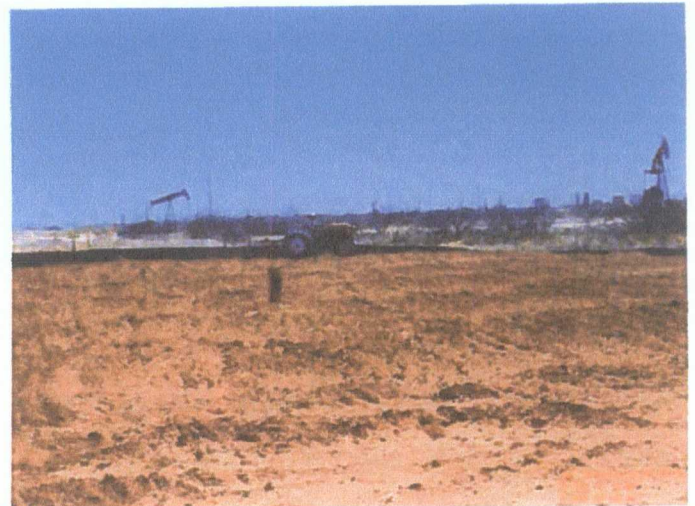
Tilling the seed into the soil
