**RE: Rice Operating Company, Hobbs SWD System A-6 Vent Site: T-19-S, R-38-E,
Section 6, Unit A, Lea County, New Mexico, (NMOCD CASE #1R428-59),
Report on Corrective Actions Taken**

Re-Seeding Site Documentation

Hobbs A-6 vent
(UL A, Section 6, T19S, R38E)

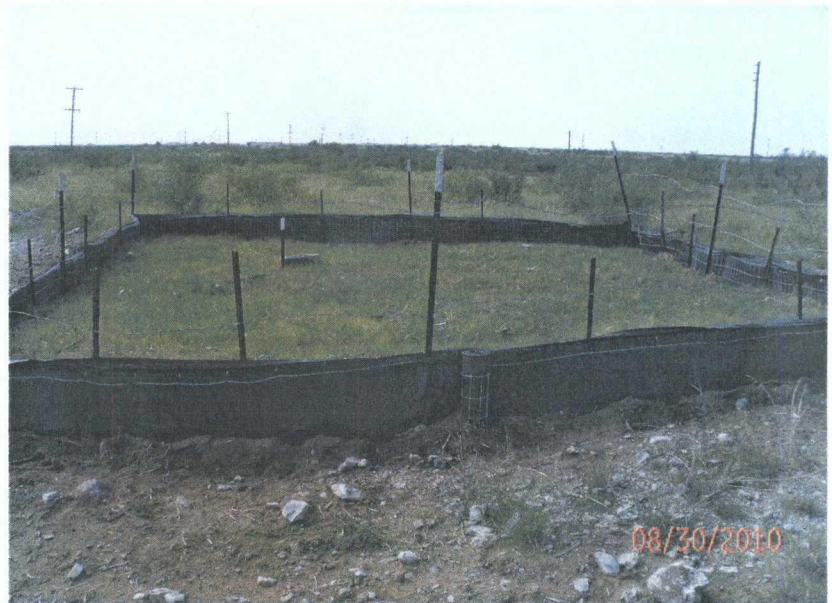
Figure 1. Photo documentation of site vegetation, August 2010.

Our recommended corrective action for the site is re-vegetation of the ground surface to limit infiltration of precipitation and the subsequent migration of constituents of concern to ground water. Attachment A includes documentation of re-seeding efforts. These included:

- Scraping the site down to 1 ft below grade,
- Removing 36 cubic yards of soil from surface of site for disposal at Sundance facility,
- Importing 36 yards of clean blow sand,
- Blending soil amendments into imported soil,
- Installing silt net fencing around the site in a 20 ft x 25 ft area
- Placing imported and amended soil inside fenced area and seeding with native grasses

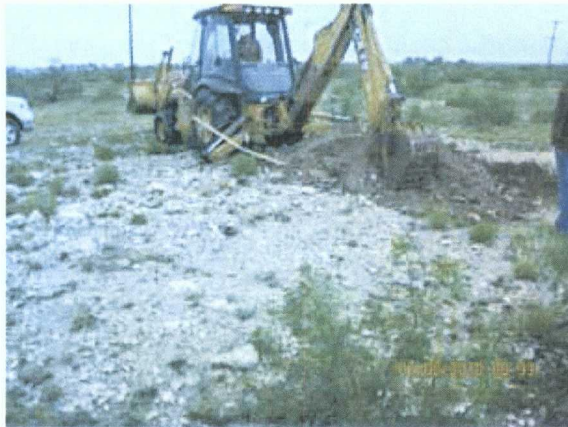
scraping the site

7/2/2010 Site was scraped down approximately 1 ft below ground surface (BGS). 36 cubic yards were properly disposed of at the OCD approved facility Sundance. 36 cubic yards of clean blow sand was imported to the site. The imported soil was blended with peanut hay, 2 bags (4 cubic feet) of peat moss, and 6 bags (6 cubic feet) of organic compost. Silt net fencing was installed around the site, a 20x25 ft area.

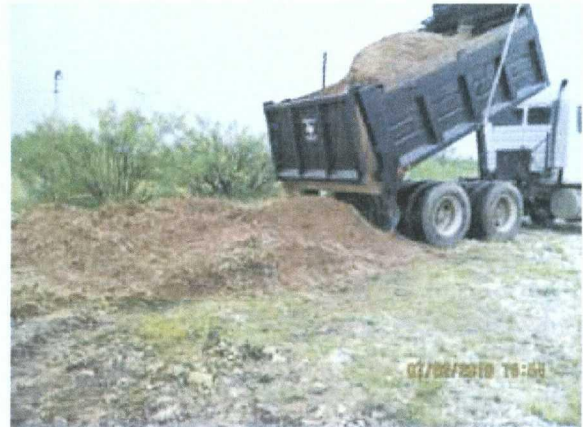
hauling in clean, imported soil to blend with peanut hay

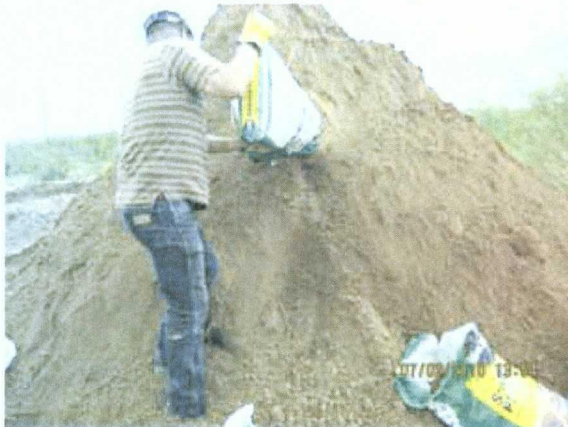
adding amendments

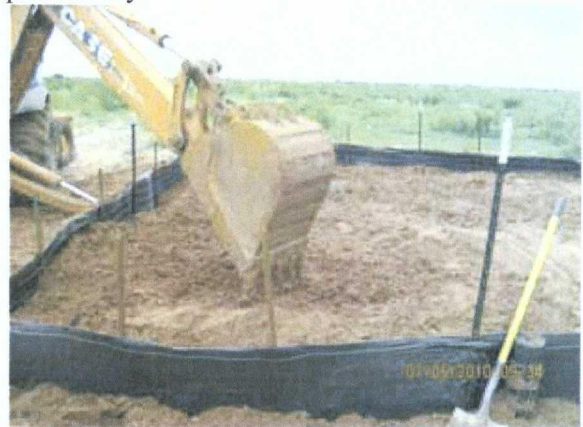
spreading clean, imported soil blended with peanut hay and amendments

7/6/2010 The blended soil was returned to the scraped area and the site was seeded with 3 lbs of Pecos Mix, 3 lbs of wild oats, and ½ lbs of blue grama. The seed was chained in and the silt netting and fence was completed around the site.

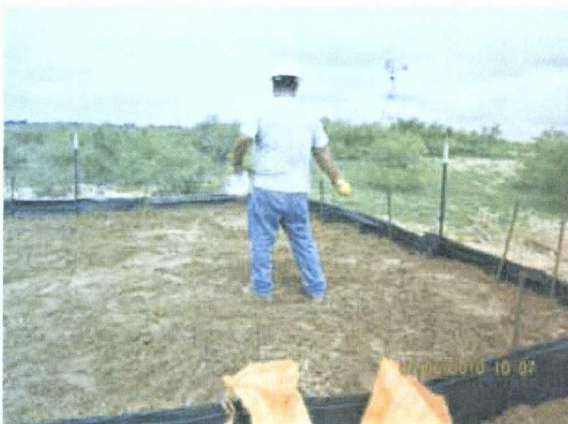
seeding the site

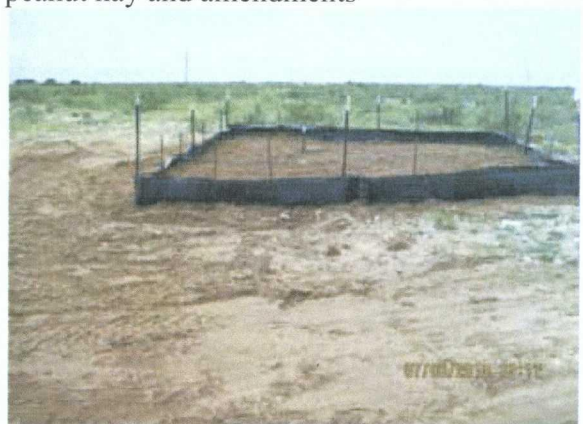
site complete
