Release Notification and Corrective Action

Re: Shepard #5 (1RP-1865)

On June 10, 2008, Ocotillo Environmental, LLC (Ocotillo), on behalf of Southern Union Gas Services (SUG) completed the delineation and remediation of a historical release occurring on a four (4) inch natural gas pipeline. The release was located in Unit Letter "P", Section 36, Township 25 South and Range 36 East in rural Lea County, New Mexico. The release GPS coordinates were 32° 04.886' N, 103° 12.659' W and the property is owned by Mr. Jay Anthony. A site location map is attached for your reference. The release was discovered by the landowner on July 22, 2004, occurring on a natural gas pipeline which had been idle for several years prior to the discovery of the release. The volume of the release is unknown, with no recovery. On May 23, 2008, an initial C-141 was prepared and submitted to the New Mexico Oil Conservation Division (NMOCD) for approval. The initial C-141 is attached for your reference.

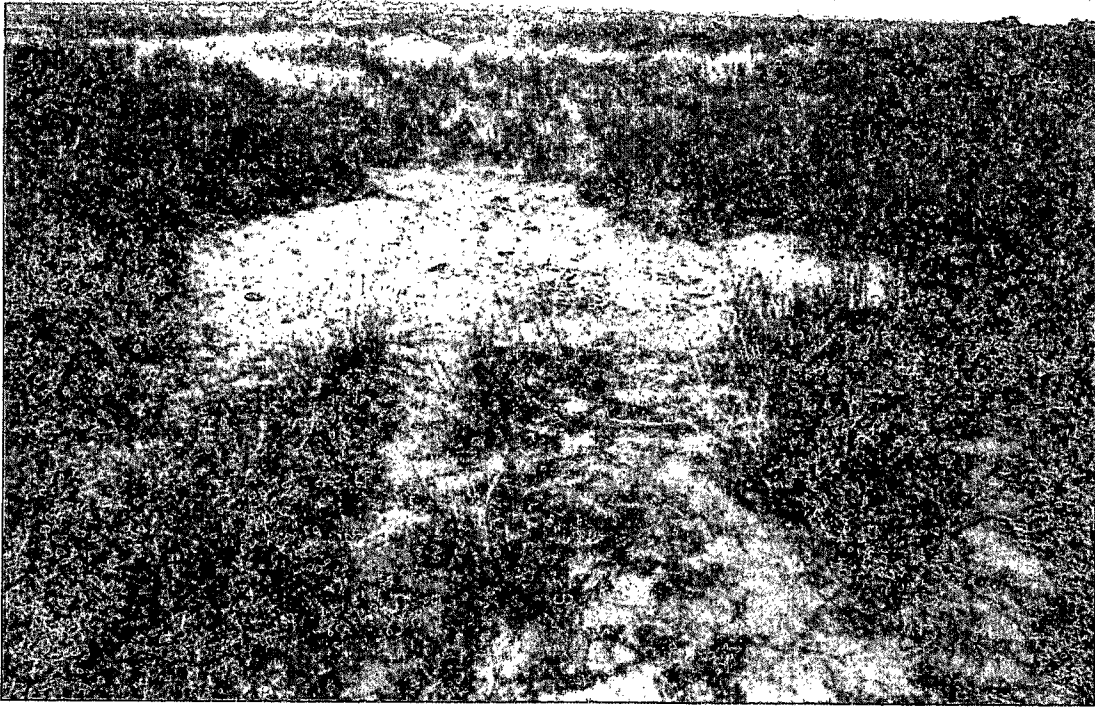
Photo 1

Southern Union Gas Services Site: Sheperd #5  
Job # 2008-013  
Site Assessment 5/5/08

On May 30, 2008, excavation of the release began; impacted soil was stockpiled adjacent to the release, pending transportation to the SUG Landfarm (NM2-19-0). The final dimensions of excavation were approximately fifteen (15) feet in width by fifteen (15) feet in length and

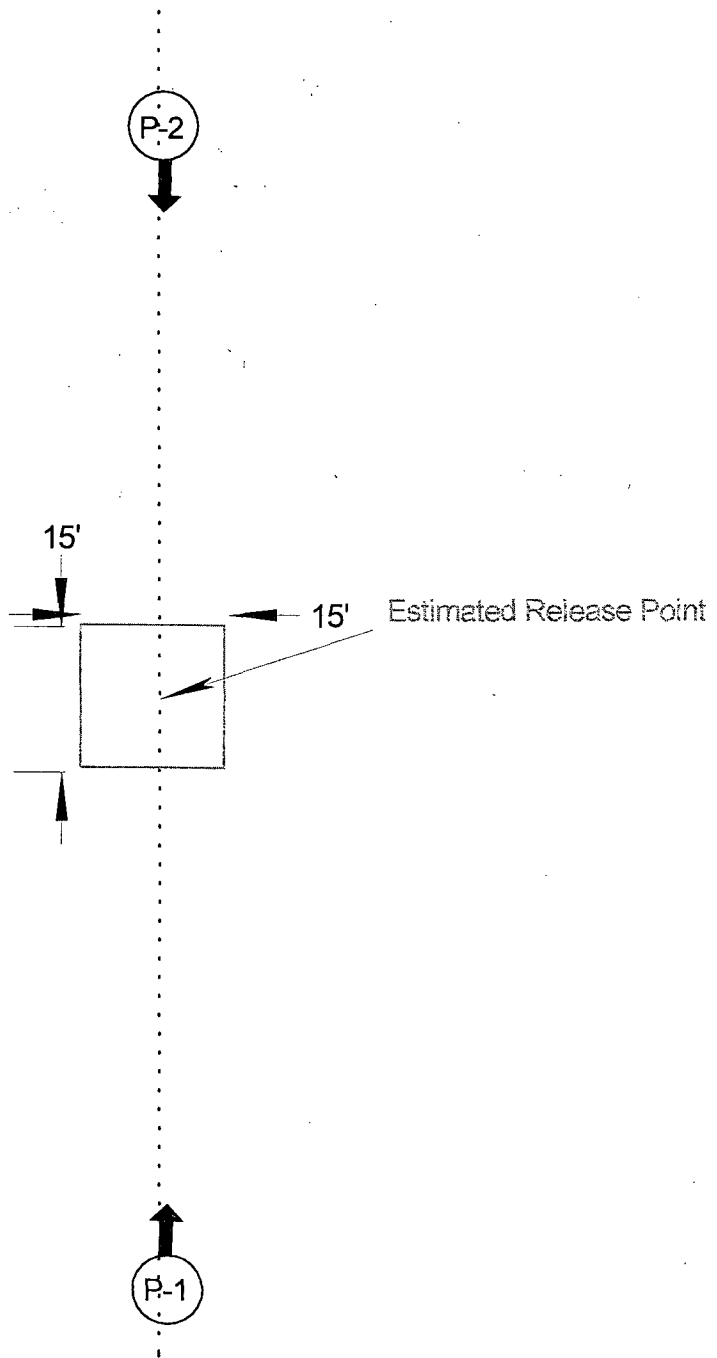
Approximate  
Scale 1"= 20'

five (5) feet bgs. On May 30, 2008, following the excavation activities, two (2) soil samples (P.R. @ 5' and B-Comp) were collected and submitted to the laboratory. A site map is attached and depicts the locations of the collected soil samples. The soil samples were analyzed for concentrations of total petroleum hydrocarbons (TPH) using EPA Method SW-846 8015M and chloride using EPA 300.1. The analytical results indicated chloride concentrations ranged from less than 10.8 mg/Kg in soil sample B-Comp to 16.3 mg/Kg in soil sample P.R. @ 5'. Total petroleum hydrocarbons were less than the laboratory method detection limit (MDL) for both soil samples. Soil sample P.R. @ 5' was analyzed for concentrations of benzene, toluene, ethyl benzene and xylene (BTEX) using EPA Method 8021b. The analytical results indicate benzene and BTEX concentrations were less than the appropriate laboratory MDL. Concentrations of Benzene, BTEX, TPH and Chloride are summarized on the attached table. The laboratory analytical reports are attached for your reference.
