**Release Notification and Corrective Action**

Name of Company: Targa Midstream Services L P	Contact: Ralph England
Address: PO Box 1689 Lovington, NM 88260	Telephone No. (575) 441-4653
Facility Name: Saunders Gas Plant	Facility Type: Gas Manufacturing Plant

Type of Release: Natural Gas and liquid from a 6 inch steel gathering line.	Volume of Release: Approximately 5 Barrels of liquid and unknown amount of natural gas	Volume Recovered: Approximately 4 Barrels
--	---	--

## South Peterson Saunders

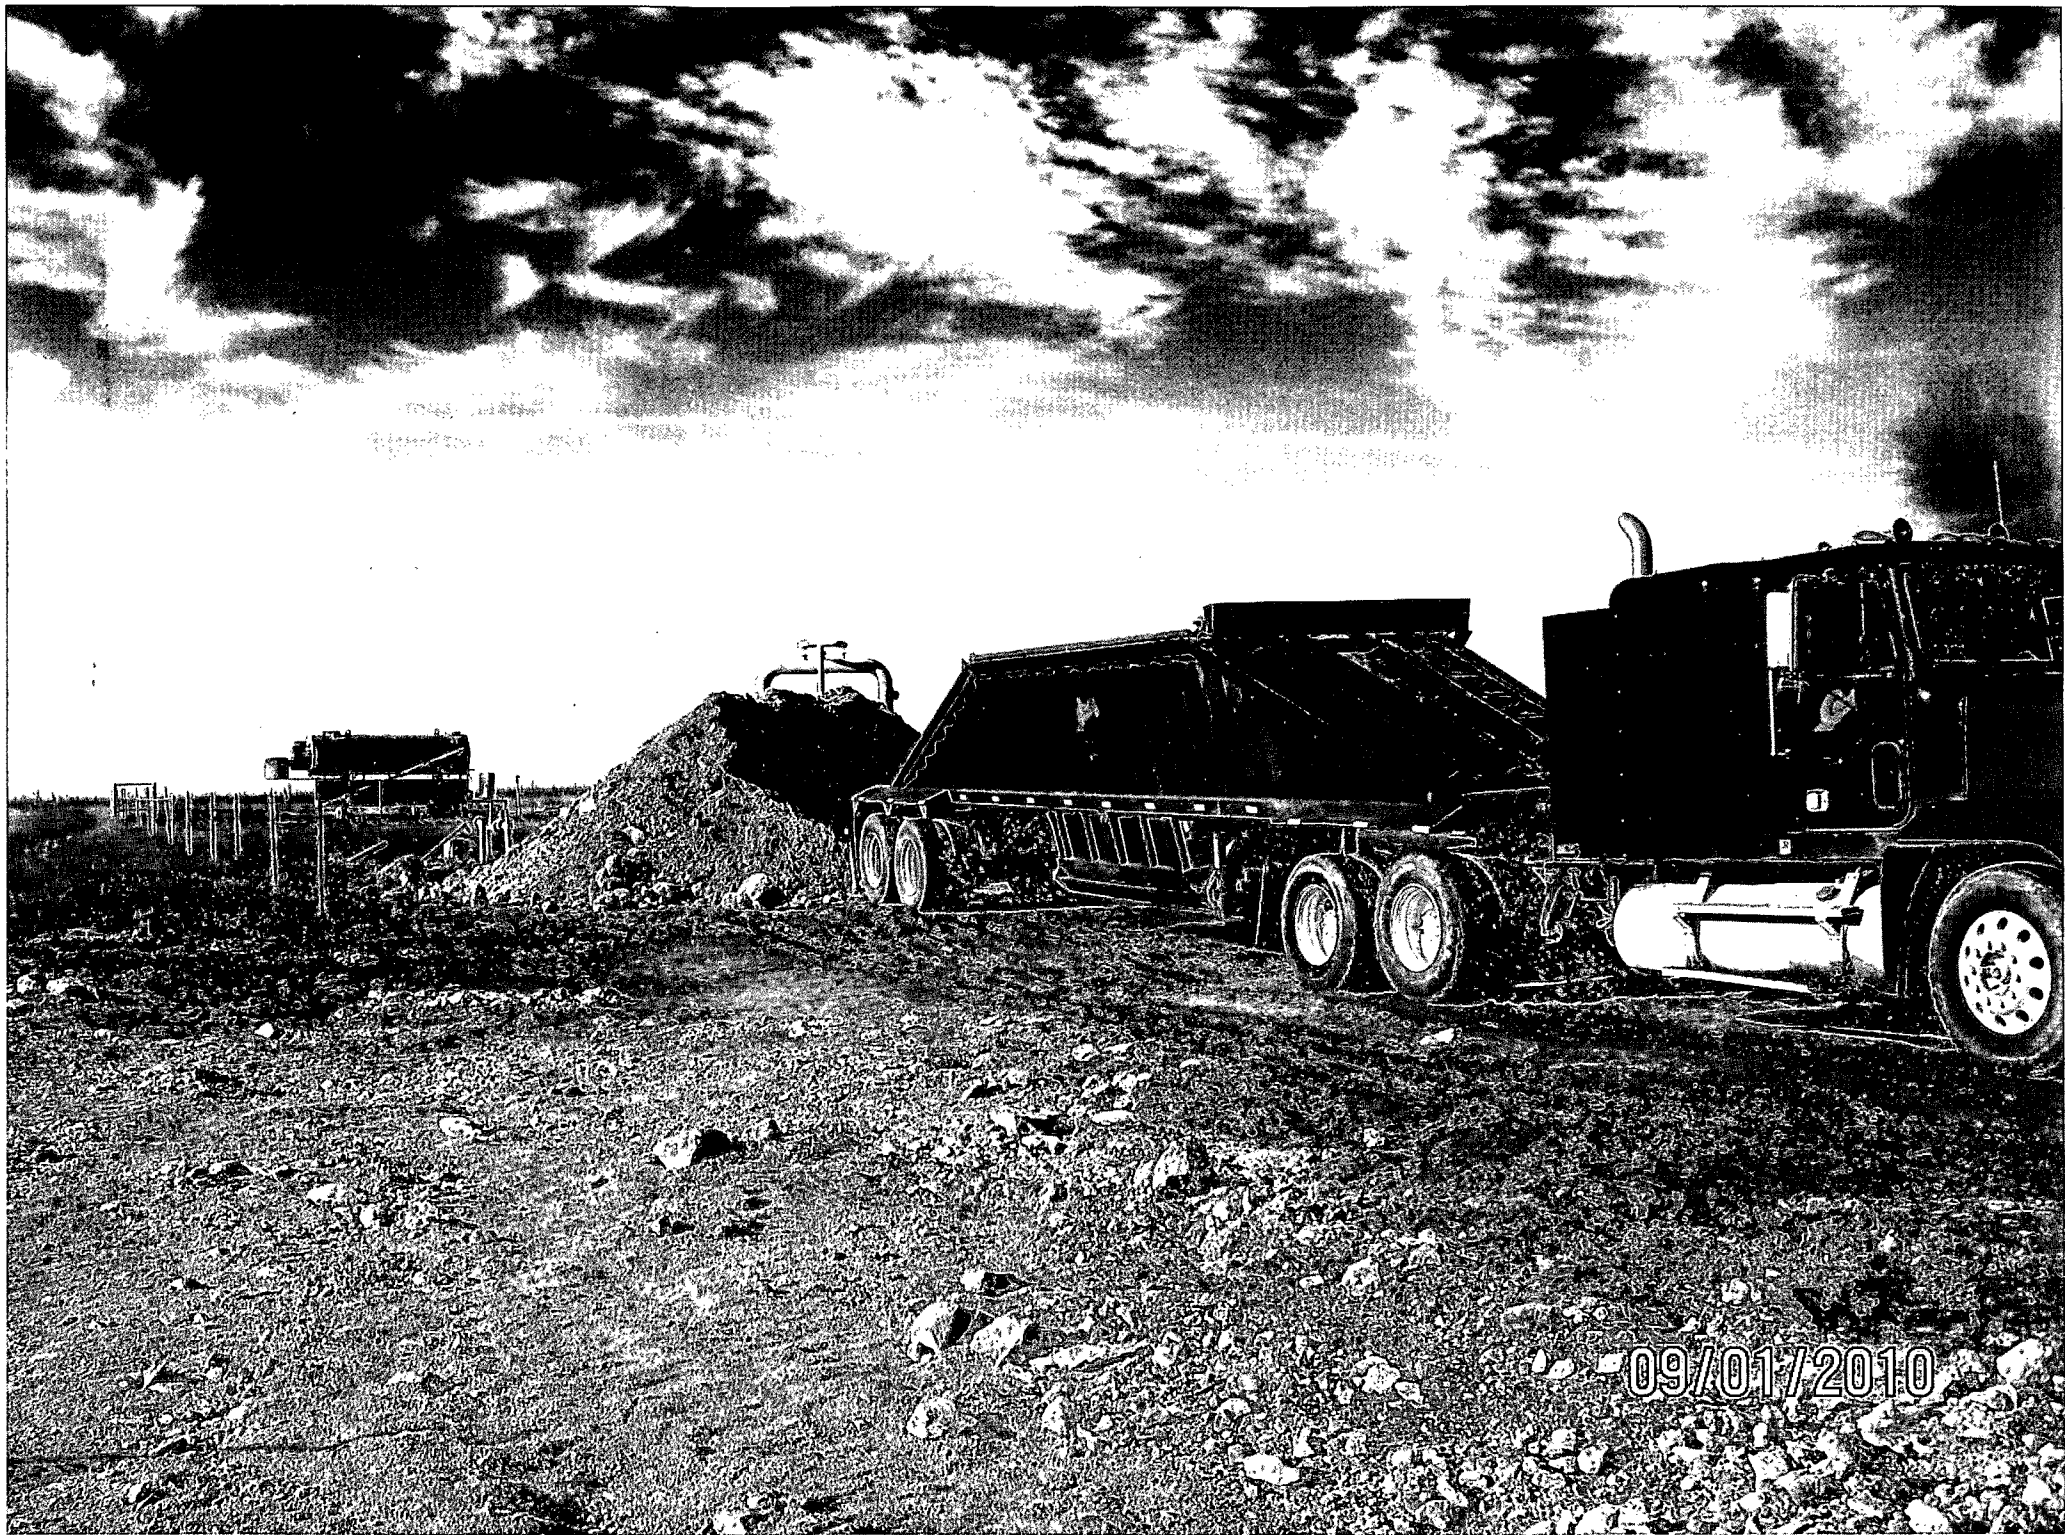
Looking ~~South~~ NORTH

Describe Area Affected and Cleanup Action Taken.\*  
Affected area was contained within our pipeline right of way. Vacuum truck was used to recover fluid. Contaminated soil was removed and taken to an OCD approved land farm. Area has been cleaned and sampled to insure compliance with OCD guidelines. Excavation will be backfilled with new soil from area approved by landowner.

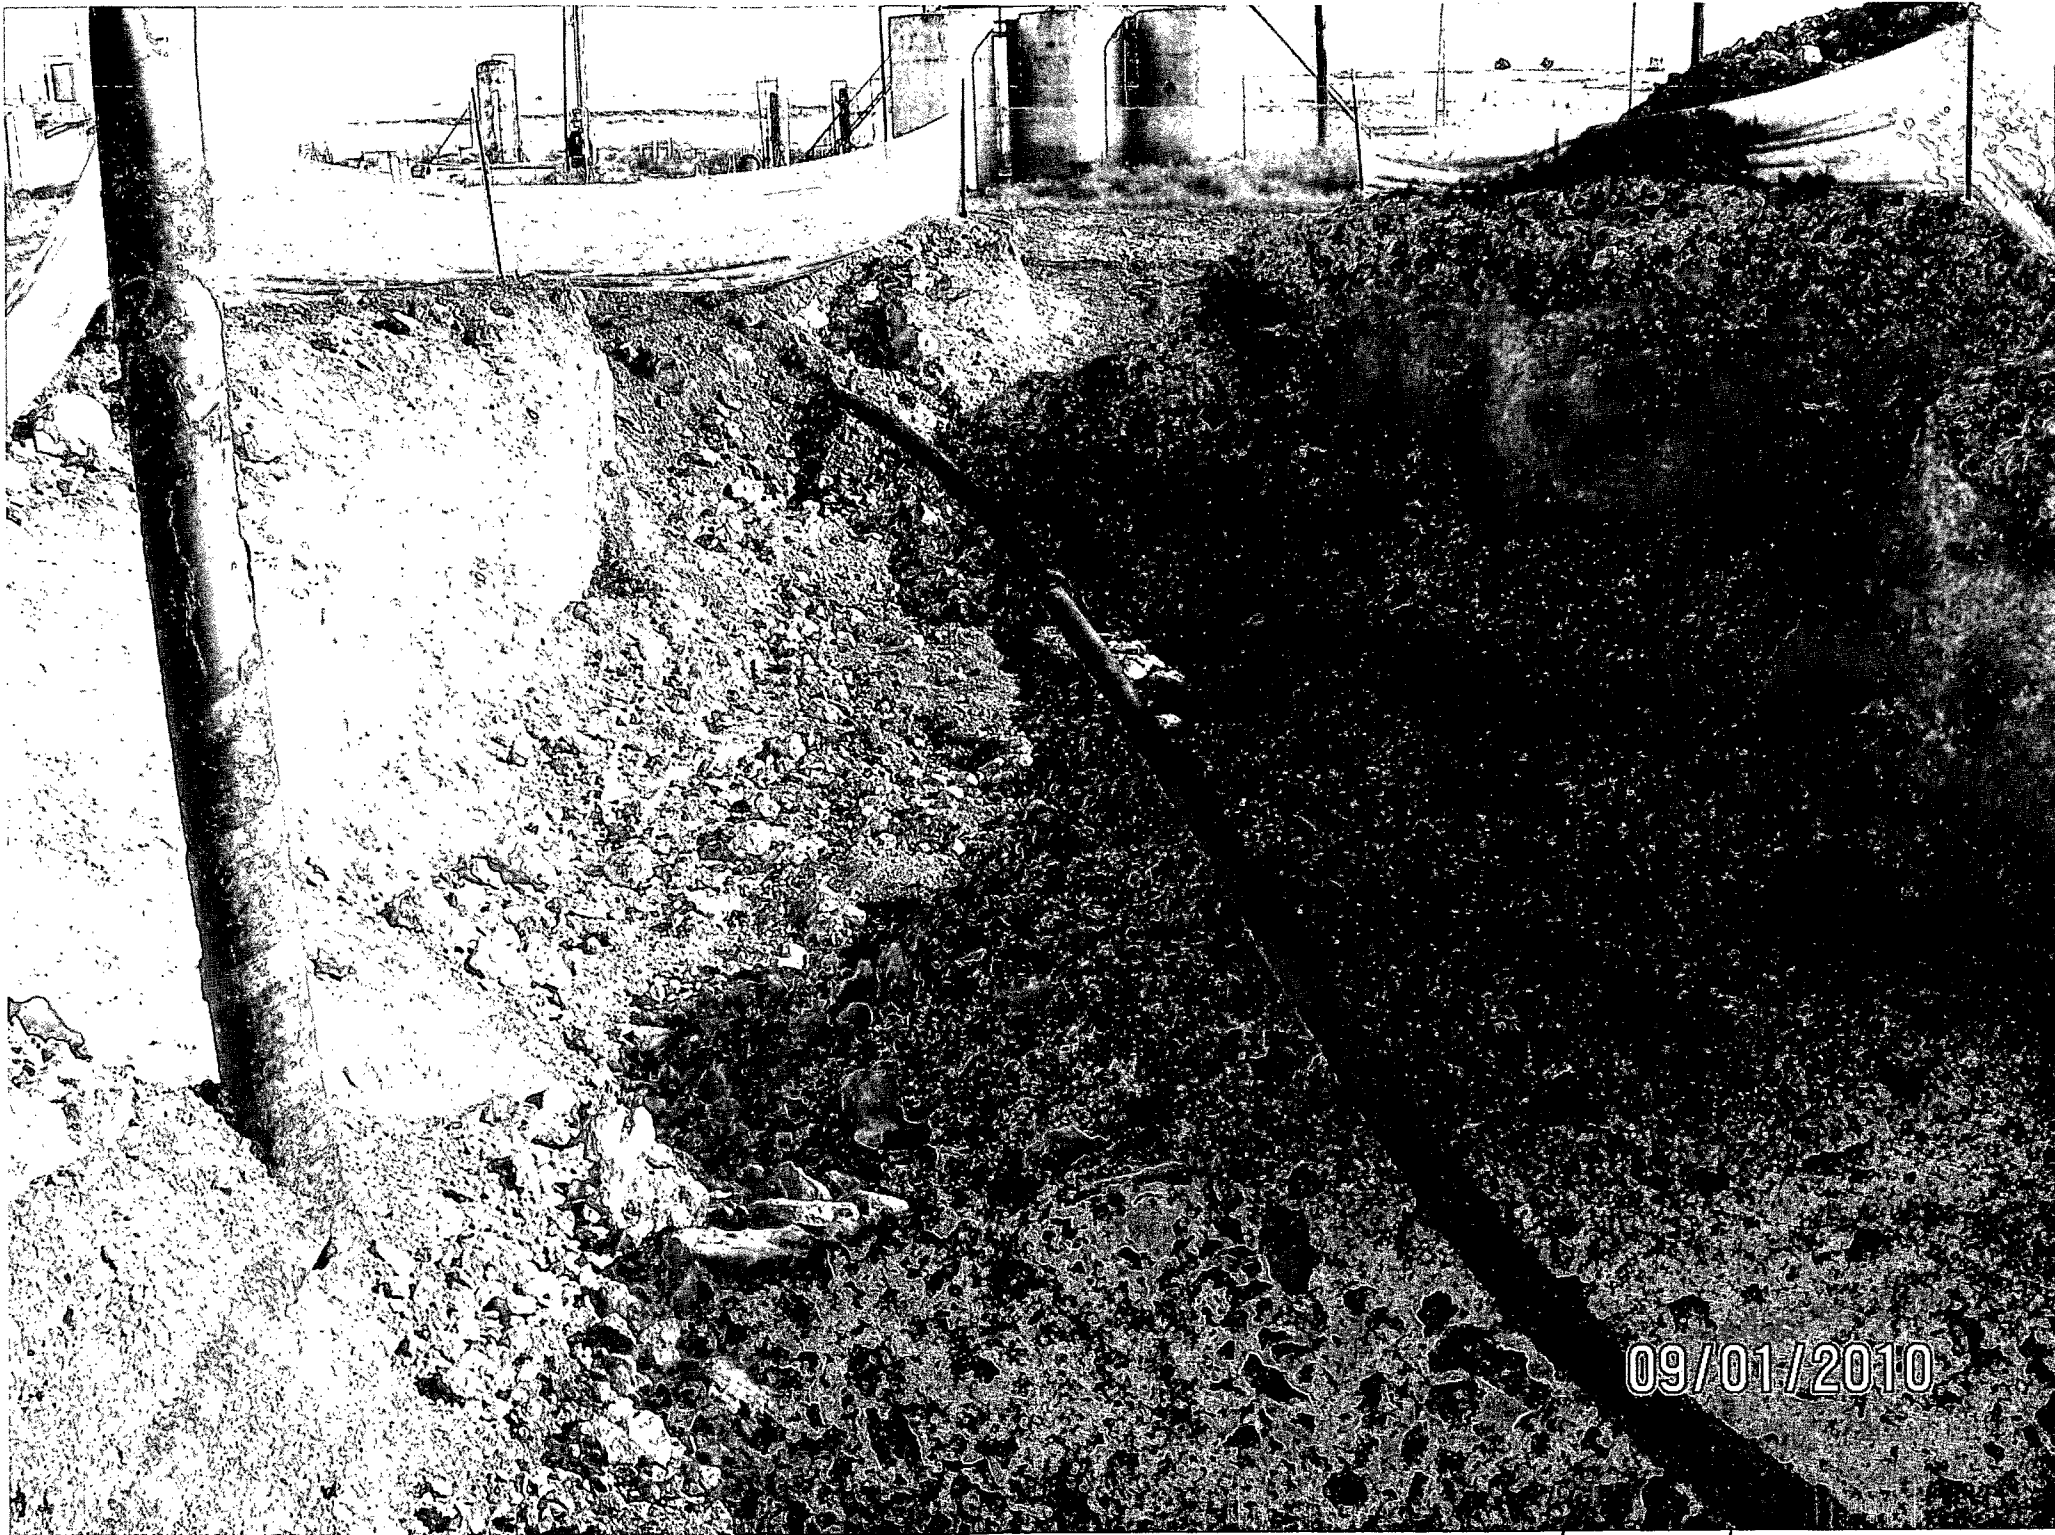
09/01/2010

Looking NORTH
