Annual GW Mon. REPORTS

December 22nd, 2010

RE: **Annual Report - OCD Case Number 1R0479**
Rice Operating Company – Vacuum N-6-1 Junction Box, UL N Sec 6 T18S R35E

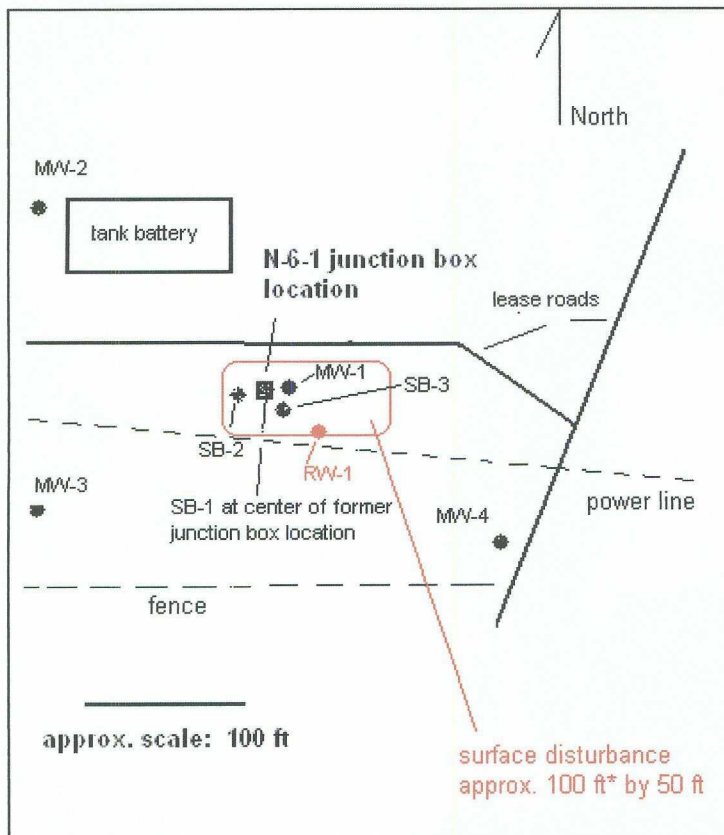
Figure 2 – Vac N-6-1 approx. monitor/recovery well locations.

- Approximately 4,138 barrels of chloride affected groundwater were been removed during 2010 from a near-source recovery well (RW-1, Figures 2 and 3). This water was subsequently used for Rice SWD line and well maintenance purposes.
- Groundwater chloride concentrations in a near-source well (MW-1) continued their decline from approximately 12,200 ppm to 8,900 ppm over this period (Figure 4).

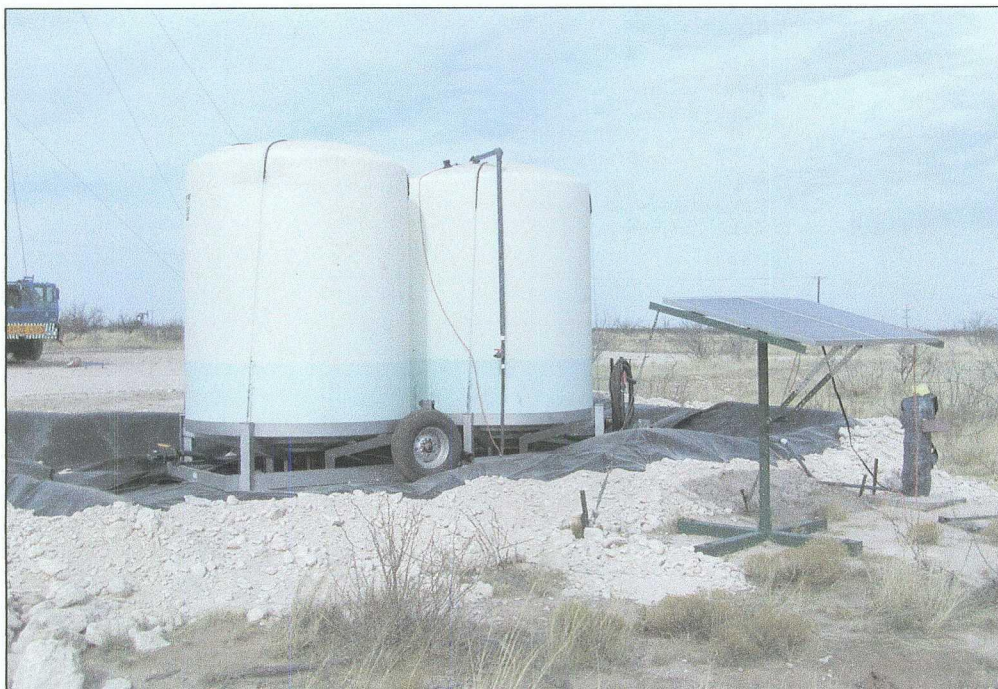
Figure 3 – Vac N-6-1 solar-powered groundwater recovery system.

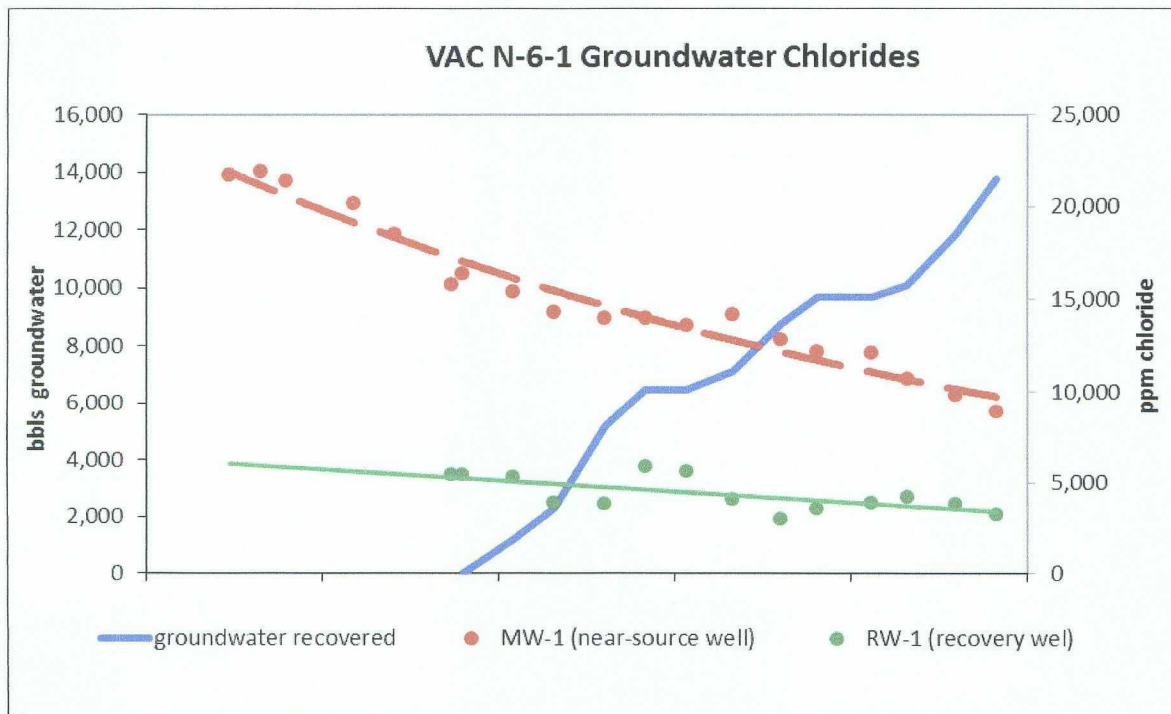
Figure 4 – Vac N-6-1 groundwater chloride concentrations (right axis) and cumulative groundwater recovery volumes (left axis).

As we see groundwater quality substantially improving we plan to continue this present course of action through 2011. Please note that we plan to submit subsequent annual reports for this project in the same time frame as other, by April 1st of the following year, unless NMOCD requests otherwise.
