1R - 427-87

**Annual GW Mon.
REPORTS**

RE: **Annual Report: OCD Case Number: 1R427-87**
Rice Operating Company – EME SWD System
H-20 SWD (UL H Sec 20 T 20S R 37E)

Rice Operating Company: EME H-20 SWD Annual Report

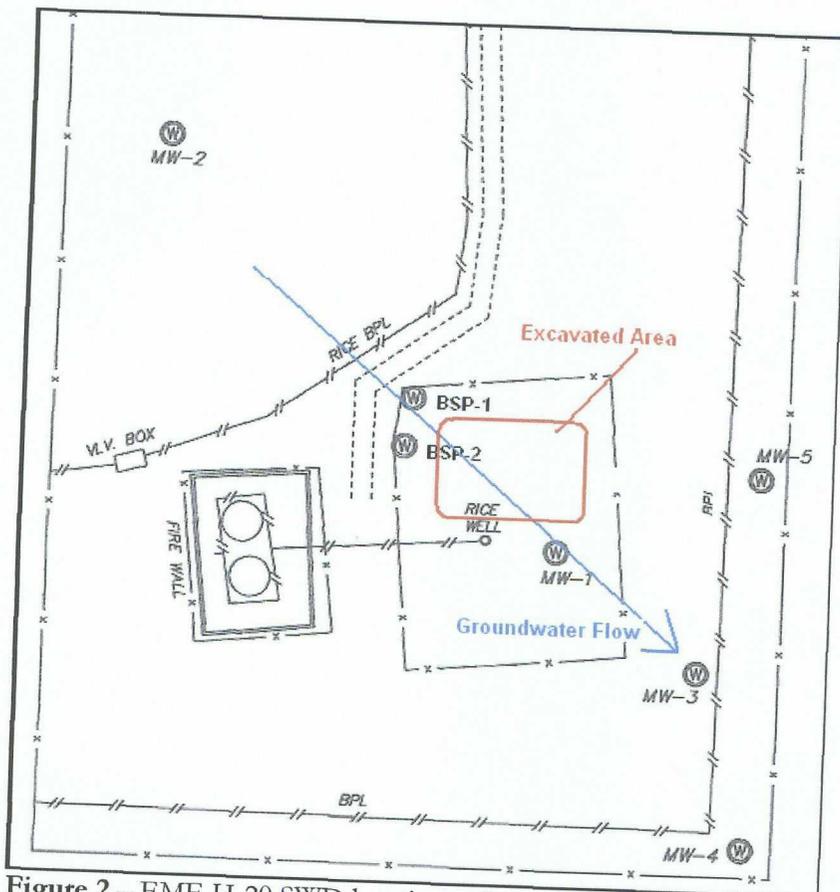
Figure 2 – EME H-20 SWD locations of monitor wells MW-1 through MW-5 and bio-sparge wells BSP-1 and BSP-2.

Over the course of 2010 we continued to operate two bio-spargers, (BSP-1 and BSP-2; Figures 2 & 3) to facilitate the natural attenuation of benzene previously found in the at-source monitor well (MW-1). We also continued to monitor up and down-gradient monitor wells for chlorides and petroleum hydrocarbons (BTEX). The results of this work may be summarized as follows:

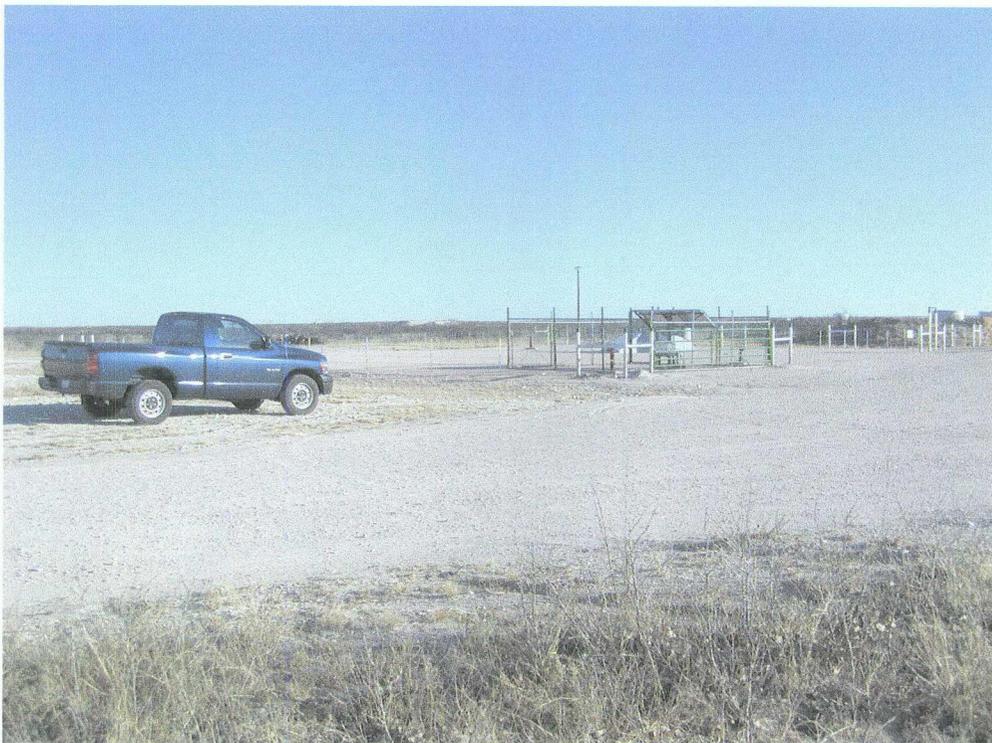
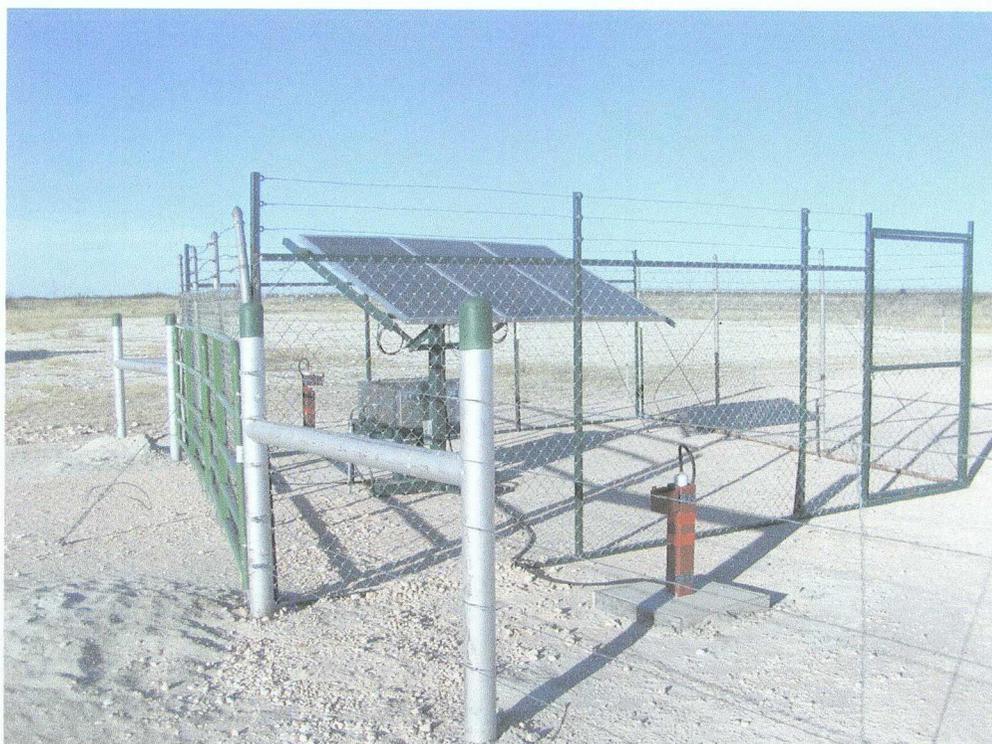
Figure 3a (above) – EME H-20 SWD solar powered bio-spargage system, view across system toward the southeast (in the direction of groundwater flow). **Figure 3b** (below) close-up view showing bio-spargage air injection wells looking toward the north.

During the course of 2011 we plan to continue the operation of the solar-powered bio-sparge system and to continue the quarterly monitoring of groundwater for chlorides and BTEX. Please note that we plan to submit subsequent annual reports for this project in the same time frame as other, by April 1st of the following year, unless NMOCD requests otherwise.

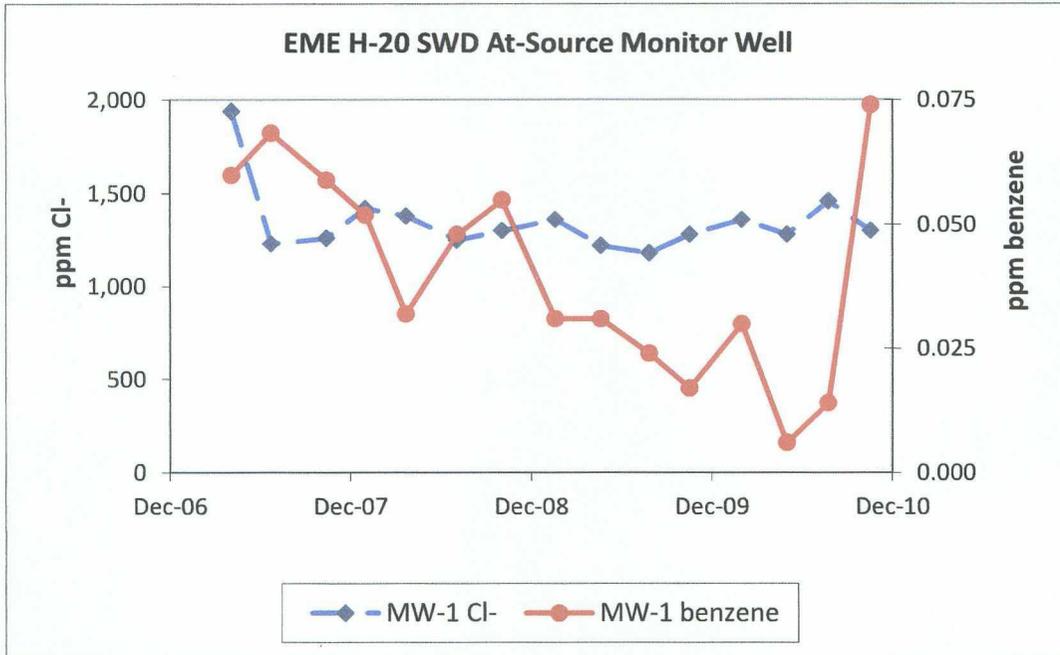
Figure 4 – Groundwater chloride (dashed blue line, left axis) and benzene (solid red line, right axis) concentrations in near-source monitor well (MW-1).

1. Benzene concentrations in the at-source monitor well (MW-1) were rather erratic in 2010 but ended up from 0.017 ppm in November 2009 to 0.074 ppm in November 2010 (Figure 4). We do not believe that this represents an upward trend but will watch this closely during 2011. Groundwater chloride concentrations in the at-source monitor well (MW-1) were relatively stable, oscillating around an average value of 1,300 ppm during 2010.

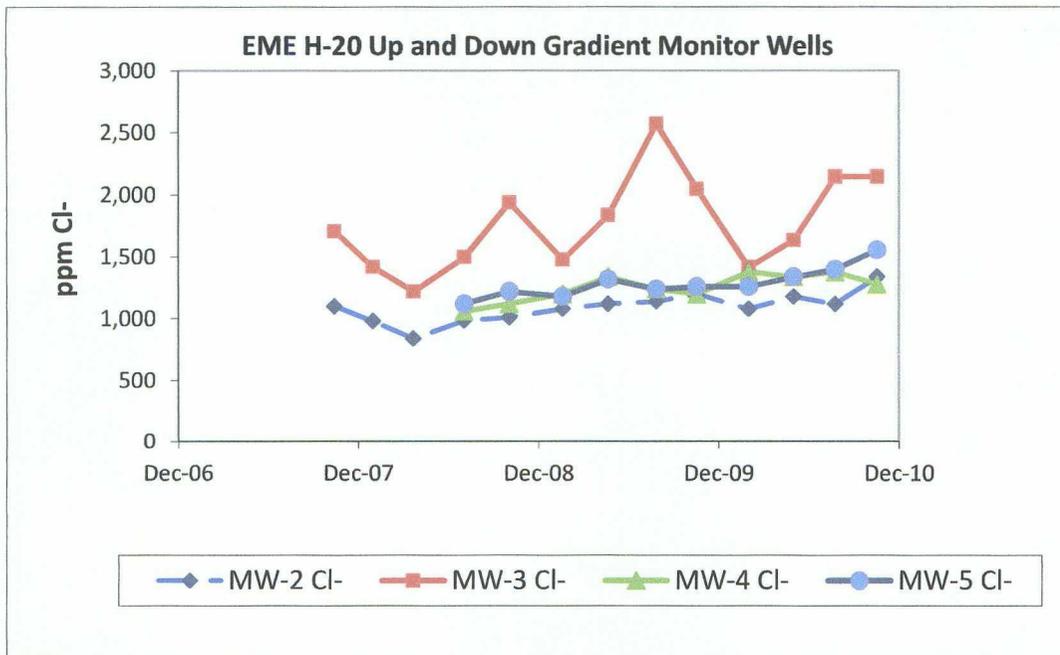
Figure 5 – Groundwater chloride concentrations in up-gradient monitor well (MW-2) and down-gradient monitor wells (MW-3, MW-4 and MW-5). See site map for monitor well location.

2. Groundwater chloride concentrations in the up-gradient monitor well (MW-2) have continued their previous upward trend, rising from 1,200 to 1,340 over the course of 2010 (Figure 5). This indicates that the groundwater flowing onto and across the subject site from up-gradient has become increasingly contaminated with respect to chloride.

3. The monitor well (MW-3) most directly down-gradient from the subject site exhibited were also rather erratic in 2010 but ended substantially unchanged from 2,050 in November 2009 to 2,150 ppm in November 2010. Again, we do not believe that this represents an upward trend but will watch this closely during 2011.

4. The off-center, down-gradient monitor wells (MW-4 and MW-5) exhibited slight increases in groundwater chloride concentrations in comparison with late 2009 levels (Figure 5). We will watch these closely during 2011 to determine if this represents a sustained, upward trend.
