Release Notification and Corrective Action

**Cimarex Energy Company
Crestone #1
Section 12, Township 15S, Range 37E
Lea County, New Mexico**

Closure Report

January 17, 2011

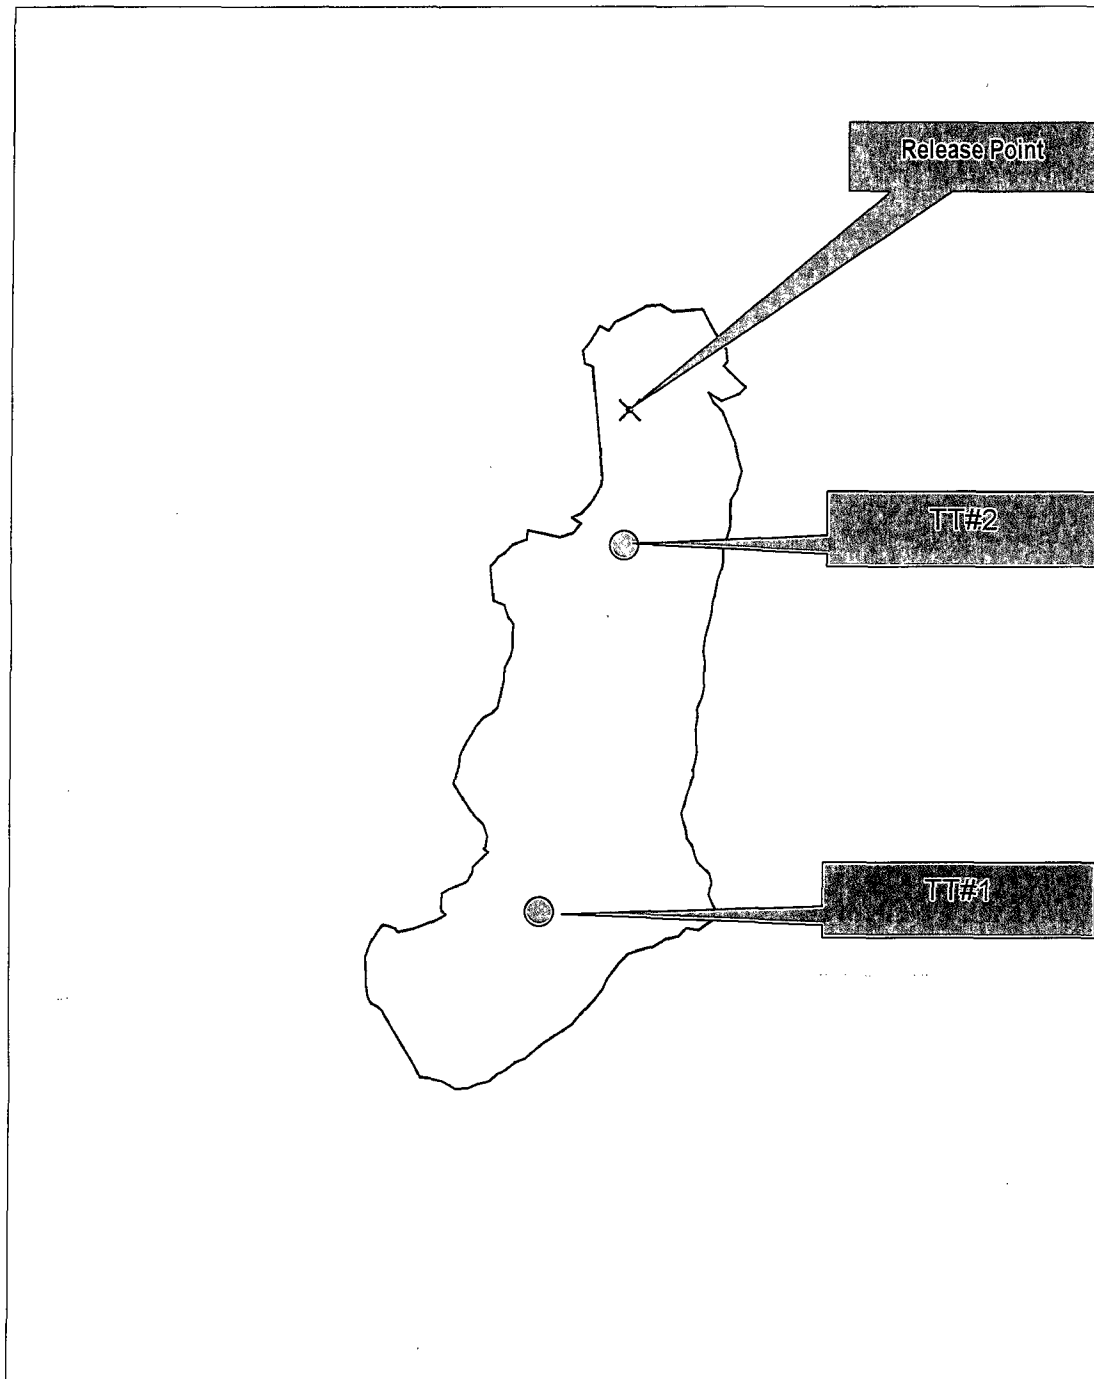
Figure 2 Site Map

On August 17, 2010, SESI was onsite with Mr. Marty Davis, Cimarex Energy Company, to assess release area. The location area was mapped utilizing a Trimble Geo Explorer XM handheld device. The release appeared to be confined to the location pad.

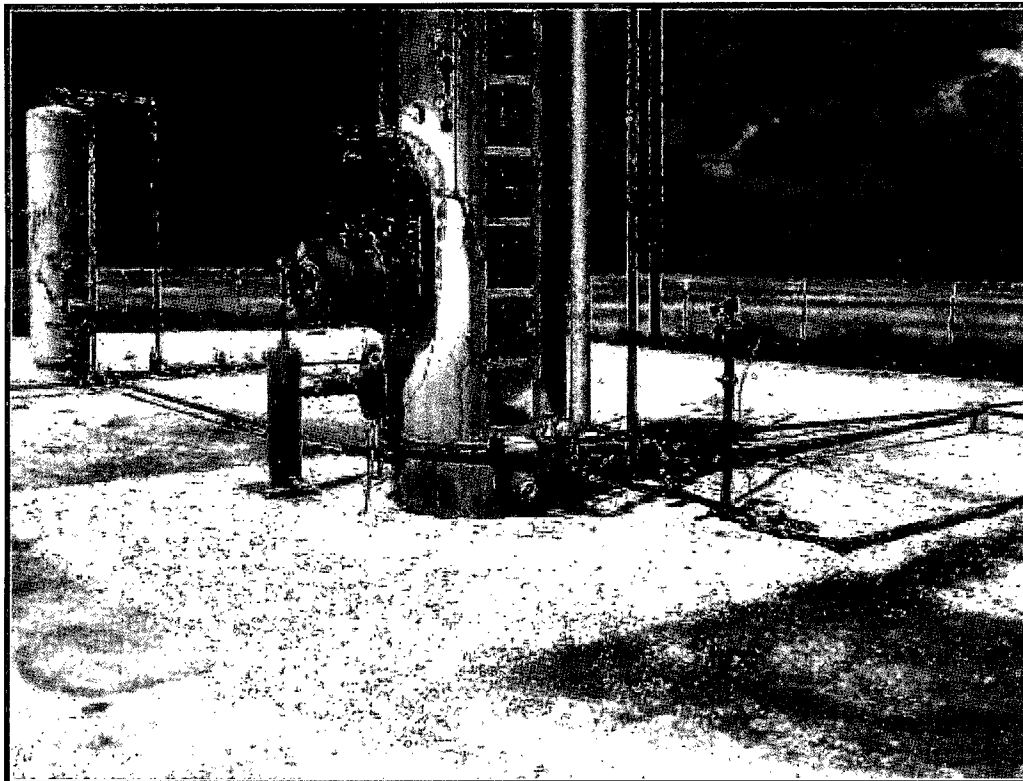
The nipple at the bottom of the heater treater was ruptured due to internal corrosion.

Release point facing northeast

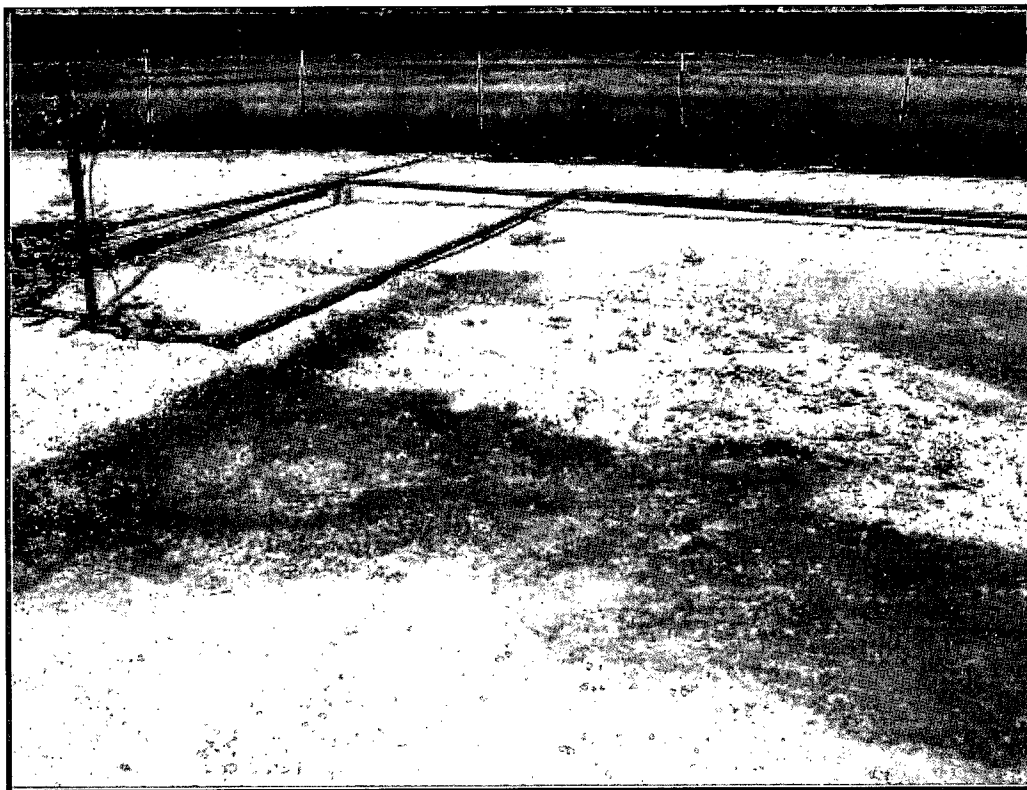
Release area facing east

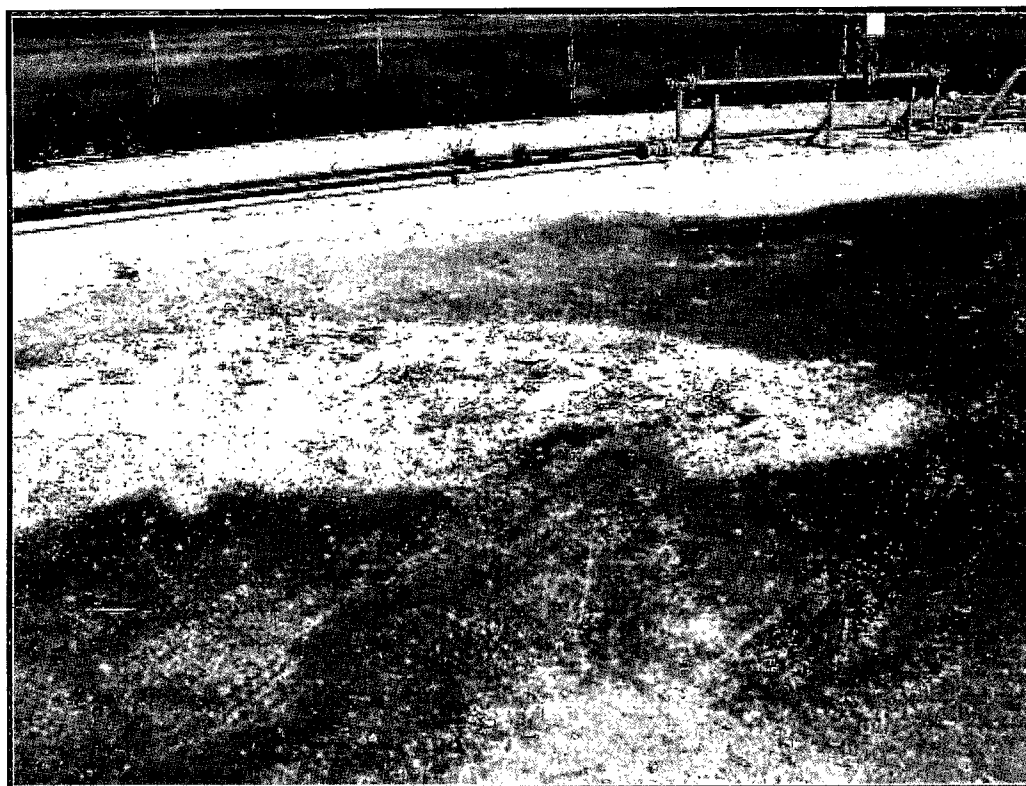
Release area facing south east

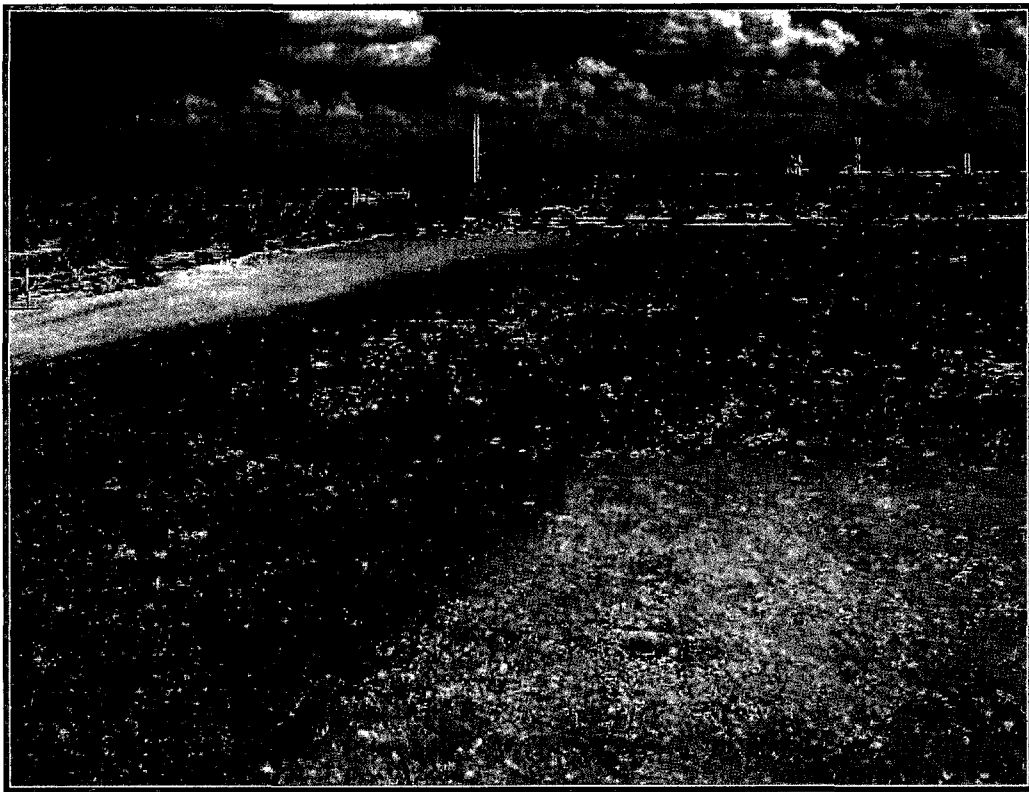
Release area facing south

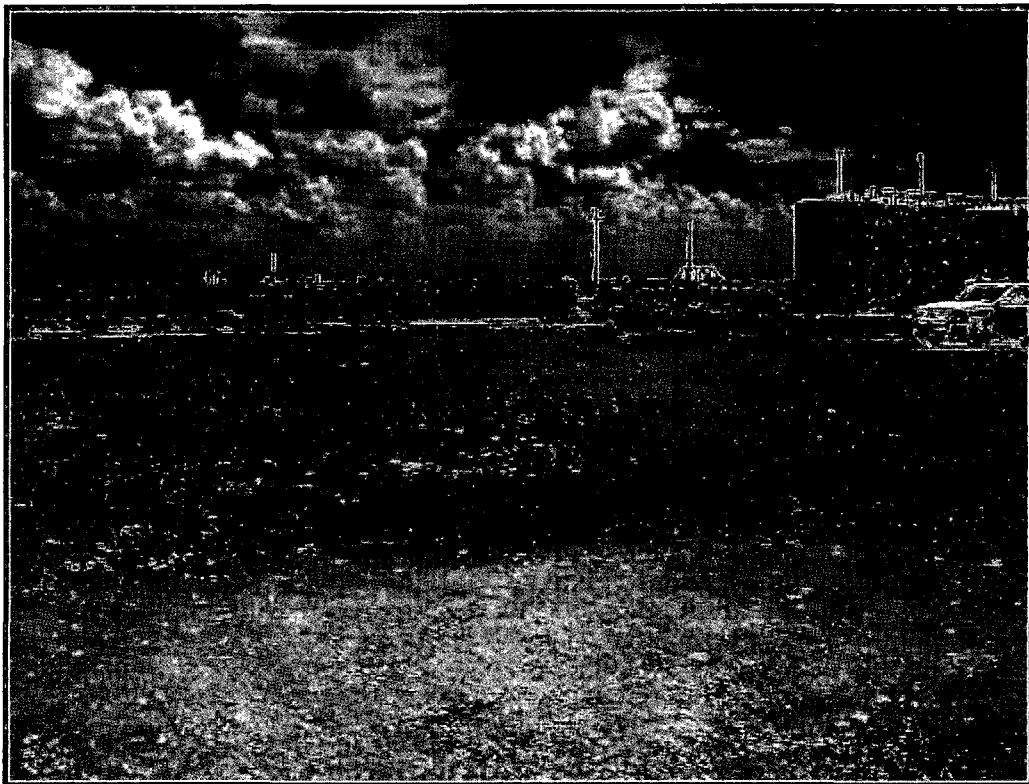
Release area facing south

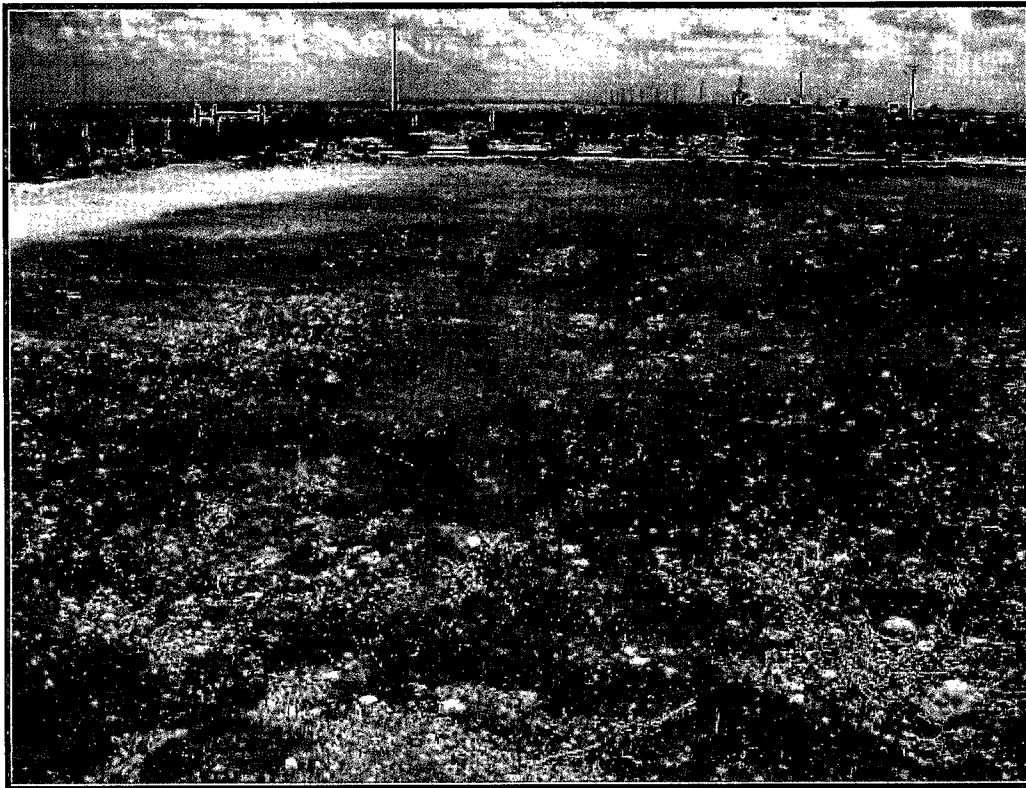
Release facing south

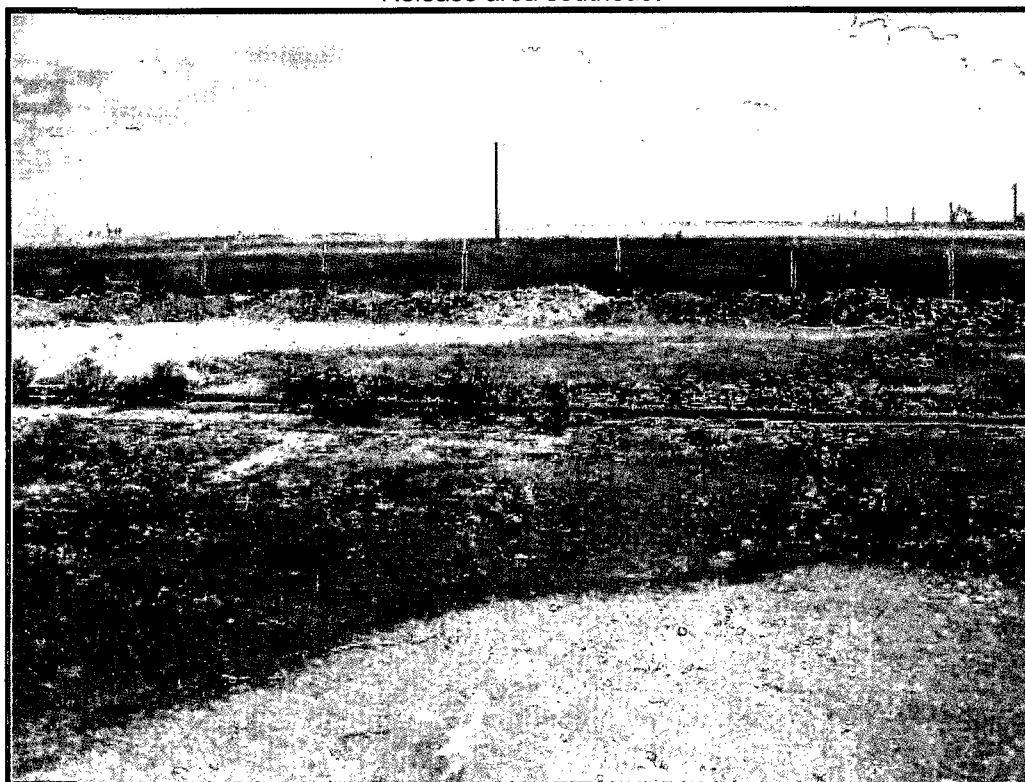
Release area facing east

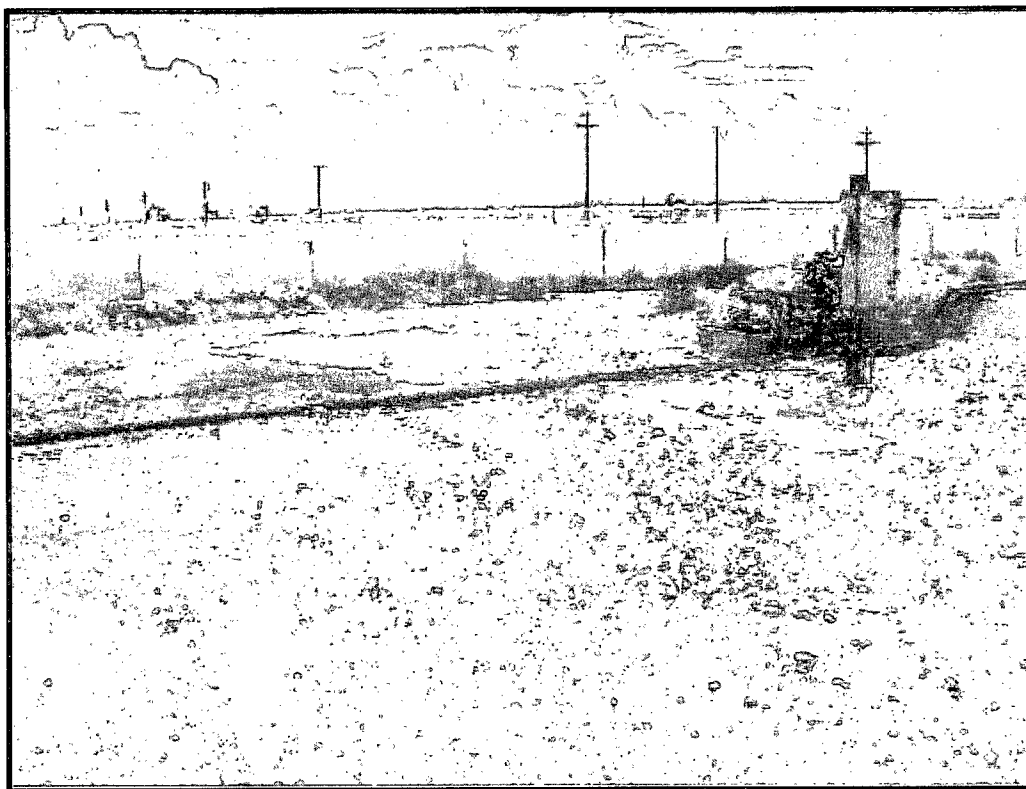
Release area facing south

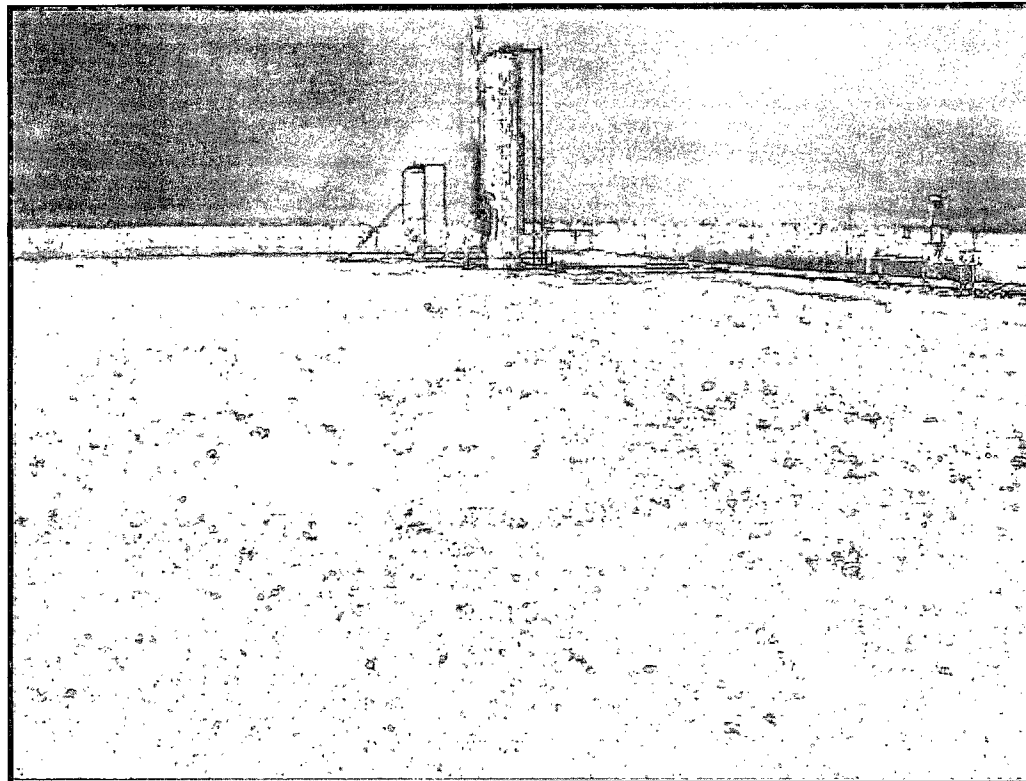
Release area facing north

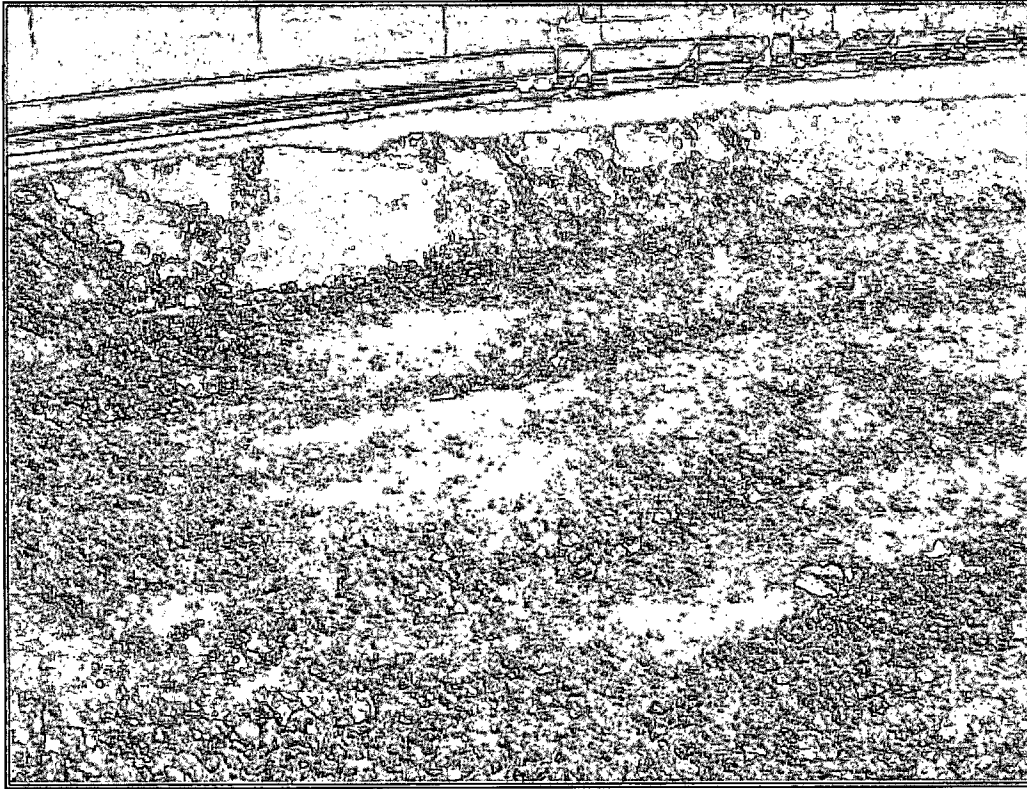
Excavation facing east

On December 29, 2010 Safety and Environmental Solutions, Inc. worked with Hungry Horse Construction to start excavation of location area. Upon approved worked plan by Mr. Geoff Leking with New Mexico Oil Conservation Division (NMOCD). The release area was excavated to a depth of four (4) feet below grade surface and hauled 960 yards of contaminated soils to Gandy Marley Land Farm for disposal. Test Trench #1 was re-installed to determine vertical extent of contamination. The trench was installed to a depth of nine (9) feet below grade surface. Composite samples were retrieved from the sidewalls as well as the bottom of the excavation. Confirmation samples were taken to Cardinal Laboratories in Hobbs, New Mexico to be analyzed for Total Petroleum Hydrocarbons (TPH EPA Method 418.1), Benzene Toluene Ethyl-benzene and Total Xylenes (BTEX) (EPA Method SW-846-8021B) and Chlorides (EPA Method 4500Cl-B).

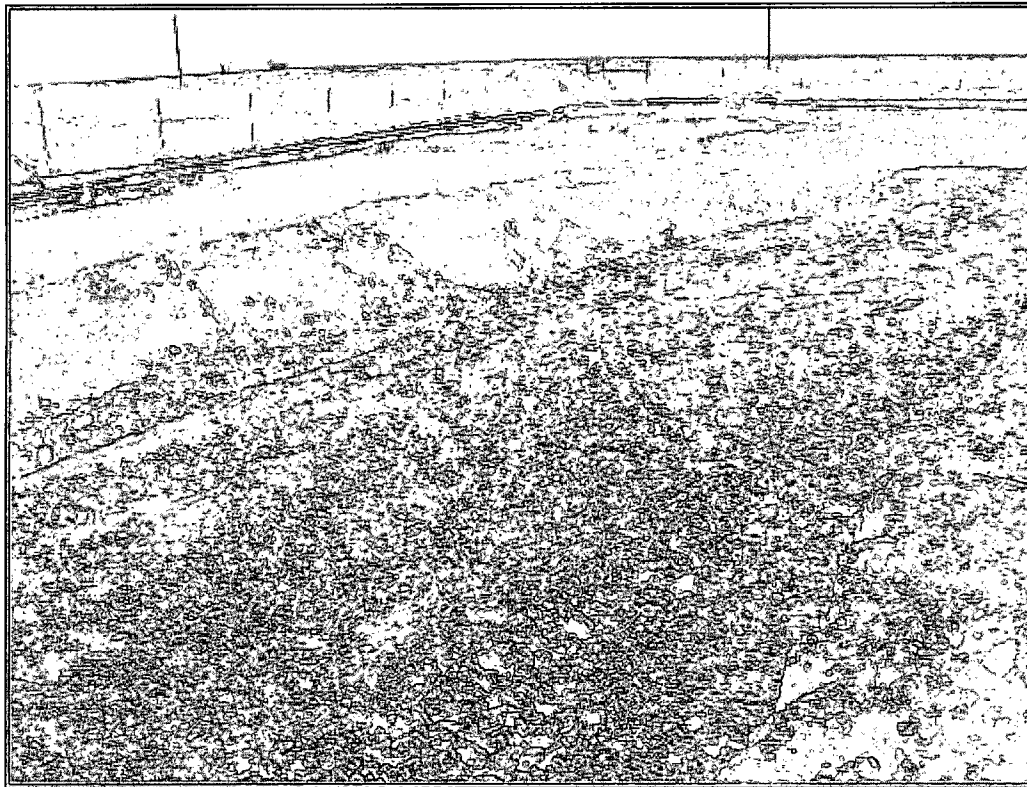
Excavated area facing southeast

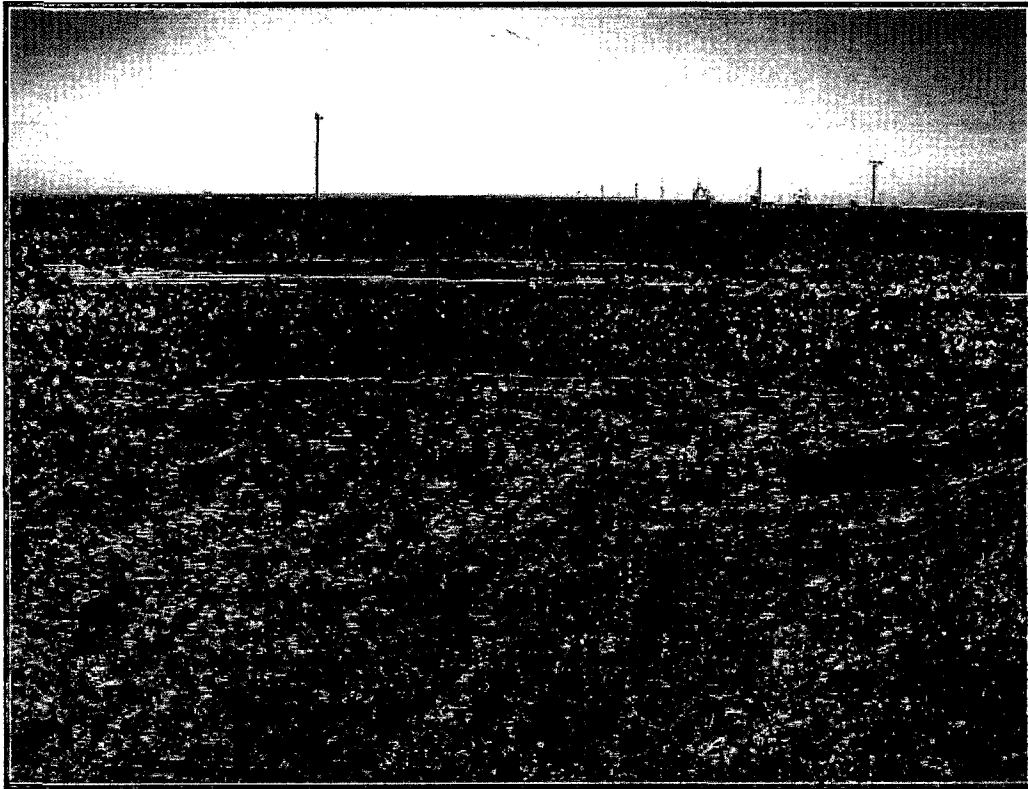
Excavated area facing south

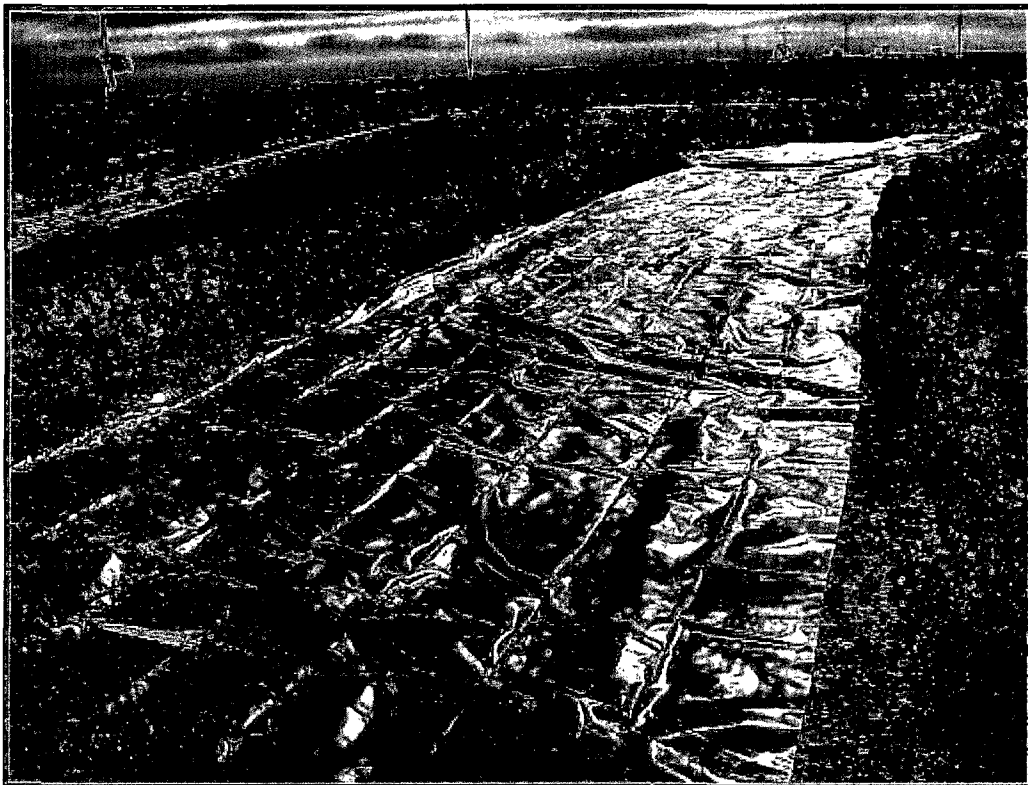
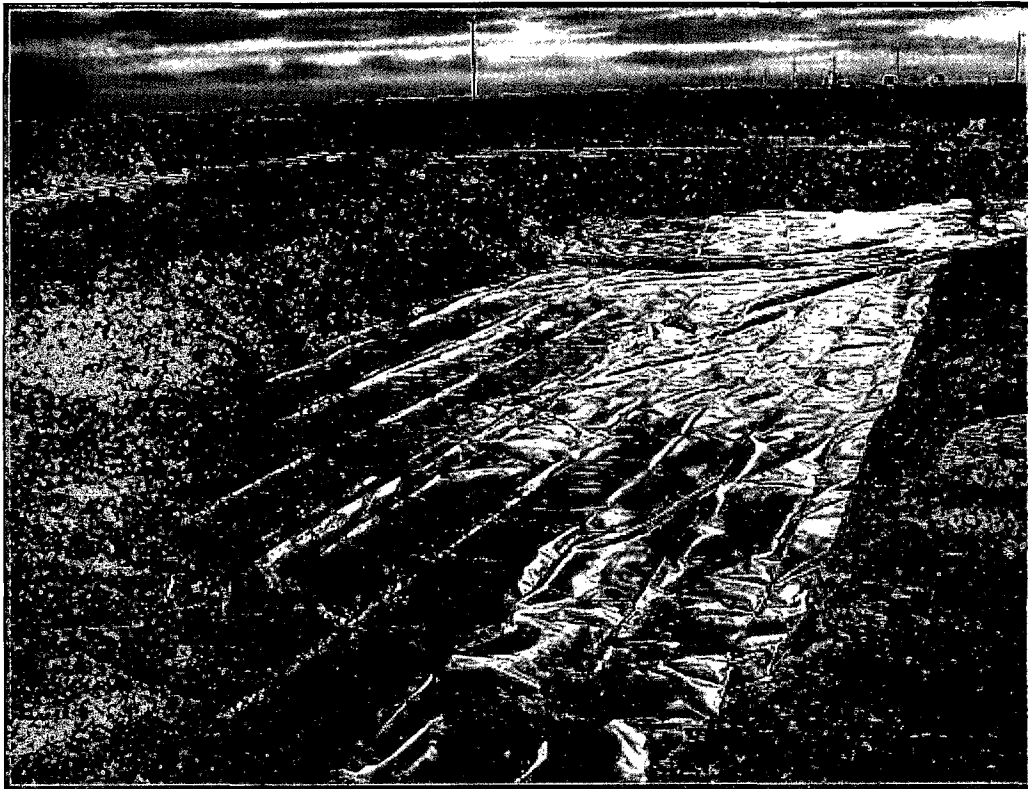
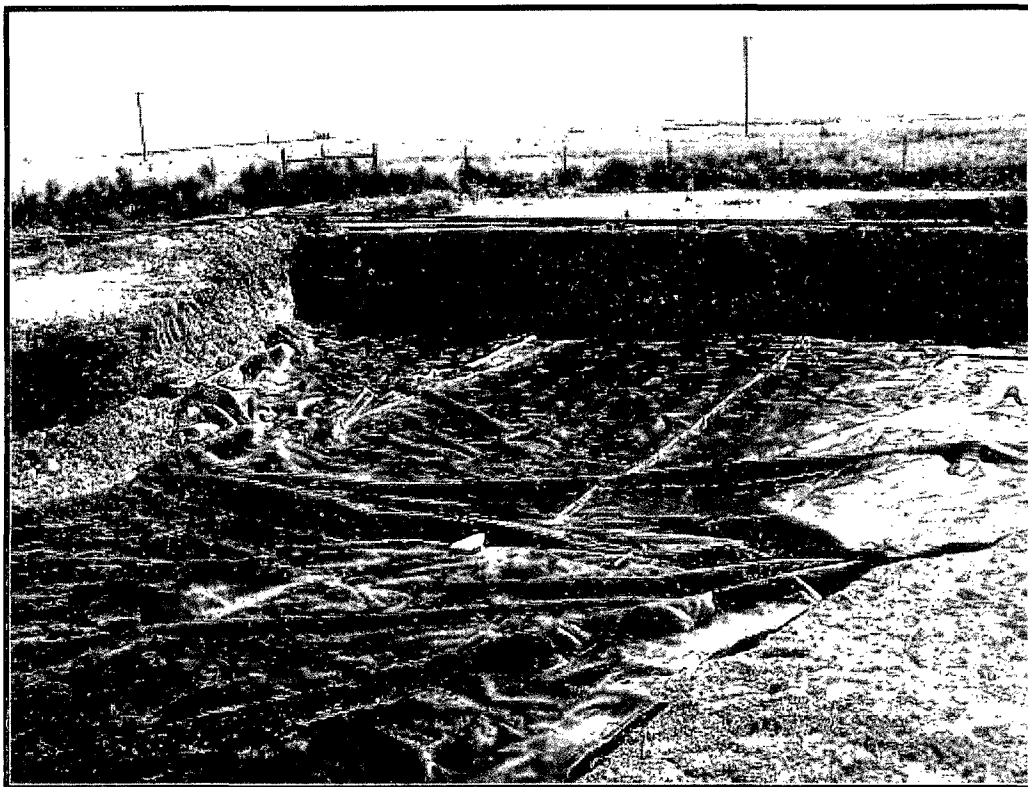
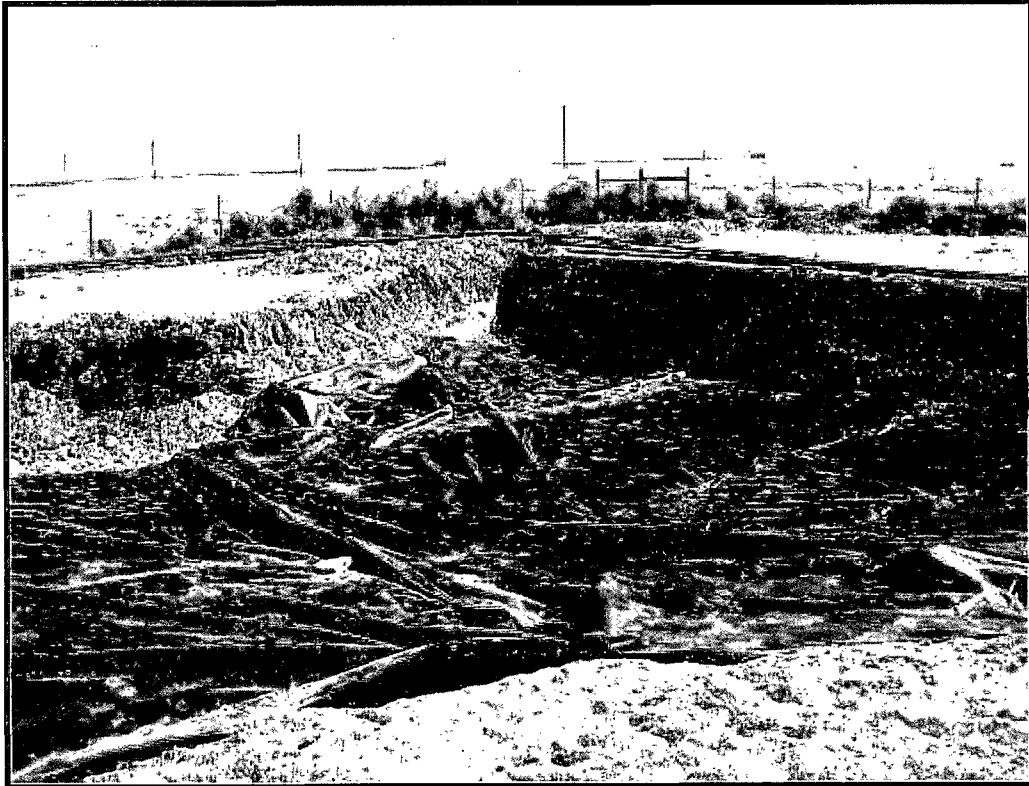
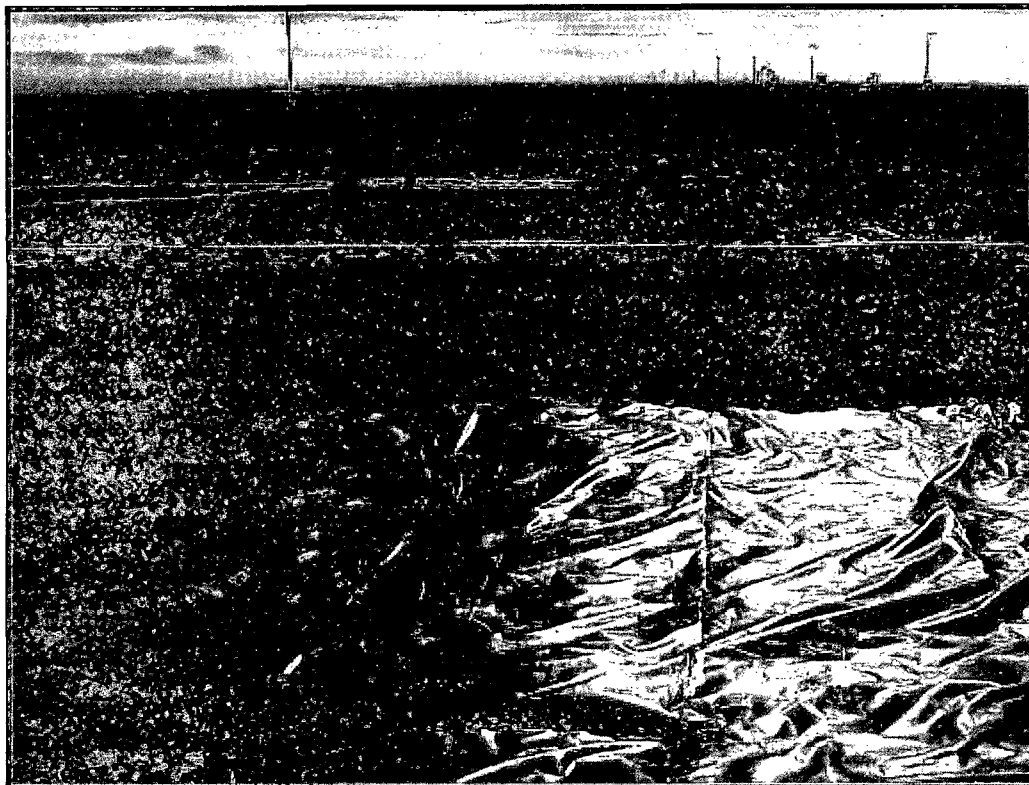
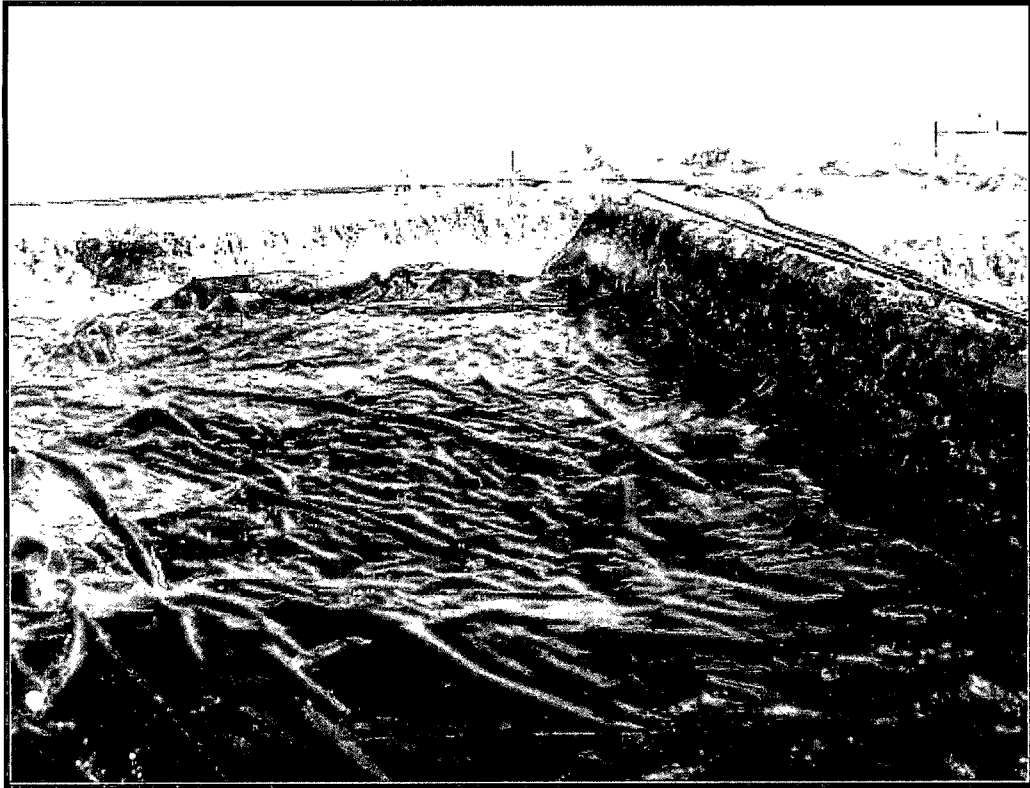
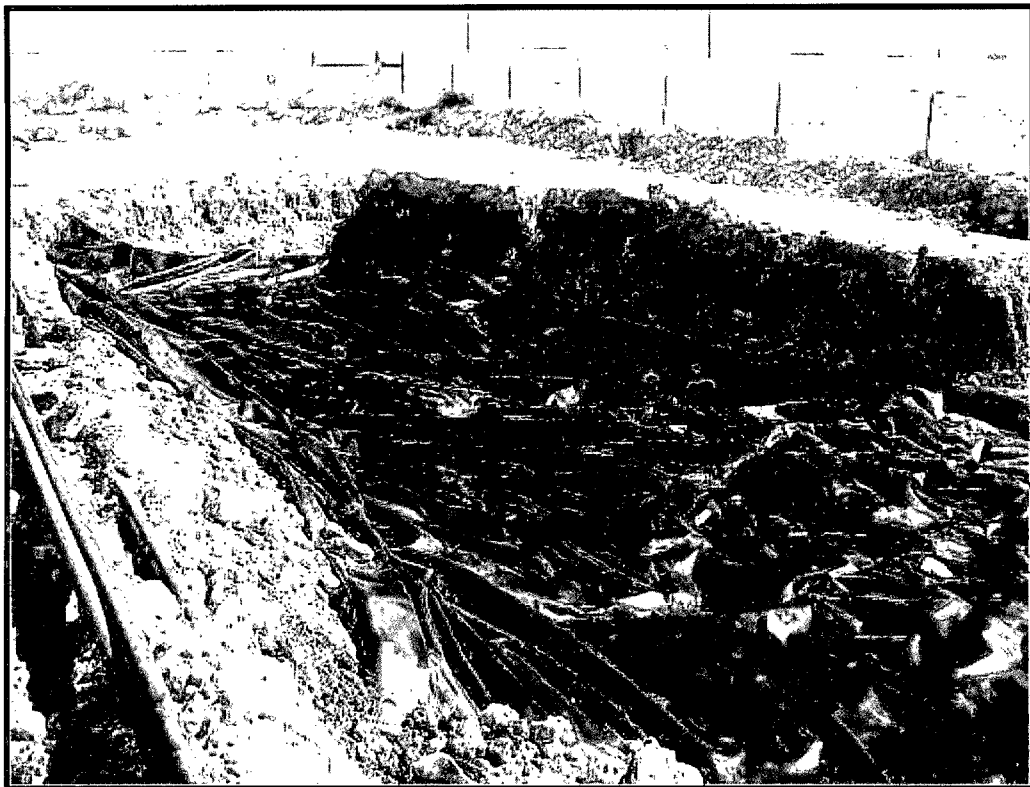
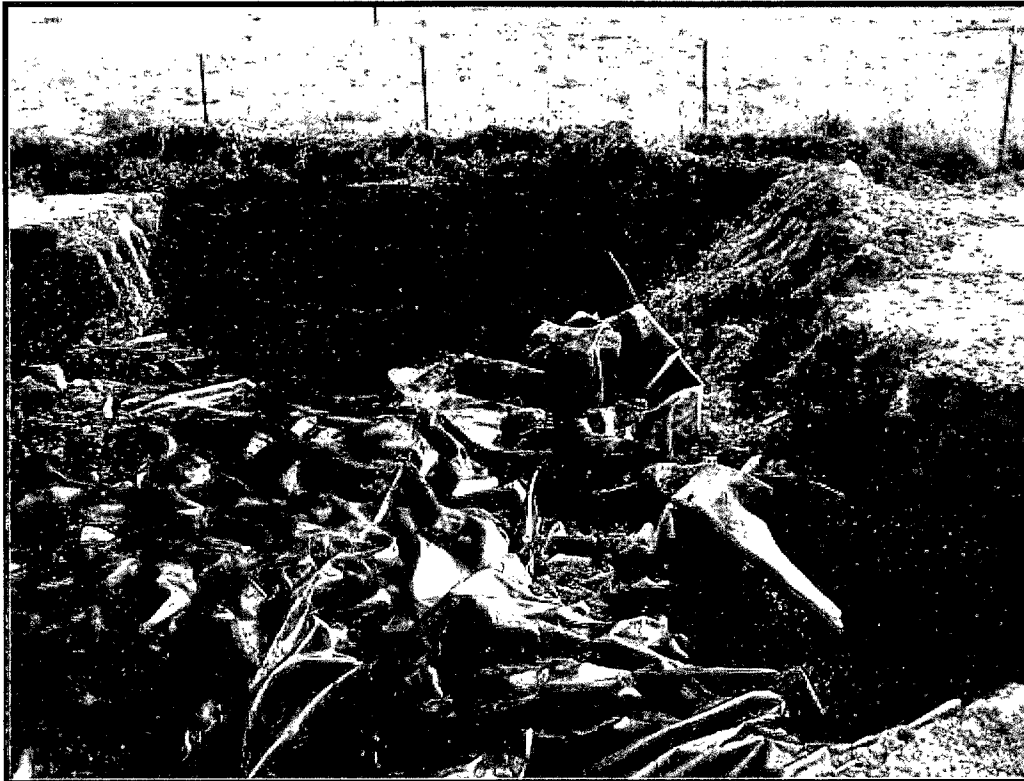
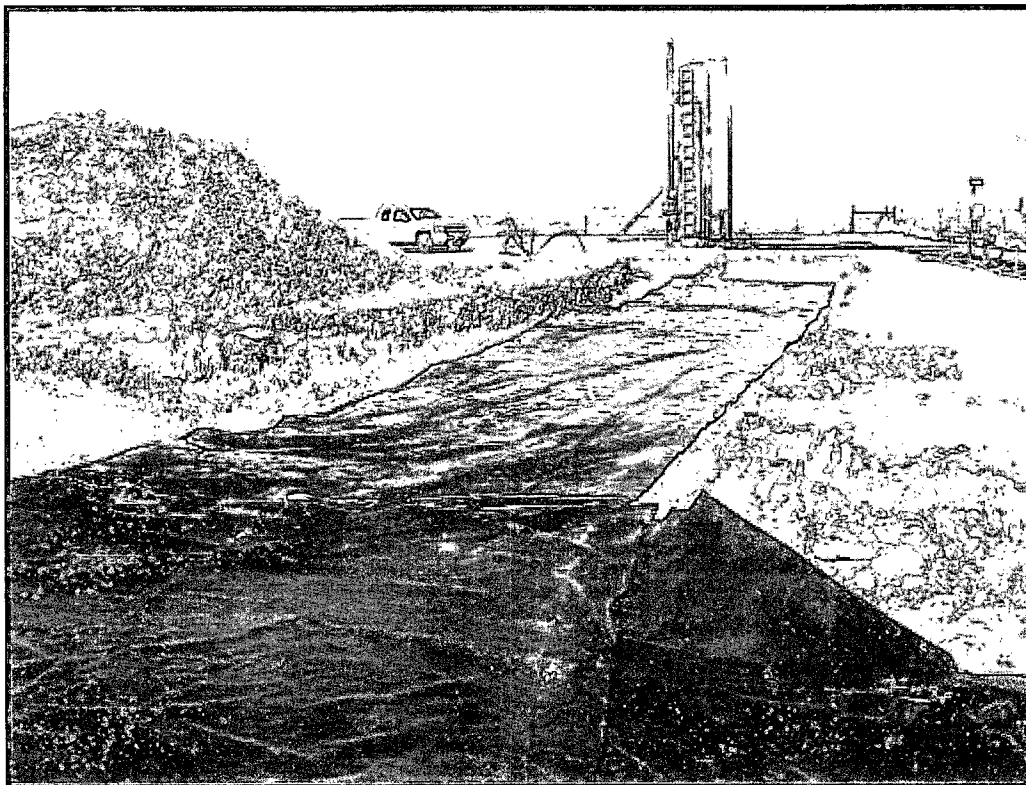
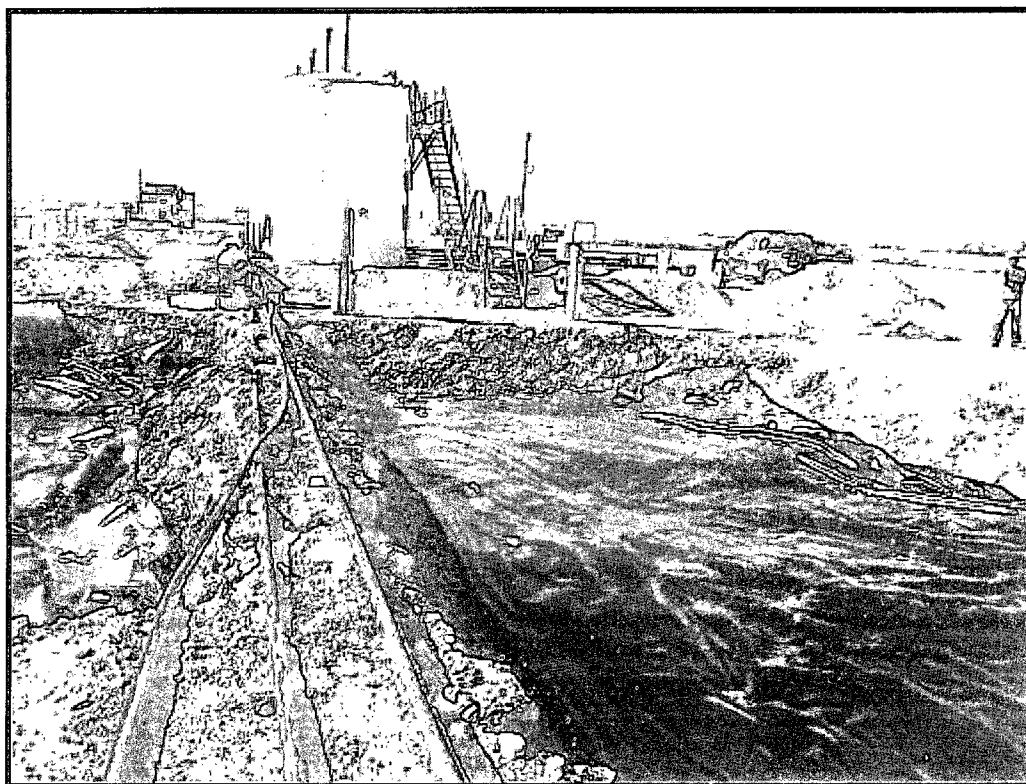
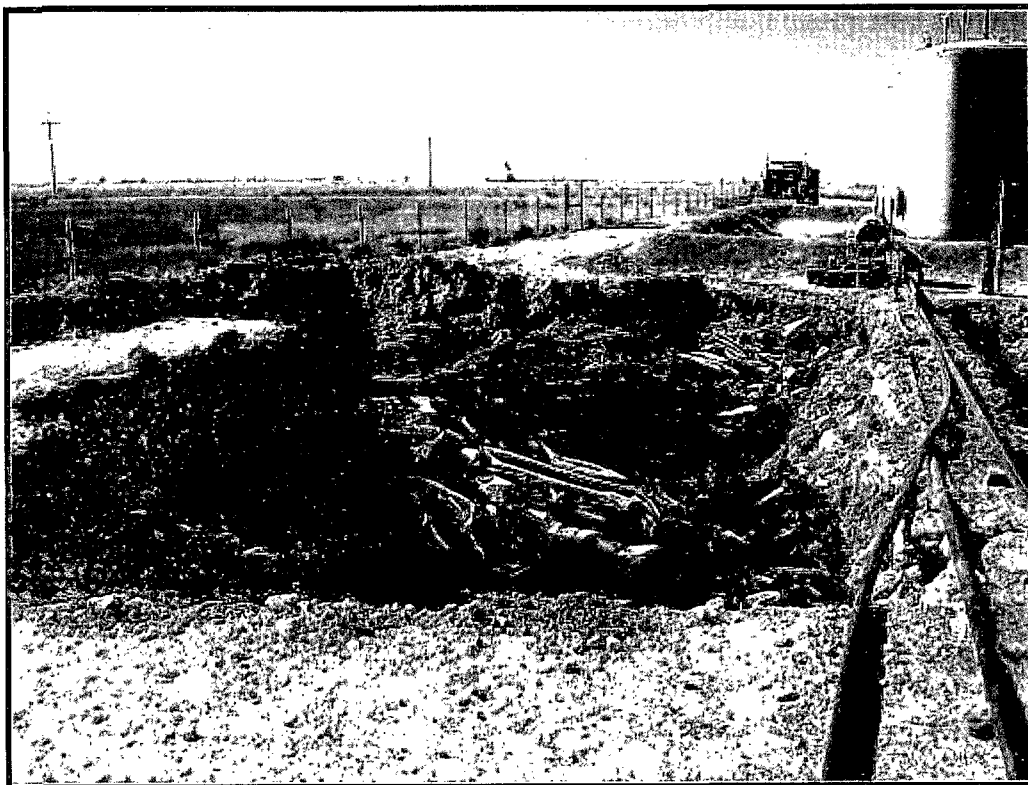
Excavated area lined facing south

Excavated area lined facing southeast

Excavated area lined facing east

Excavated area lined facing northwest

Excavated area lined facing west

A 20-mil improvised liner was installed at the bottom of the excavation to prevent any further migration. The area was then backfilled 1,000 yards of caliche from an offsite location. The location pad was then restored to its previous state.

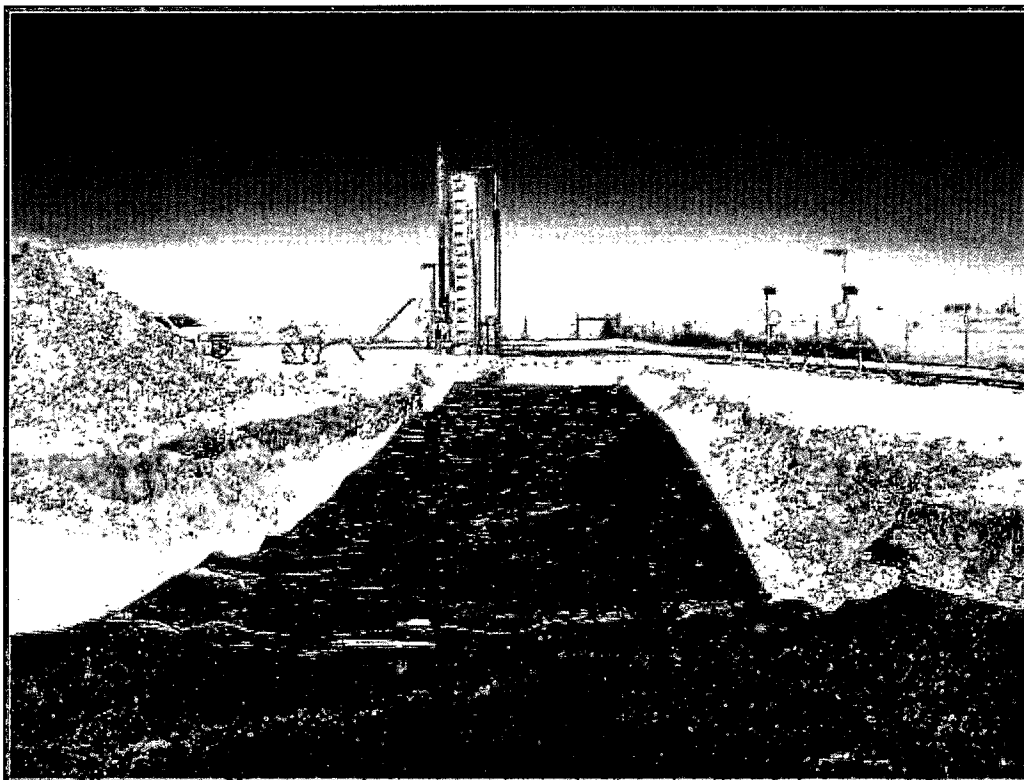
Excavated area facing north
