Release Notification and Corrective Action

**Cimarex Energy Company
Crestone #1
Section 12, Township 15S, Range 37E
Lea County, New Mexico**

Closure Report

January 17, 2011

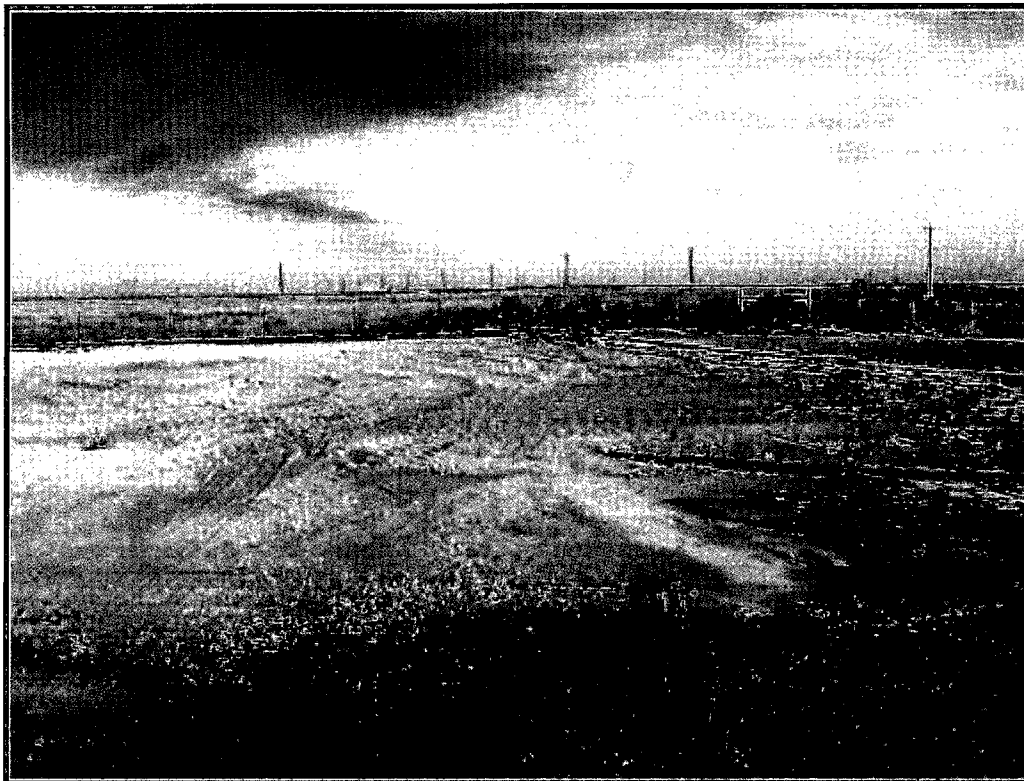
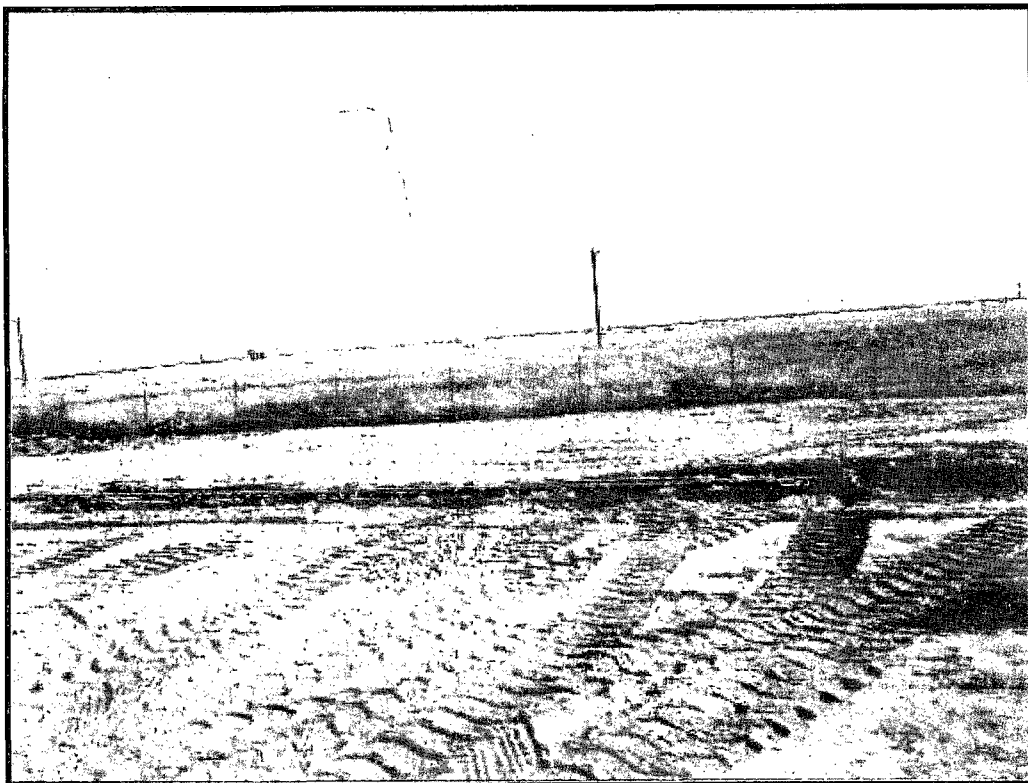
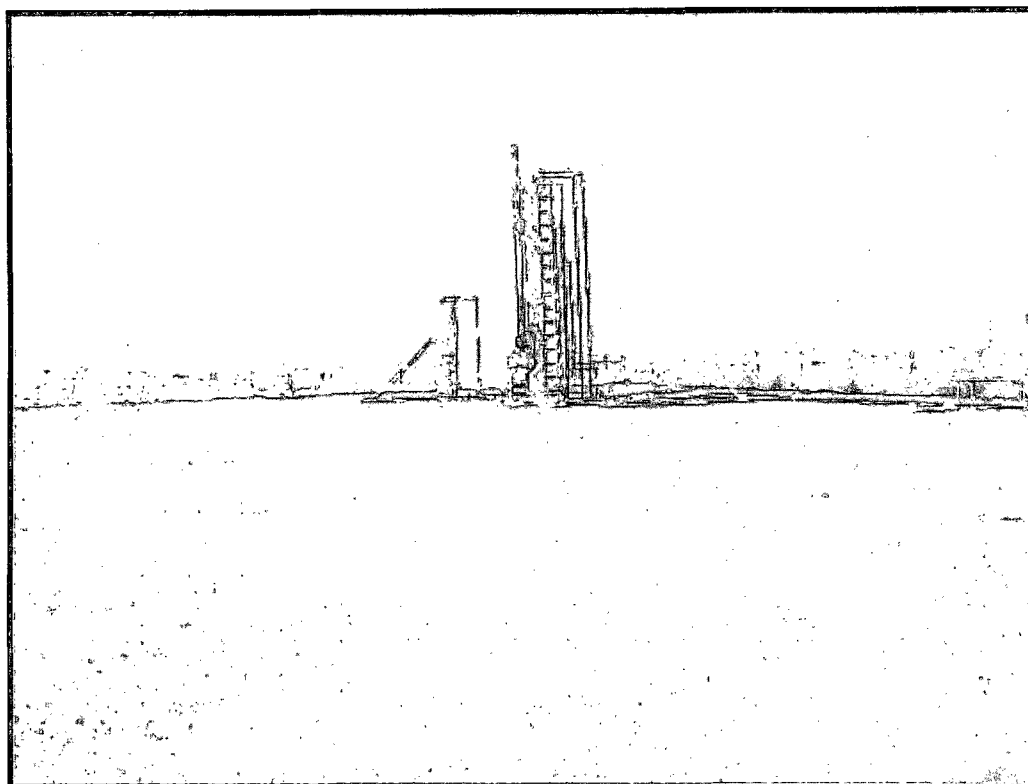
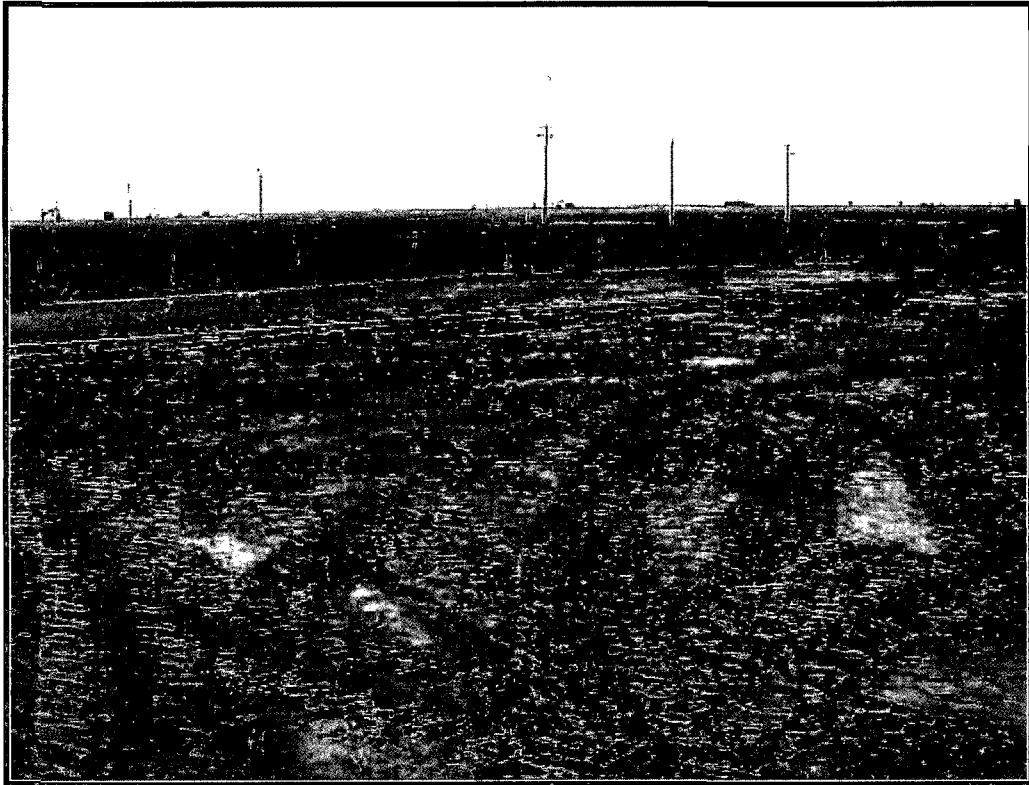
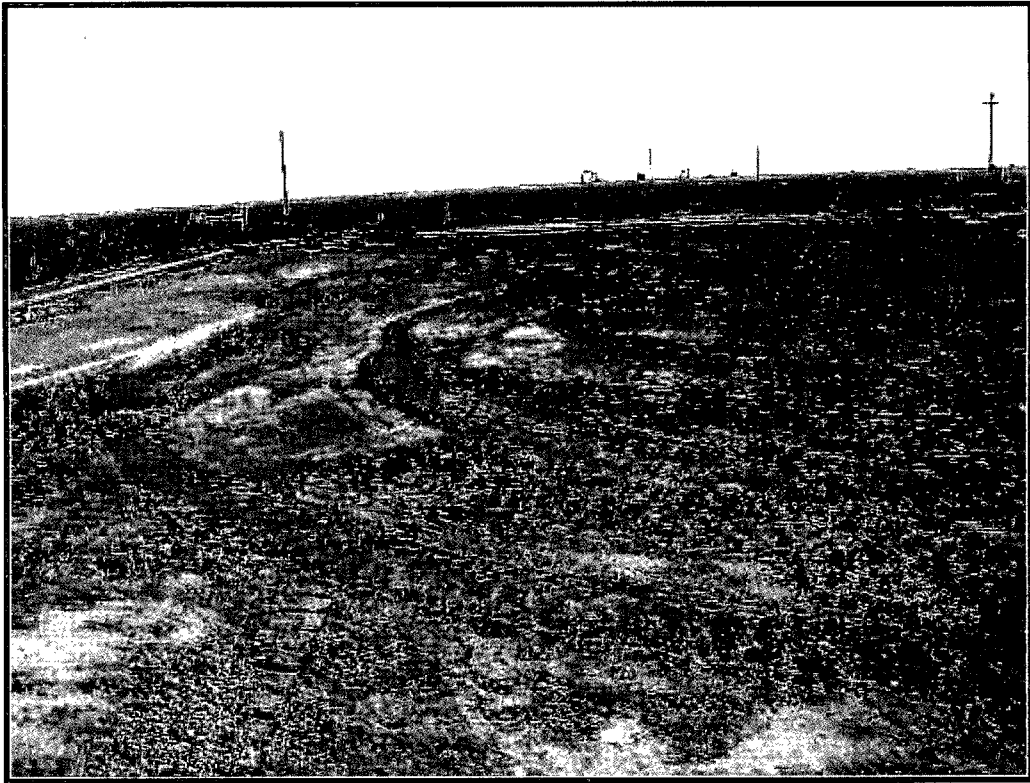
Backfilled area facing east

Backfill area facing southeast

Backfilled area facing north

Backfilled area facing south

A 20-mil improvised liner was installed at the bottom of the excavation to prevent any further migration. The area was then backfilled 1,000 yards of caliche from an offsite location. The location pad was then restored to its previous state.
