AP - 60

STAGE 1 & 2 REPORTS

RE: **Groundwater Monitoring Report & Remediation Termination Request**
Rice Operating Company EME SWD System
Sarah Phillips Jct - NMOCD Case Number 1R-427-17
K-33-1 Jct - NMOCD AP-60

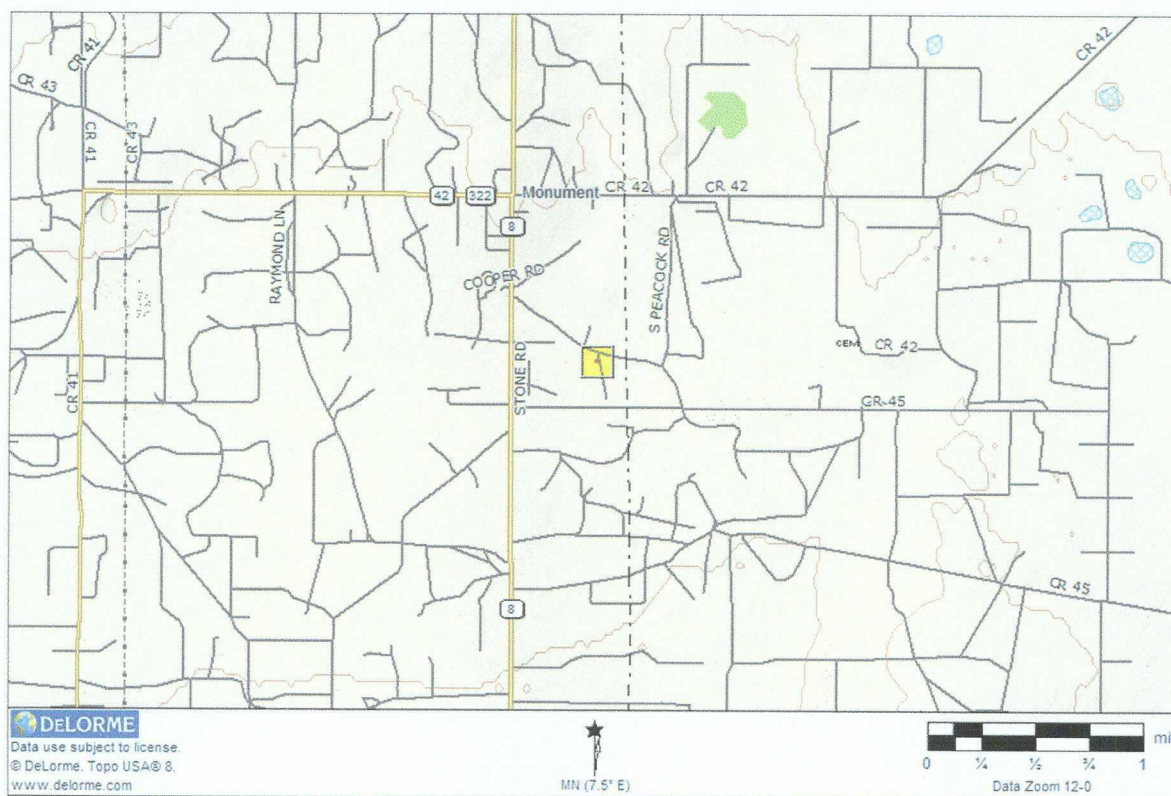
Figure 1 – Location of EME Sarah Phillips & K-33-1 sites (yellow box). The prevailing direction of groundwater flow is toward the southeast (lower right).

This letter presents and interprets groundwater chloride monitoring data collected for the above-referenced projects over the past several years. In this report we are aggregating the groundwater monitoring data from both the EME K-33-1 and the EME Sarah Phillips sites because of their close proximity (Figures 1, 2 & 3). The location of the K-33-1 and Sarah Phillips sites relative to the known regional chloride plume south of Monument is shown in Figure 4.

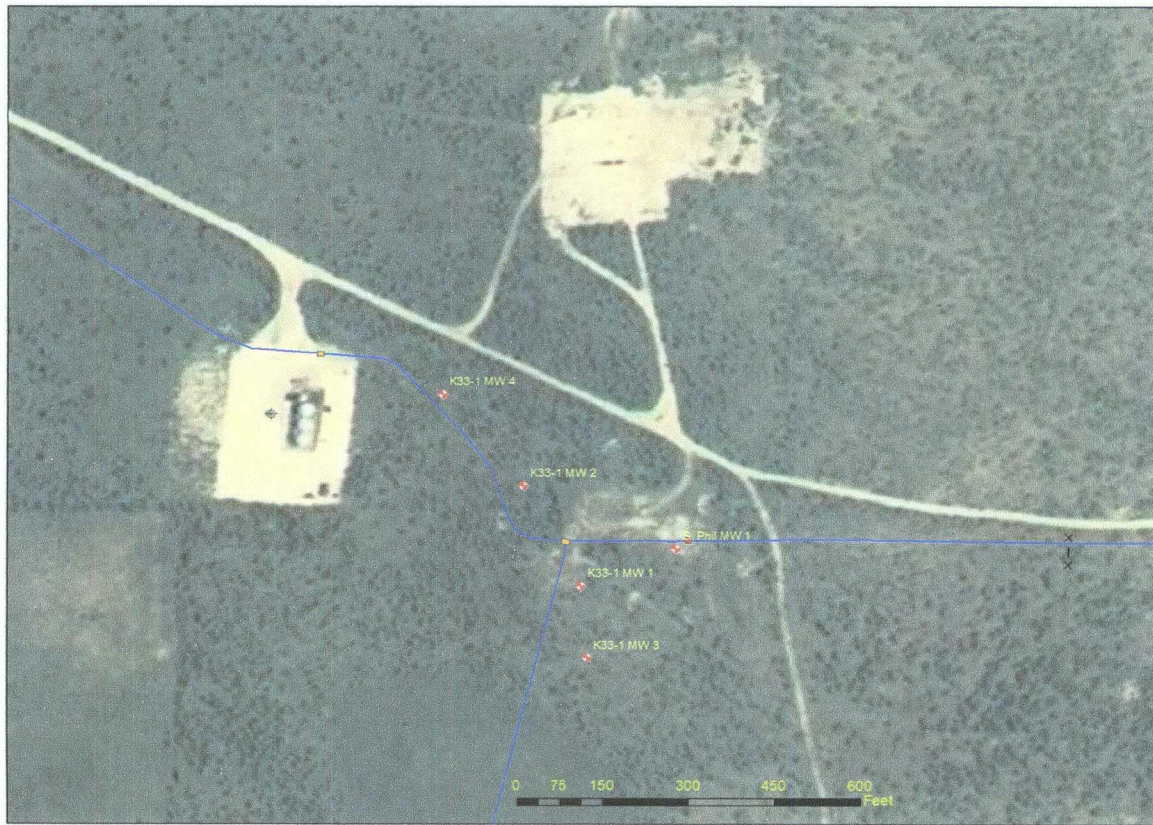
Figure 2 – Aerial photograph showing locations of Sarah Phillips and K-33-1 sites and monitor wells. The up-gradient monitor well (K-33-1 MW-2) provides data on the baseline quality of groundwater as it encounters and flows across the K-33-1 and Sarah Phillips locations.

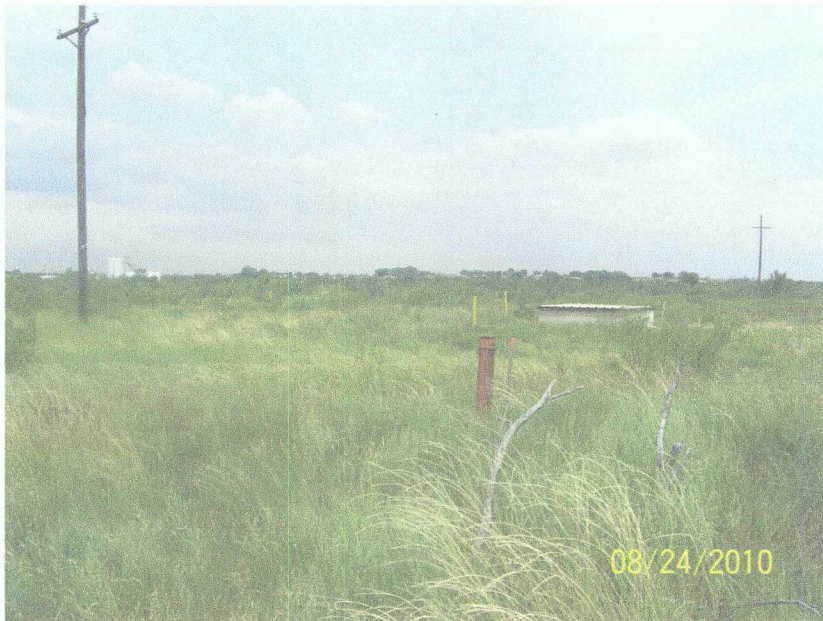
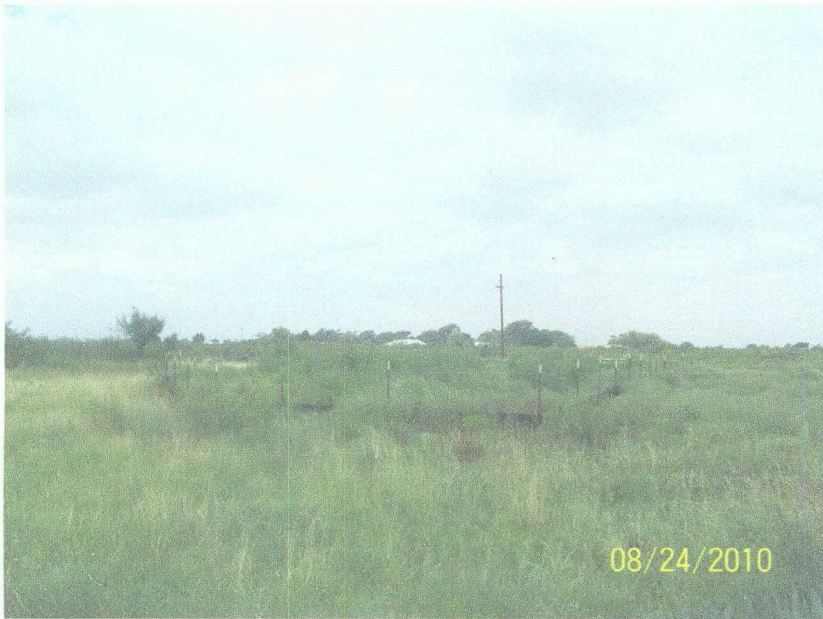
Figure 9 – Sarah Phillips and K-33-1 locations showing the reestablishment of natural vegetation. **9a** (upper photograph) – K-33-1 MW-1 facing North. **9b** (lower photograph) – Sarah Phillips facing West towards K-33-1.

It having been demonstrated that the observed impacts on groundwater quality beneath the Sarah Phillips and K-33-1 locations have apparently been caused by historical up-gradient land use practices which are gradually diminishing over time, and that natural vegetation is becoming reestablished across these sites (Figure 9), we respectfully request that NMOCD grant remediation termination or similar closure status to these projects.
